Docket No. 272 – Development and Management Plan Inspection

East Devon Substation Inspection

Date: December 20, 2007

Location: East Devon Substation

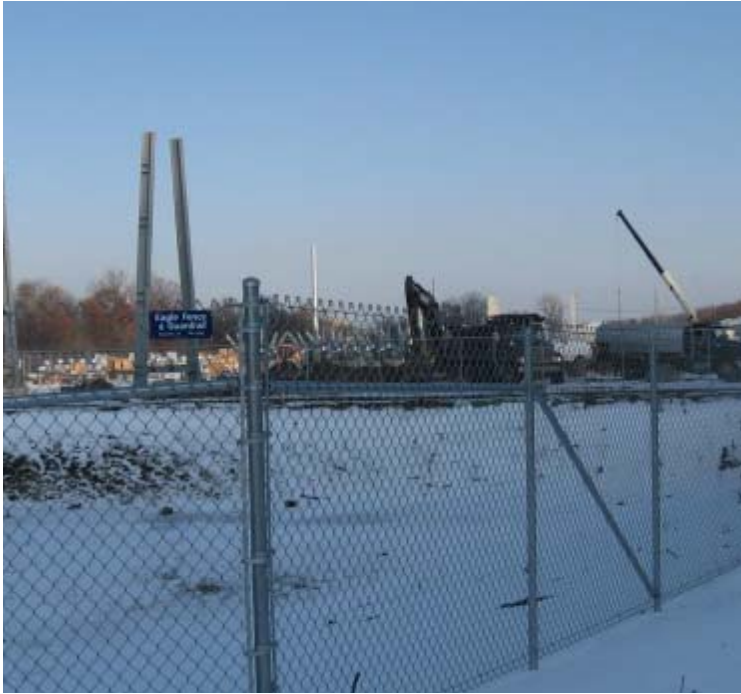
East Devon Substation (Milford): A general view of the construction at the substation.

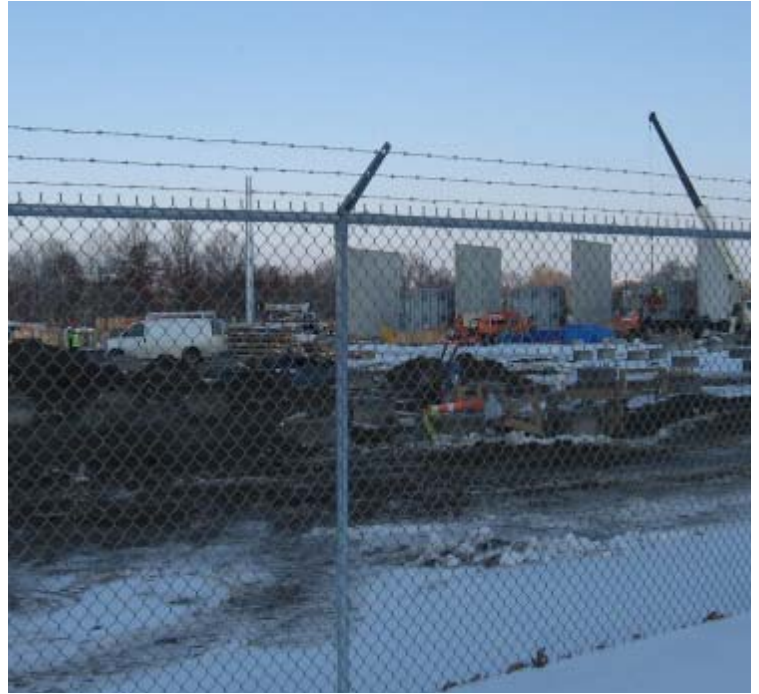
East Devon Substation: An additional view of the construction at the substation.

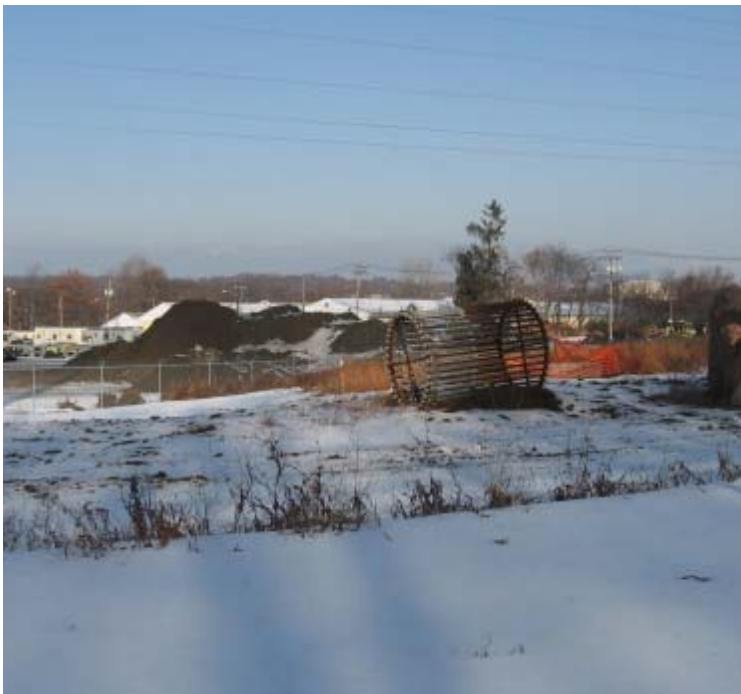
Areas of Inspection	Observation	Recommended Action	Corrected Action
Dewatering	Dewatering is not being performed for substation work at this time. 12/20/07	None at this time. 12/20/07	NA
Blasting	No blasting is proposed at this time. 12/20/07	None at this time. 12/20/07	NA
Spills, Soils and Material Storage	Construction materials and equipment are kept on the substation site and at the receiving yard located to the east of Shelland Street. 12/20/07	In general, store materials and equipment appropriately. Ensure that vehicles are equipped with spill kits and maintain them when needed. All construction vehicles should be parked at least 100 feet from a wetland or waterbody when feasible. 12/20/07	NA
	All spoils from foundation work are being stored in the northeast corner of the substation site. Soils appear to be contained on site. 12/20/07	Continue to monitor and remove spoils when feasible. 12/20/07	NA

East Devon Substation: All spoils from foundation work are being stored in the northeast corner of the site. The spoils appear to be contained on site.

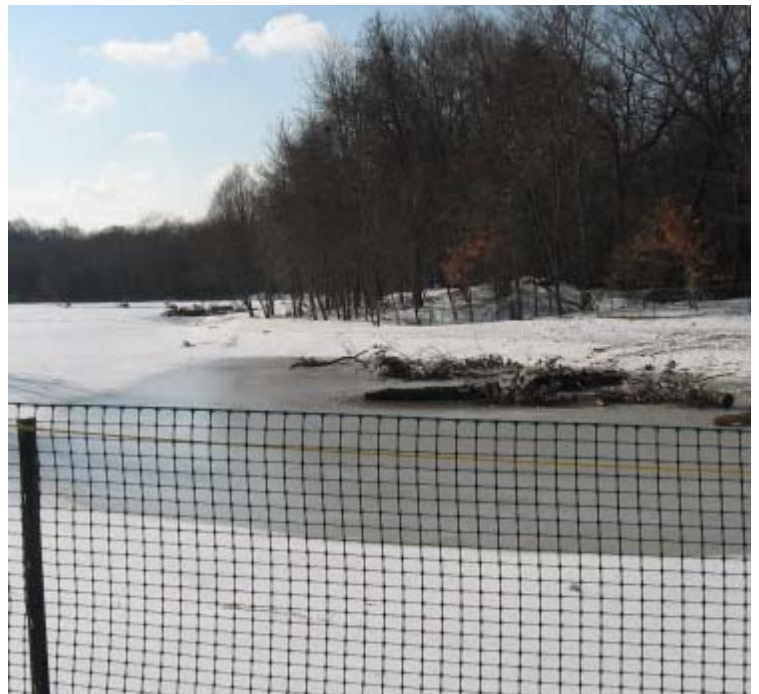
Areas of Inspection	Observation	Recommended Action	Corrected Action
	<p>Shelland Street. Stone is in place around the catch basins on the western portion of the site. 12/20/07</p> <p>Sediment build up was noted at some of the CBs on Plains Rd. “Silt saks” (or similar) remain intact but curb drop inlet protection has not been provided for any of the CBs. 12/20/07</p>	<p>Continue to monitor. Sweep the roadway on a regular basis and clean the catch basins as necessary. Curb inlet protection should be provided in areas immediately adjacent to access roads. 12/20/07</p>	<p>“Silt saks” are in place. Catch basins need regular attention</p>
<p>Inland Wetland and Watercourse encroachment and mitigation</p>	<p>Two wetlands, 300 A and 300B, were cleared and filled during the construction process, as permitted. Construction of the associated wetland mitigation areas appears to be complete near structure #3839 in Eisenhower Park at this time. 12/20/07</p>	<p>Continue to monitor mitigation areas until final stabilization is achieved. 12/20/07</p>	<p>All disturbed areas have been temporarily stabilized with erosion control blankets.</p> <p>Woody debris has been added to create wildlife habitat.</p>

Eisenhower Park-Wetland Mitigation Site (Milford): Woody debris has been added to the site to create wildlife habitat.
