Docket No. 272 – Development and Management Plan Inspection

Segment 1a Inspection

Date: December 3, 2007

Location: Segment 1a – Scovill Rock Switching Station to Chestnut Junction, Oxbow Junction to Beseck Switching Station (excluding Royal Oak Bypass), and Black Pond Junction to Beseck Switching Station

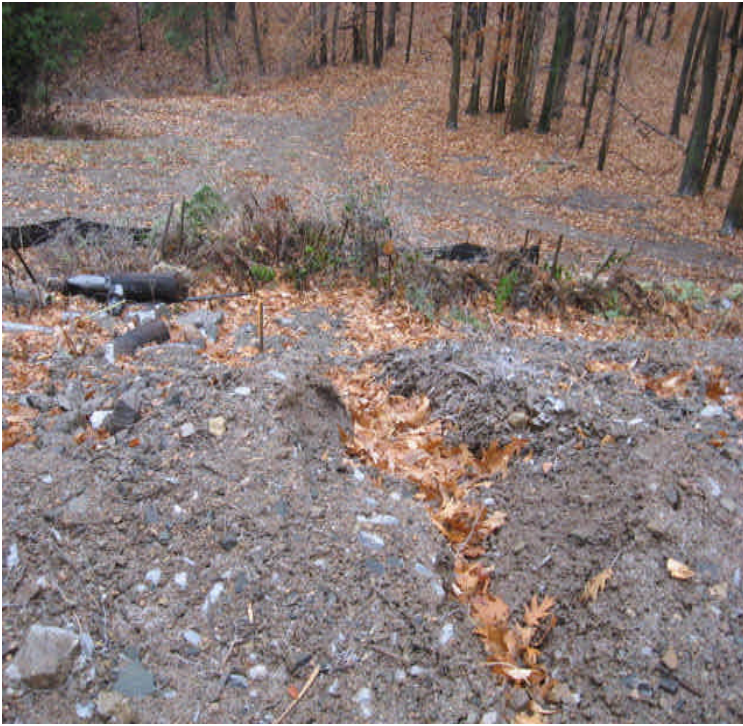
Black Walnut Dr: Silt fence remains in place upgradient from Ball Brook at the base of the washouts. Monitor silt fence but address the problem at the source. Repair the gullies and re-stabilize the slope, especially as work activities are not returning

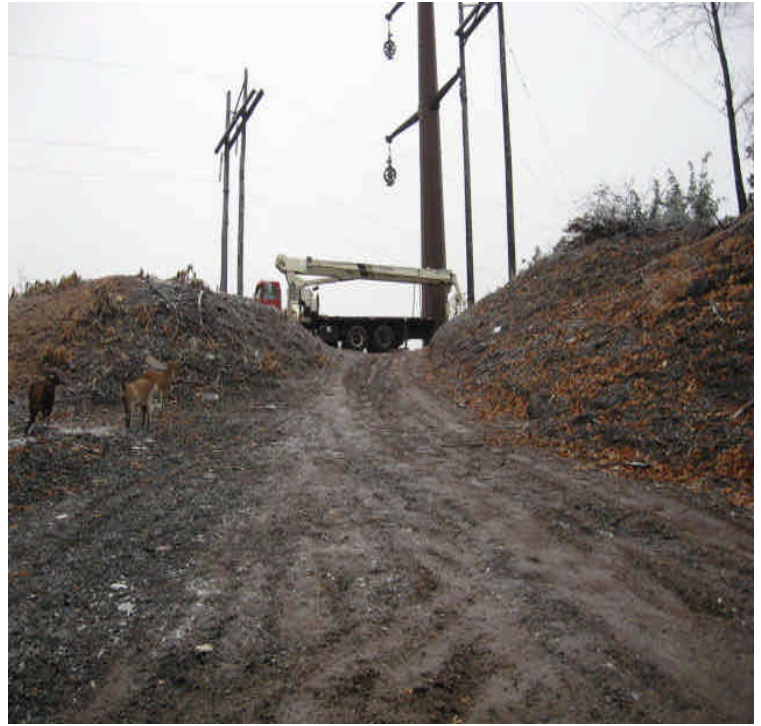
Transfer Station: Equipment was in place, preparing for line work from Little Lane through the golf course.

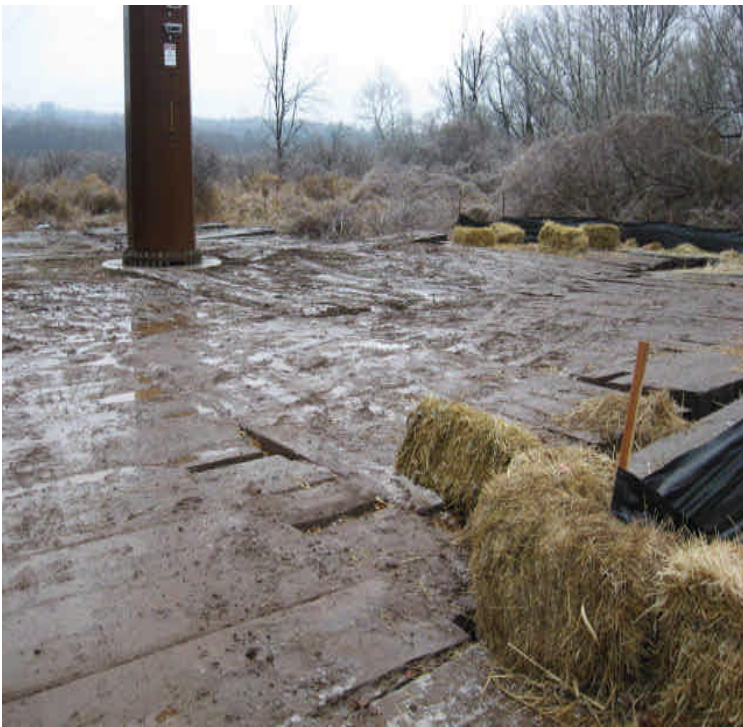
Durham Rd Golf Course: View of the structure installed within the wetlands upgradient from Durham Meadows.

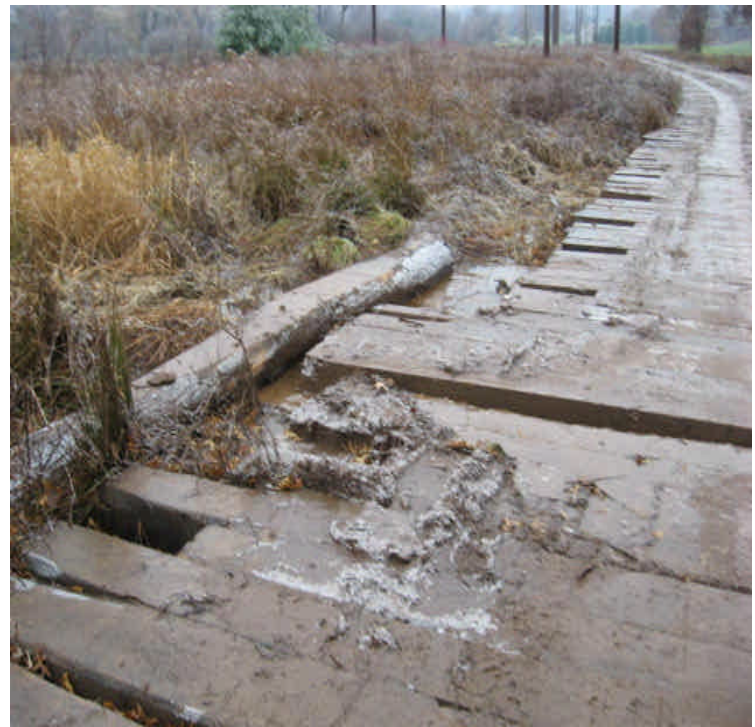
Durham Rd Golf Course: Matted access road with sediment accumulation due to timber mats compressing into the soil surface. Turbid water was noted in wetlands when mats are in use.

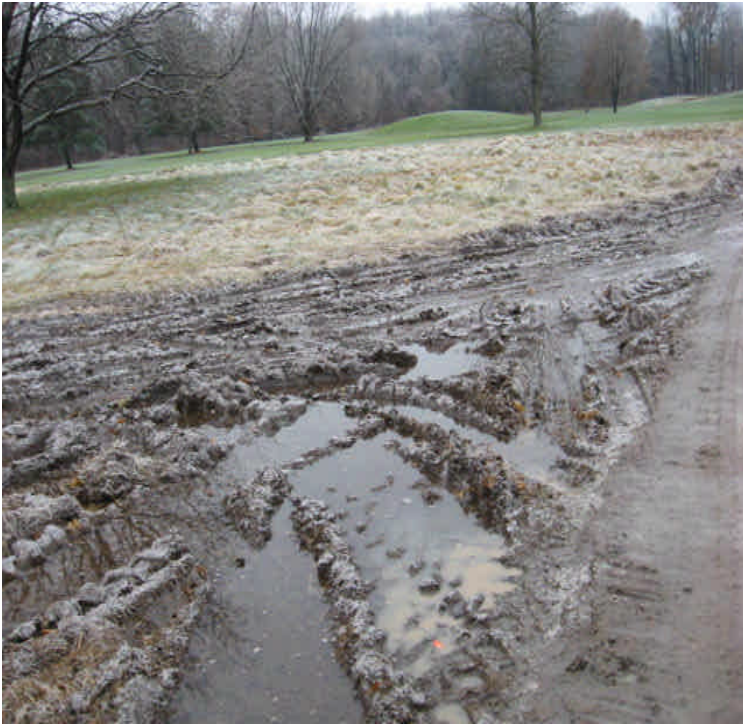
Durham Rd Golf Course: Heavy ruts from equipment were noted just off the timber mats and stone access road. Additional mats should be used here or the area should be regraded and stabilized.

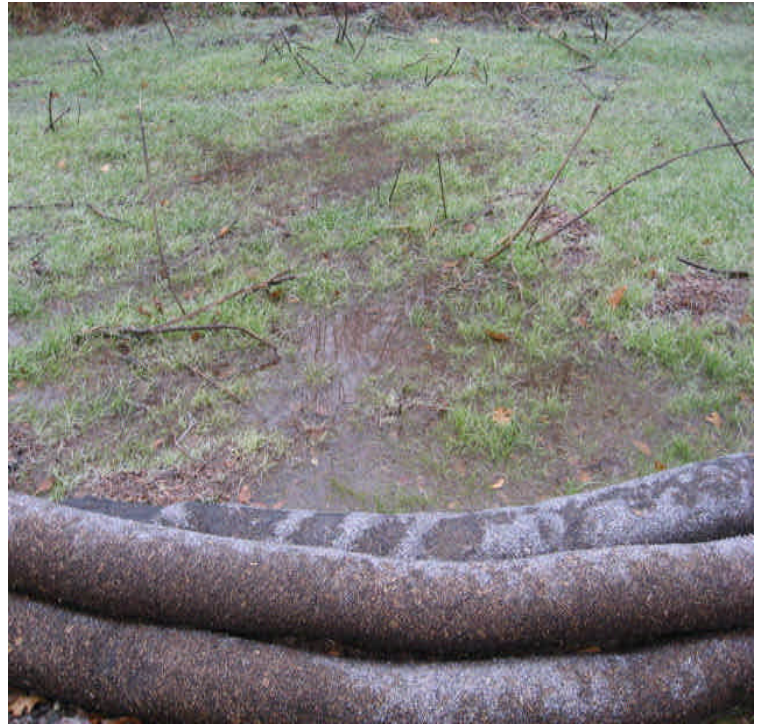
N. of Beseck SS: Water bars have been installed along access roads to divert stormwater to stable areas. Turbid water was not noted within the wetlands since installation.

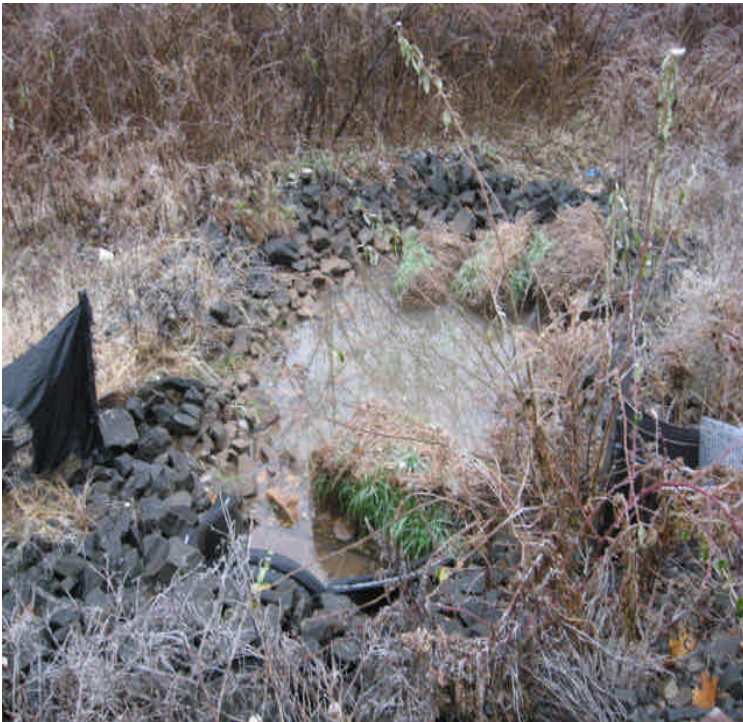
E. of Beseck SS: Turbid water from the access road was overflowing out of the sediment trap. Wetlands are located to the east.

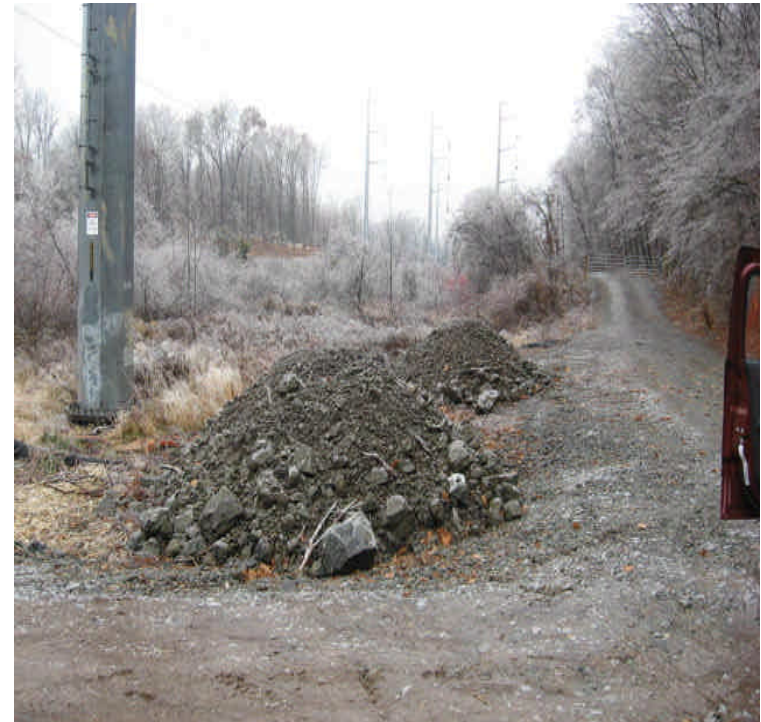
North of High Hill Rd: Three soil stockpiles were located within the wetlands adjacent to the access road and timber mat pad. These should be removed immediately. Reinforce controls to identify wetland boundaries.
