Docket No. 272 – Development and Management Plan Inspection

Segment 1a Inspection

Date: December 10, 2007

Location: Segment 1a – Scovill Rock Switching Station to Chestnut Junction, Oxbow Junction to Beseck Switching Station (excluding Royal Oak Bypass), and Black Pond Junction to Beseck Switching Station

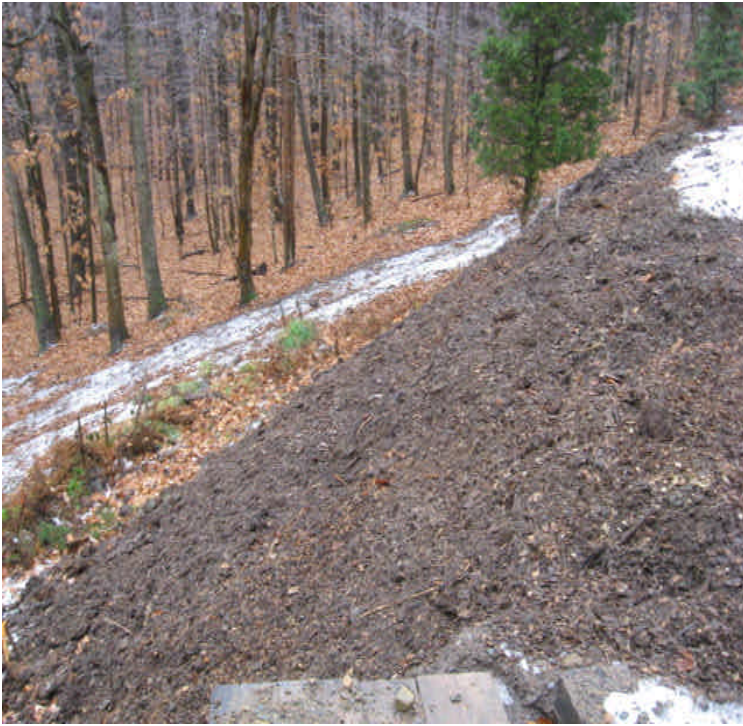
Black Walnut Dr: Silt fence remains in place upgradient from Ball Brook. The washouts on the slope have been graded and stabilized with heavy mulch.

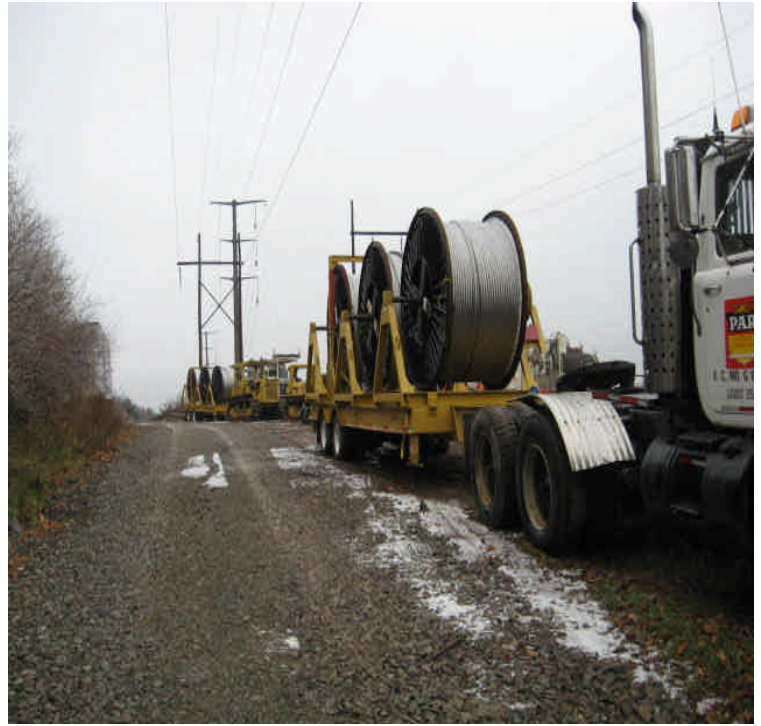
Little Lane: Line pulling equipment and crews working from Little Lane through to Powder Hill Rd.

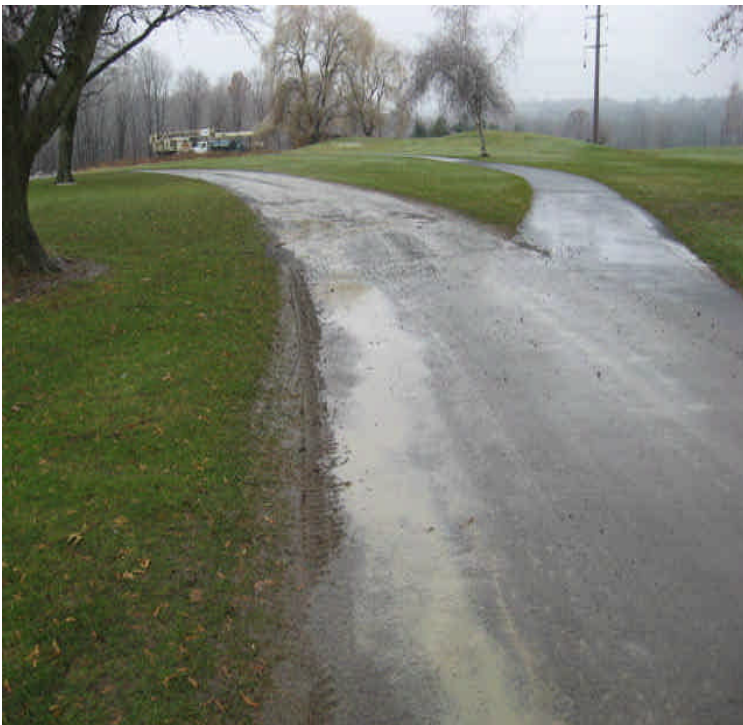
Durham Rd Golf Course: Turbid run-off noted coming from work and running along pave paths within the golf course. Attempt to control turbidity at the source.

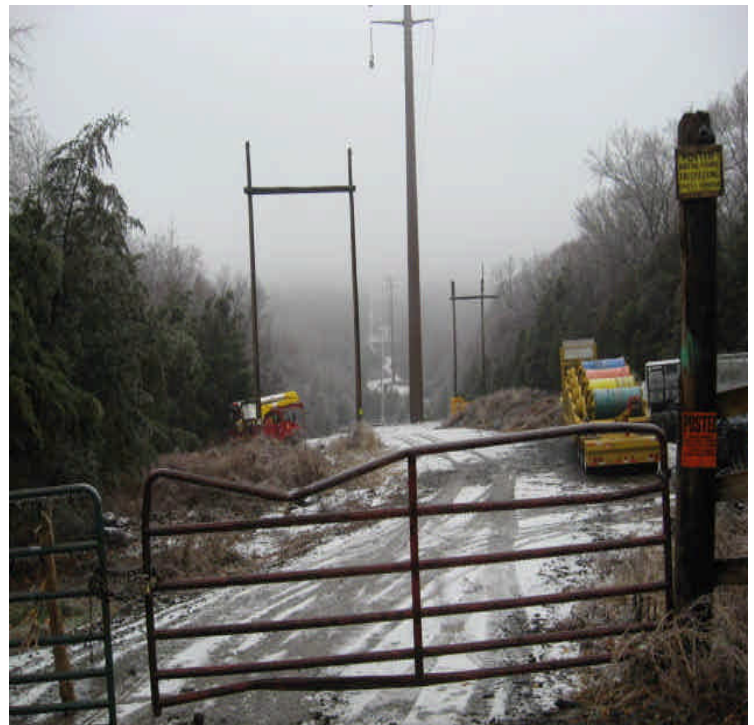
Powder Hill: Pulling equipment was in place for stringing line from Little Lane.

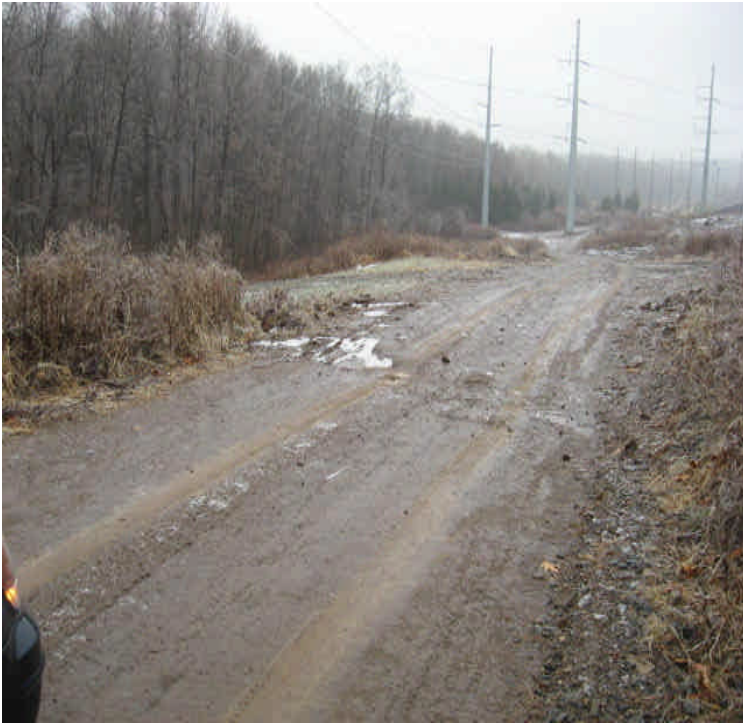
East of BSS: Drainage channels/waterbars installed to divert stormwater. Additional controls may be needed to filter stormwater before flowing off site.

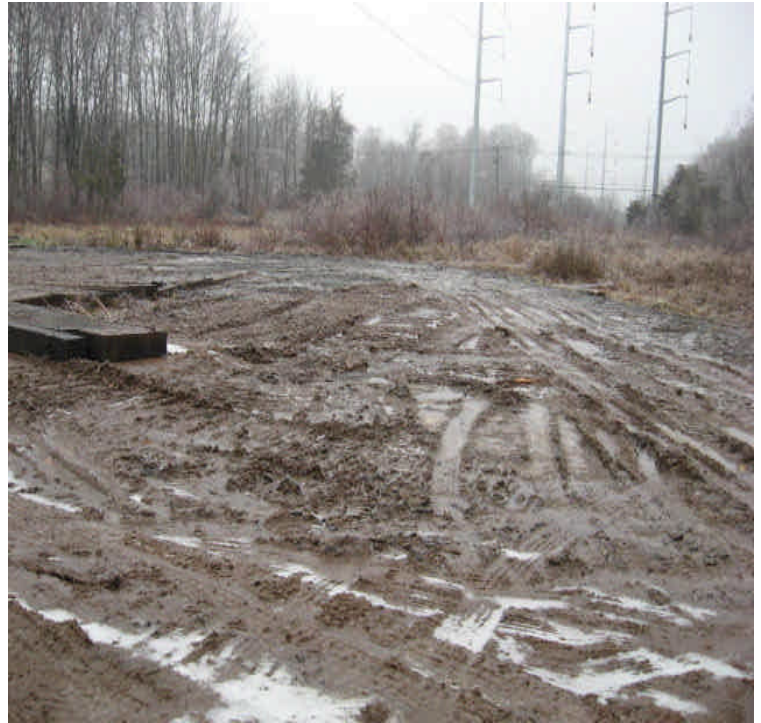
S. of High Hill Rd: Large disturbed area with mats remains partially covered with sediment. Add controls and provide temporary stabilization.

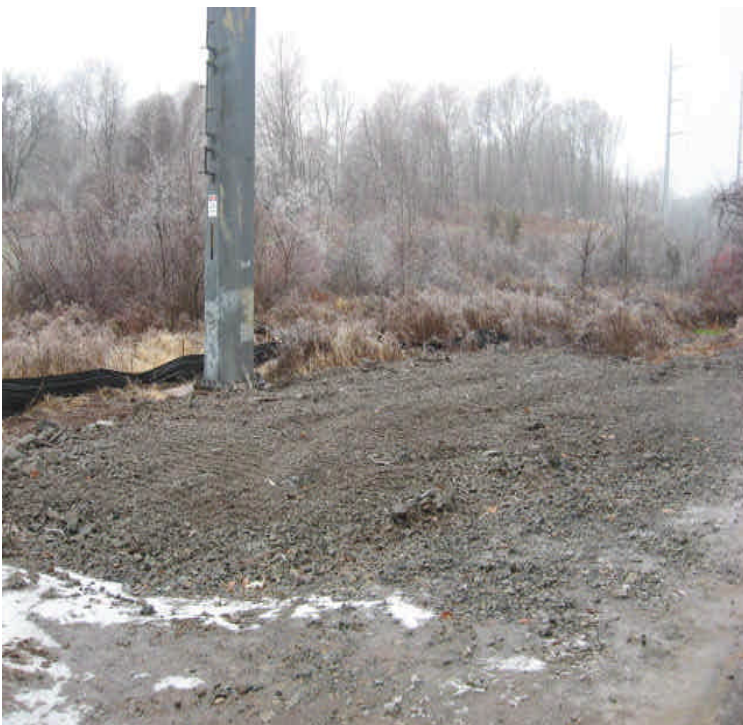
N. of High Hill: Soil stockpiles that were noted in the wetland last week were actually intended to create a lay down area for the existing structure here. Controls have been installed. Ensure all gravel is removed from the wetlands when work is completed. Timber mats may have been a better option in this case.

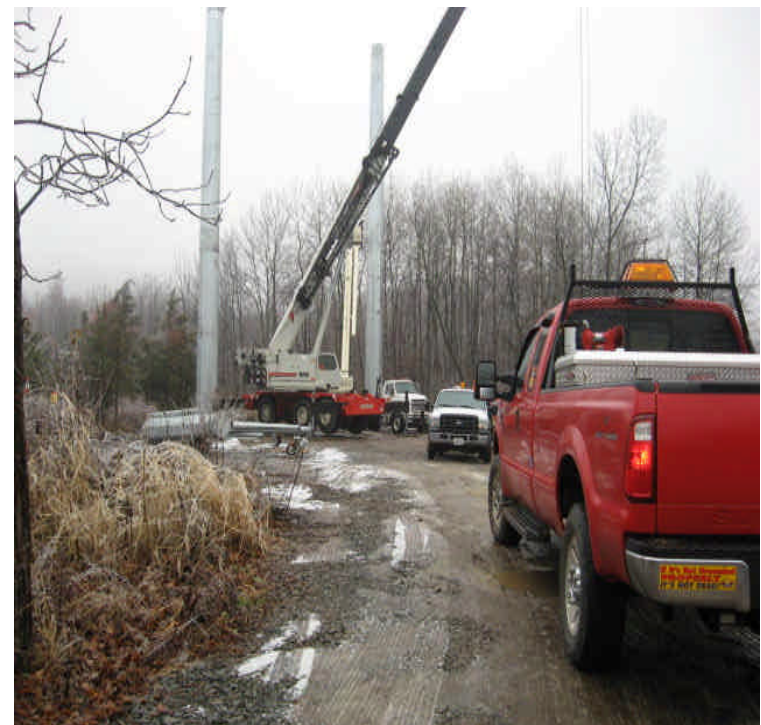
South of East Main St.: Pole installation was underway.
