Docket No. 272 – Development and Management Plan Inspection

Segment 1a Inspection

Date: December 26, 2007

Location: Segment 1a – Scovill Rock Switching Station to Chestnut Junction, Oxbow Junction to Beseck Switching Station (excluding Royal Oak Bypass), and Black Pond Junction to Beseck Switching Station

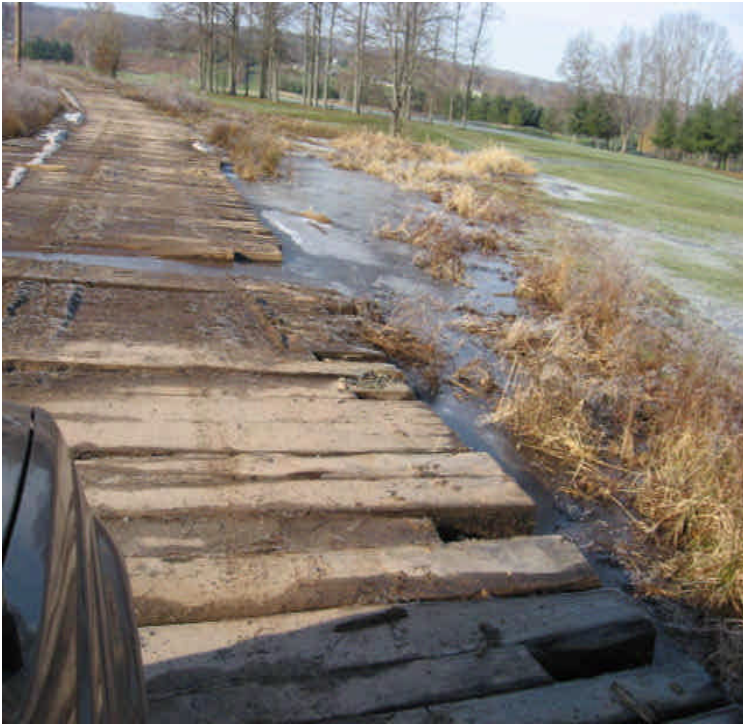
Durham Rd: Timber mats are compressing into soils at the wetland crossing

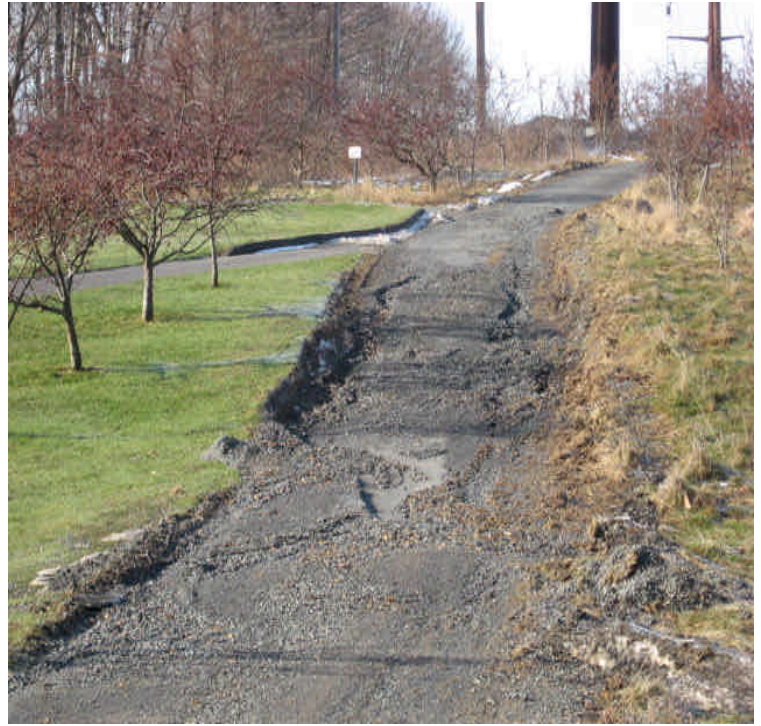
Durham Rd: Minor erosion noted along a slope on the access road.

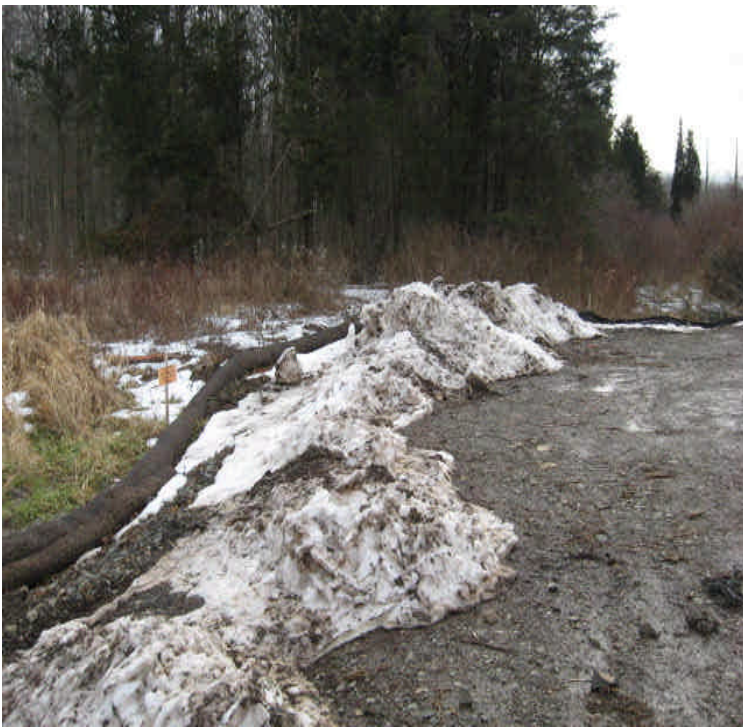
Carpenter Ln: Snow stockpile located at controls adjacent to the wetland. Use caution and observe wetland boundaries when plowing snow in order to keep snow and sediment contained.

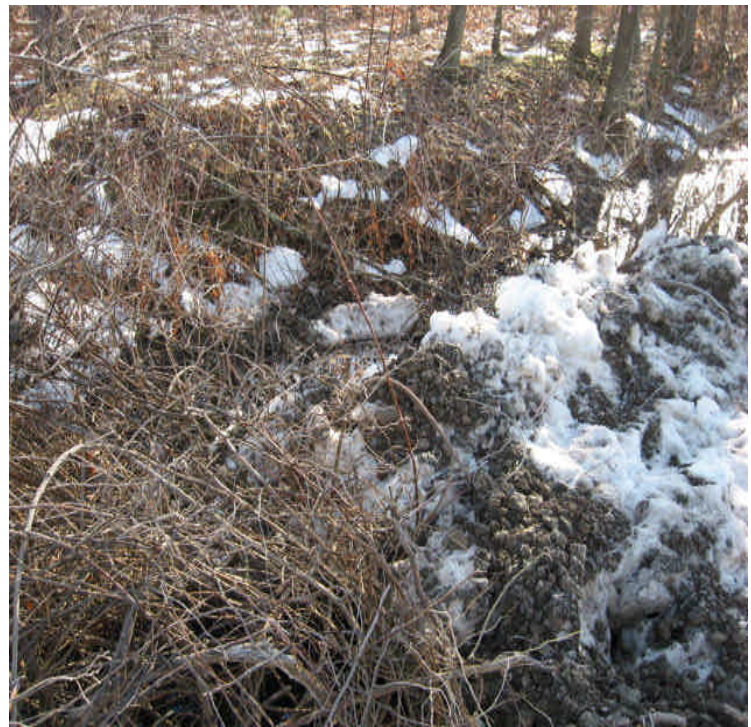
S. of East Main St: Snow was plowed beyond controls into wetlands and a flowing channel. Remove snow and the associated sediment as soon as possible.
