Docket No. 272 – Development and Management Plan Inspection

Segment 1a Inspection

Date: December 31, 2007

Location: Segment 1a – Scovill Rock Switching Station to Chestnut Junction, Oxbow Junction to Beseck Switching Station (excluding Royal Oak Bypass), and Black Pond Junction to Beseck Switching Station

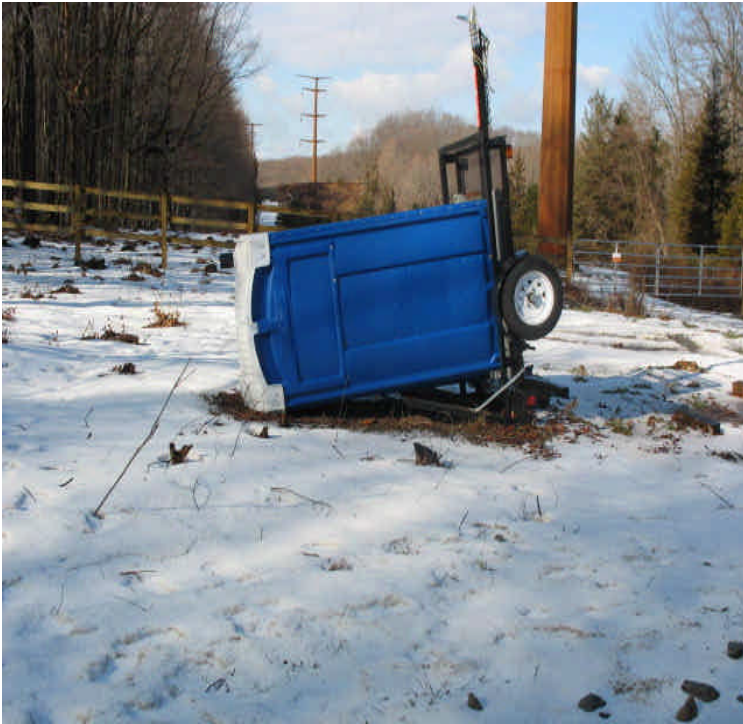
Arbutus St: Sanitary facility remains tipped over but crews are on break.

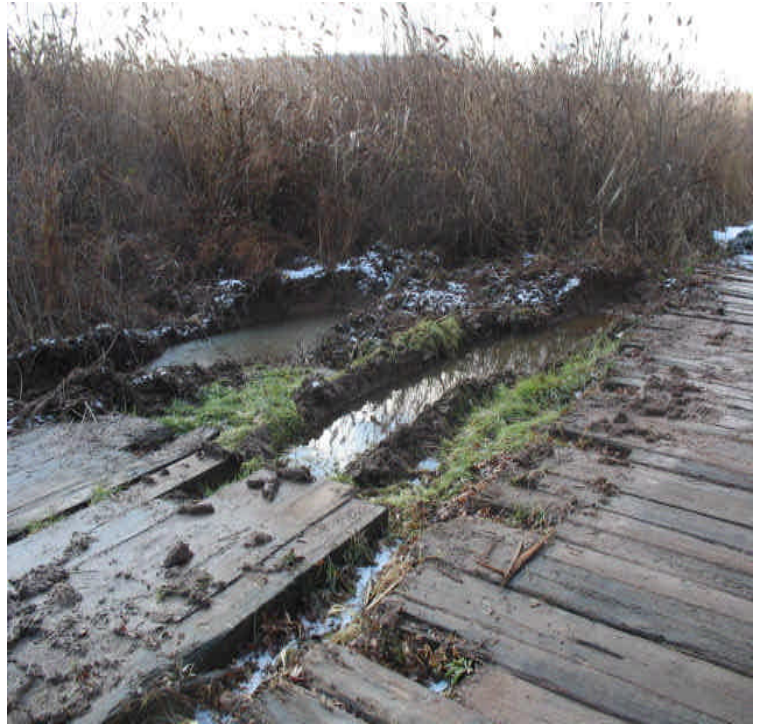
Durham Rd: View of the ruts created off the edge of the timber mats in the wetlands. This occurred several weeks ago when equipment was anchoring lines. Once crews return from break, this should be carefully repaired.

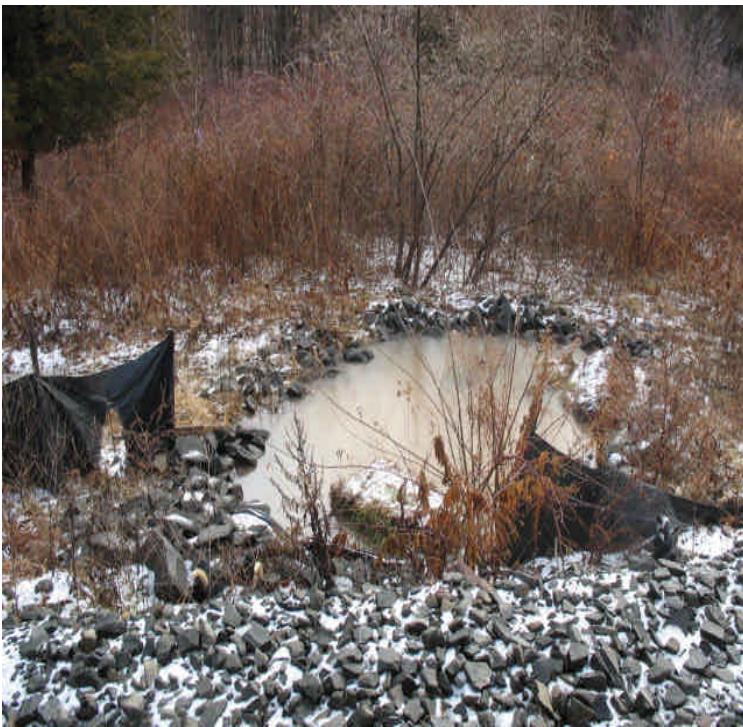
Carpenter Ln: Turbid water from access road run-off was noted in the sediment trap adjacent to Beseck.

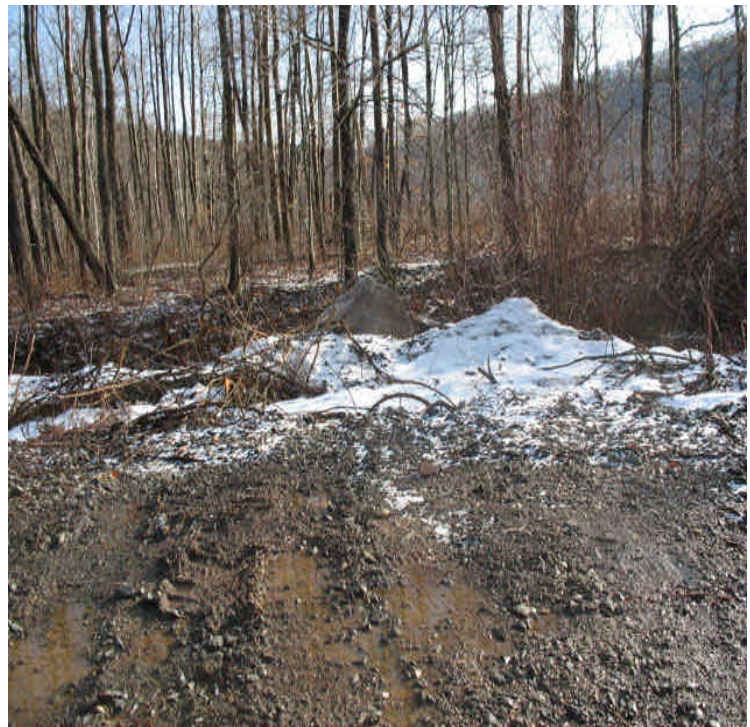
S. of East Main St: Prior to the break, snow was plowed into a wetland and a flowing channel. Remove the snow and associated sediment as soon as possible.
