**Docket No. 272 – Development and Management Plan Inspection**

**Segment 1b (Royal Oaks Bypass) Inspection**

**Date:** November 12, 2007

**Location:** Segment 1b (Royal Oaks Bypass)

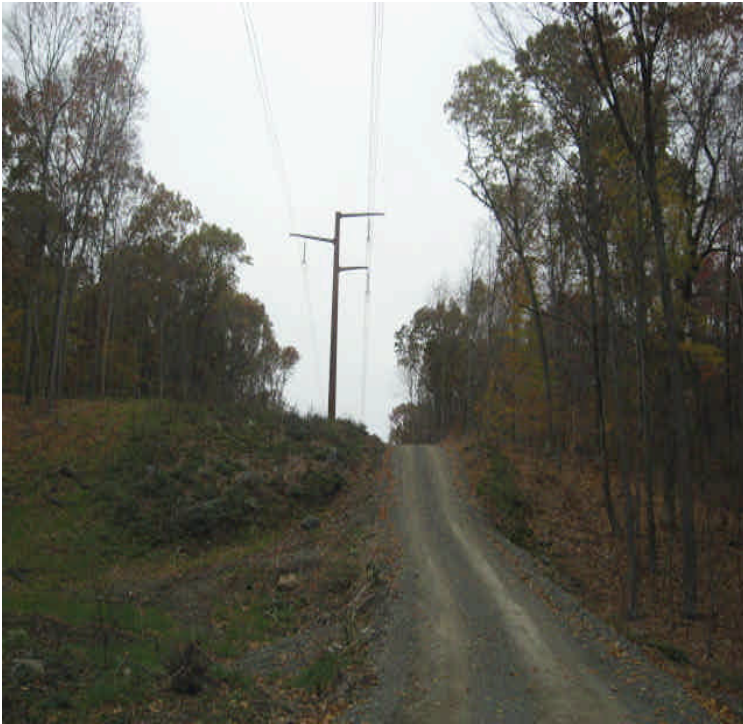
**Minor erosion noted along the access road at the steep slope off Black Walnut Drive.**

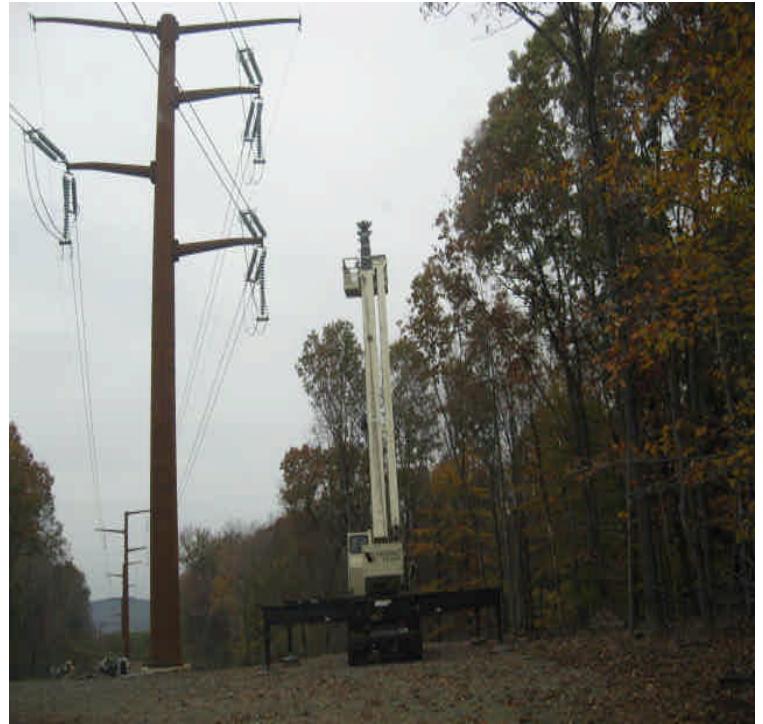
<b>Areas of Inspection</b>	<b>Observation</b>	<b>Recommended Action</b>	<b>Corrected Action</b>
	<b>wetland edge within the Laurel Brook watershed protection area last week was no longer stored here but was actively working in this area. 11/12/07</b>	<b>from wetlands when not actively working 11/12/07</b>	
<b>Additional Observations</b>	<b>None. 11/12/07</b>	<b>None. 11/12/07</b>	<b>NA</b>

**Equipment was active at the edge of the wetlands within the Laurel Brook Watershed Protection Area for line work.**

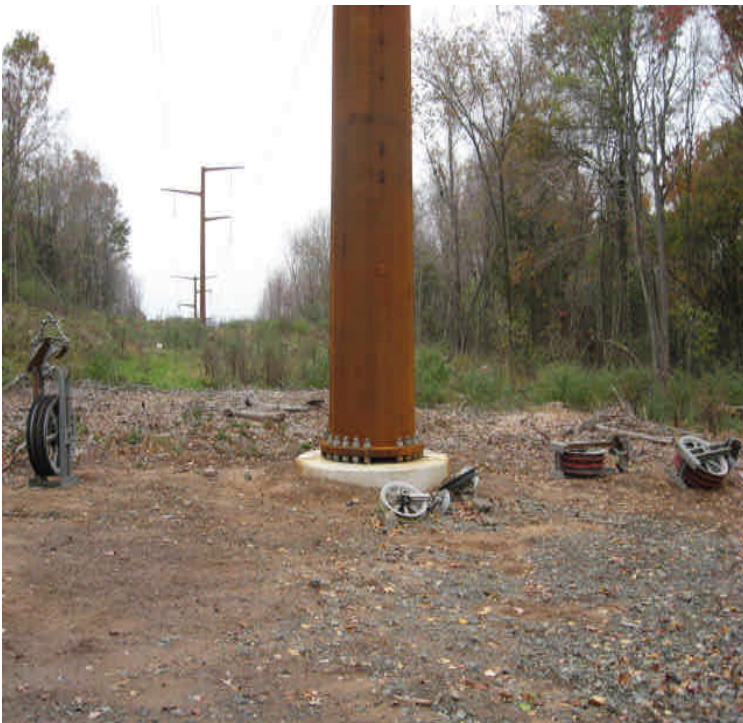
**View of line pulling materials.**

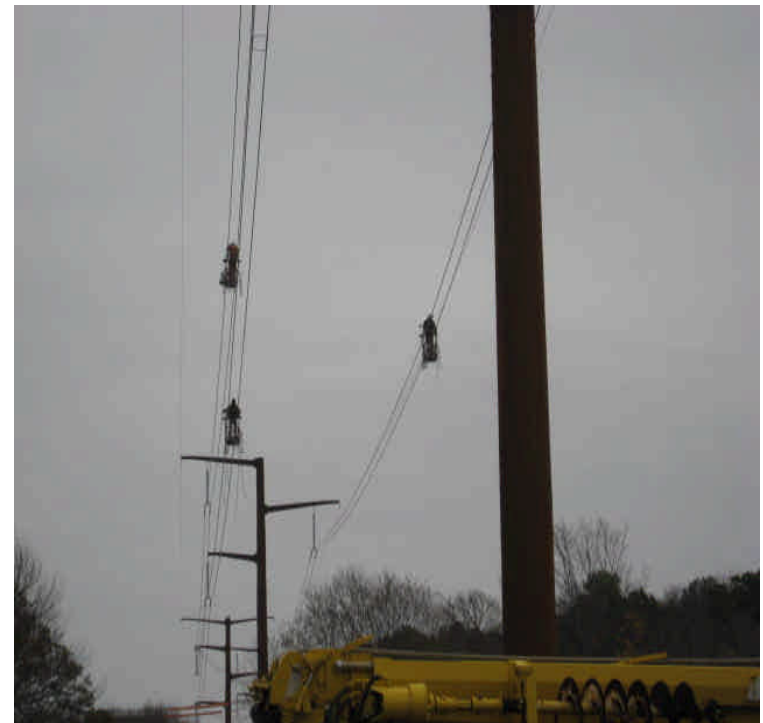
**Line work underway near the contractor receiving yard.**
