Docket No. 272 – Development and Management Plan Inspection

Segment 1b (Royal Oaks Bypass) Inspection

Date: November 26, 2007

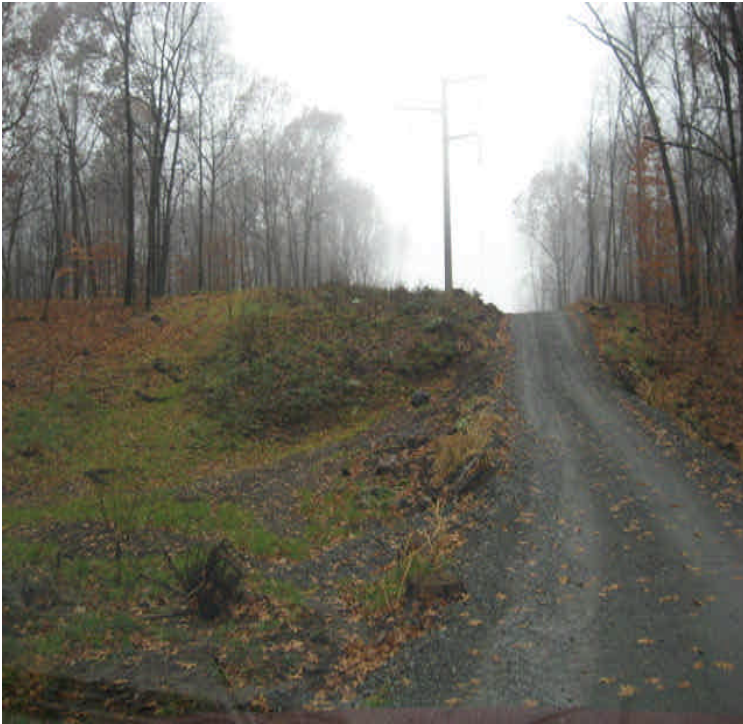
Minor erosion remains along the access road off Black Walnut Drive.

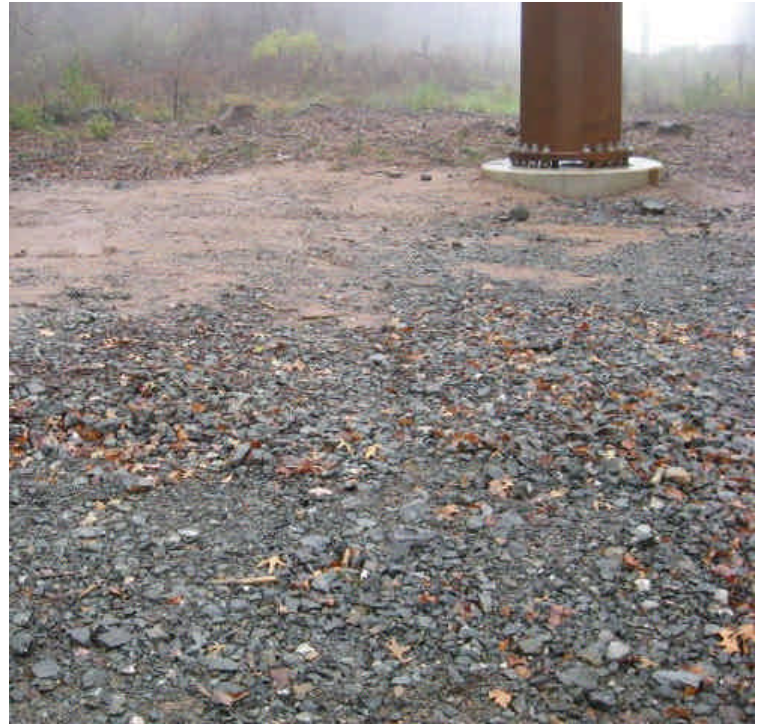
Stone from the pad is sinking into the soil and being covered over, adjacent to the no access area.

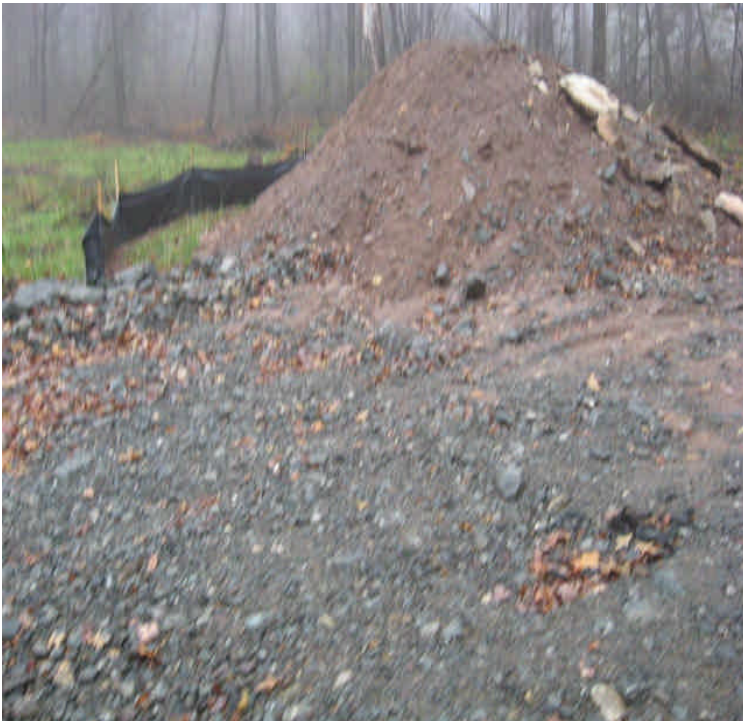
Soil stockpile off Black Walnut Drive with silt fence in place at it's base.

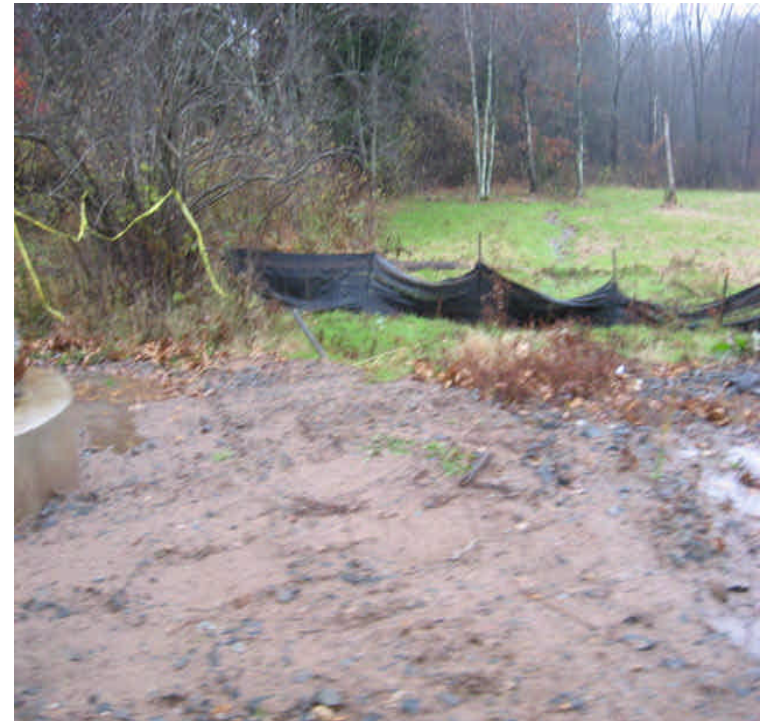
View of silt fence adjacent to wetlands at the 1A & 1B connection off Little Lane.
