Docket No. 272 – Development and Management Plan Inspection

Segment 1b (Royal Oaks Bypass) Inspection

Date: December 3, 2007

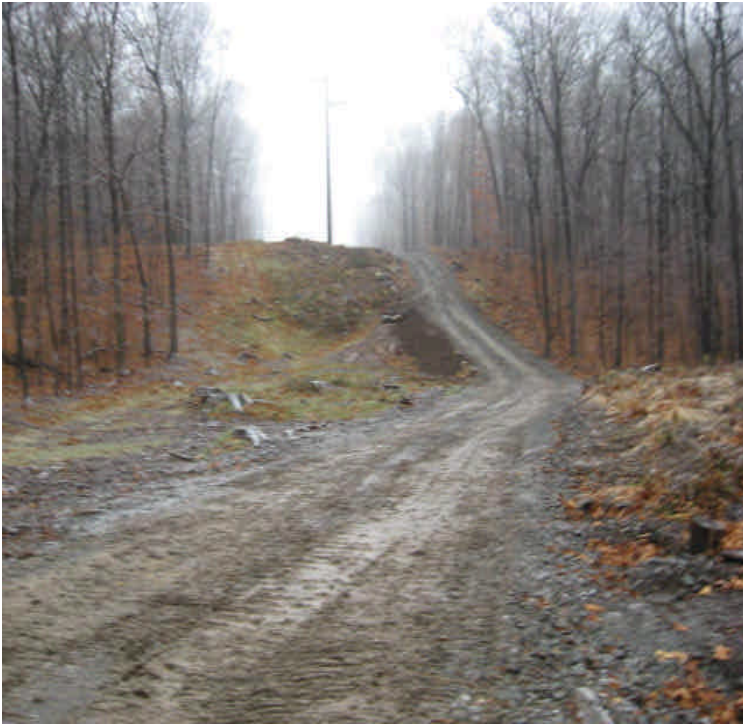
The minor erosion along the access road off Black Walnut Drive has been regraded and a water bar has been installed.

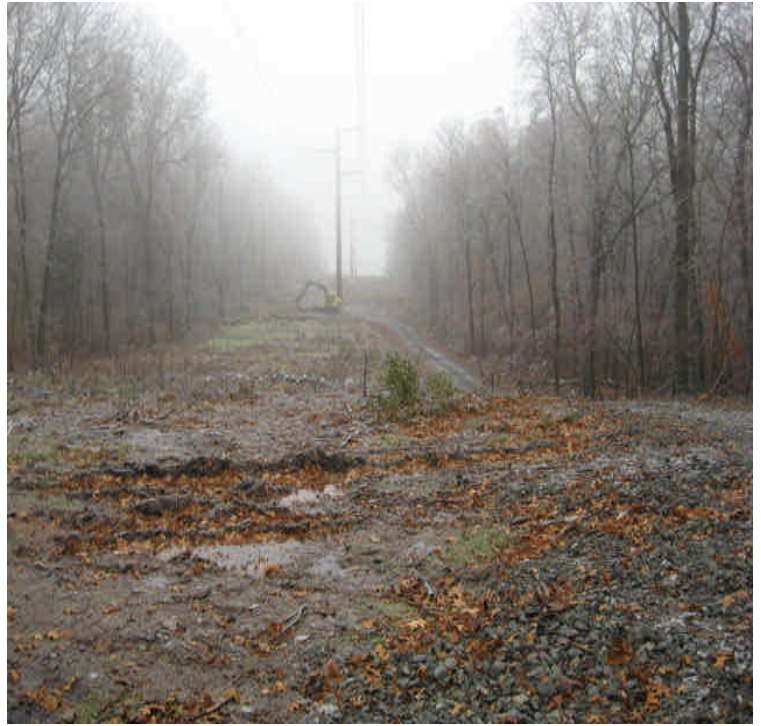
Pad work was noted at the last structure access off Black Walnut Drive

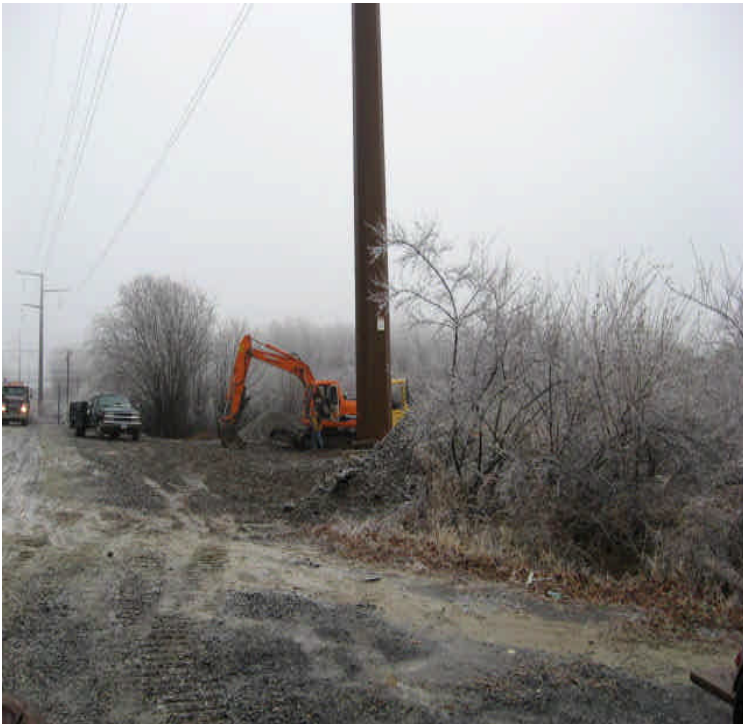
Grading and application of new stone was noted within the receiving yard. Turbid water noted flowing within the site.

Crews were adding stone to the access drives in the contractor receiving yard	Monitor new stone for effectiveness. See erosion control section for details.	Stone was added to the access drives but more attention is needed.

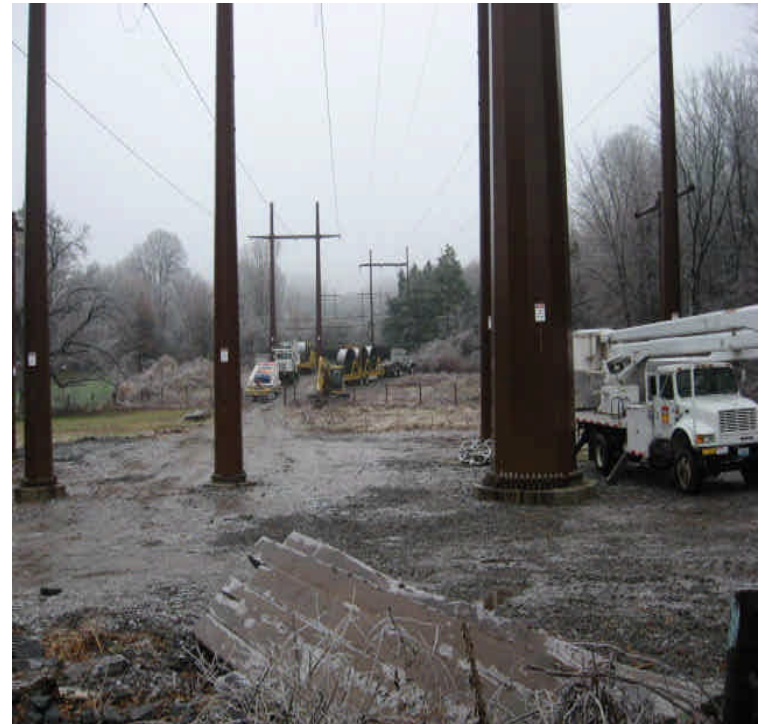
View of the intersection of segments 1A & 1B off Little Lane. Line pulling equipment was on site.
