Docket No. 272 – Development and Management Plan Inspection

Segment 1b (Royal Oaks Bypass) Inspection

Date: December 10, 2007

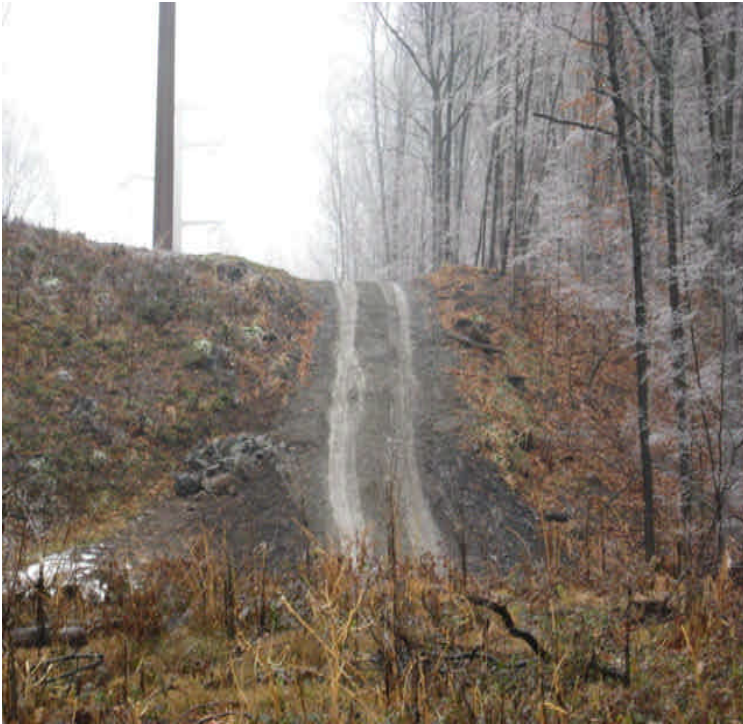
Minor erosion was no longer noted along the access road off Black Walnut Drive since the repairs had been made.

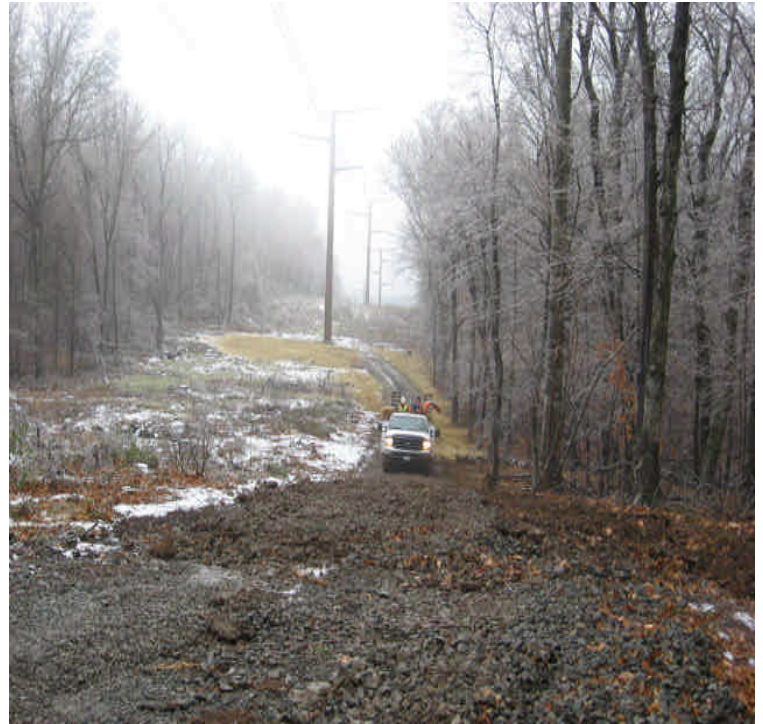
Reclaimed areas off Black Walnut Drive had been mulched and seeded.

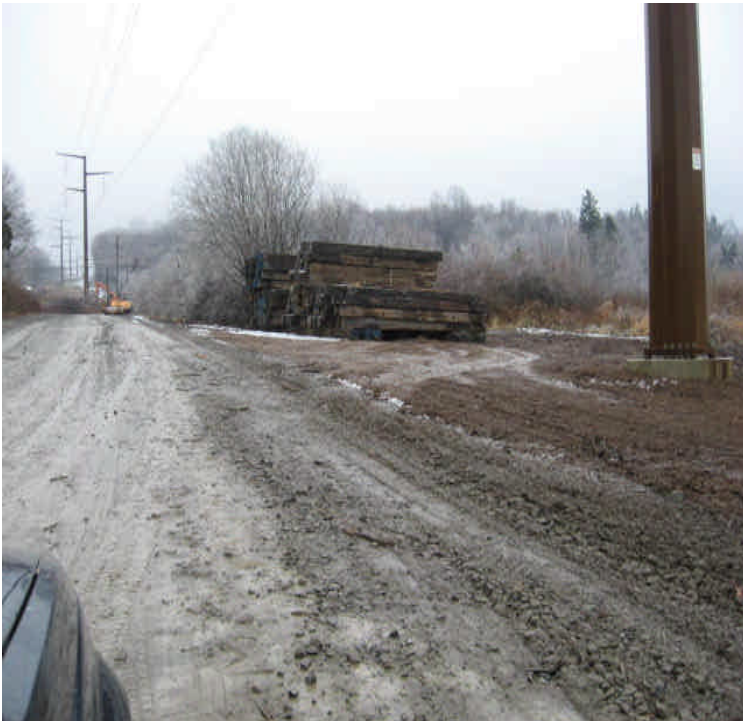
Slightly turbid water has been noted in the access roads of the receiving yard during times of heavy traffic and precipitation. New stone added to some areas. 12/10/07	Monitor new stone for effectiveness. See erosion control section for details. 12/10/07	Stone was added to the access drive but more attention may be needed.
Foundation and site construction	Hay and seed was being applied to disturbed areas	Continue to monitor and add/maintain controls as	Some reclamation activities were noted.

Turbid water noted flowing along the access drives within the receiving yard.

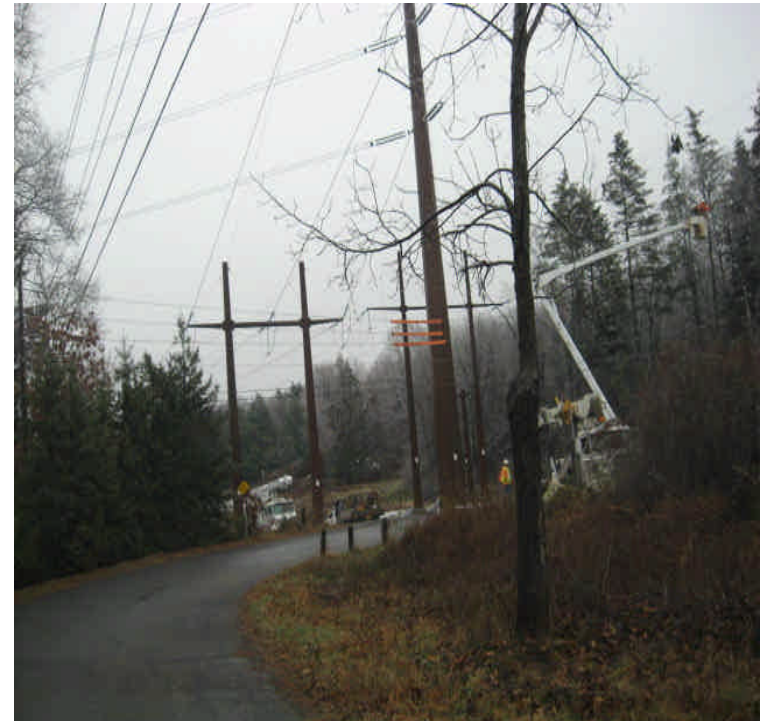
View of the intersection of segments 1A & 1B off Little Lane. Line pulling work was underway.
