Docket No. 272 - Development and Management Plan Inspection

Segment 1b (Royal Oaks Bypass) Inspection

Date: December 17, 2007

Location: Segment 1b (Royal Oaks Bypass)

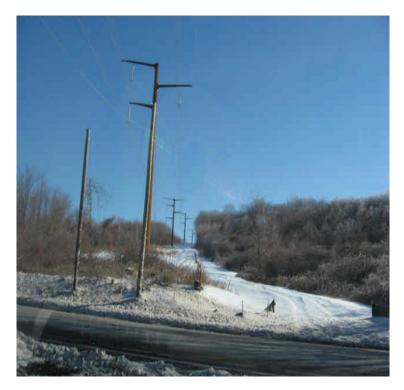
Entrance to the ROW off Rte. 17, looking to the east.

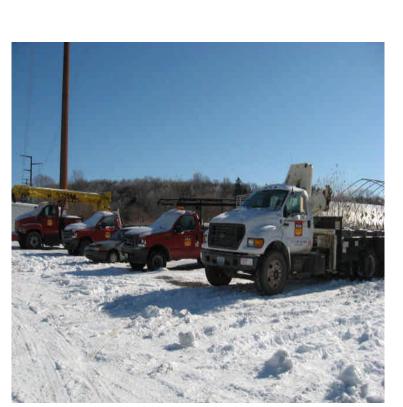
Construction vehicles parked under the new lines within the receiving yard.

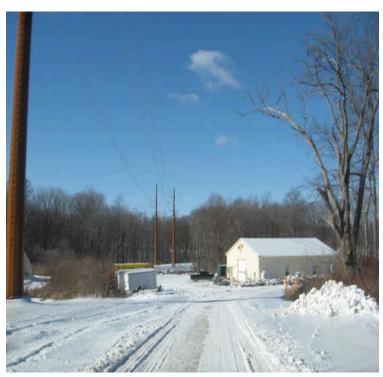
Entrance off Rte. 17, looking west into the contractor yard. The yard is starting to be demobilized.

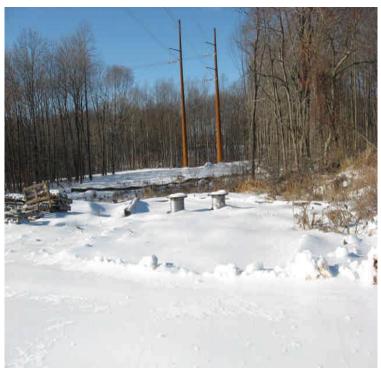
View of the turn in the ROW towards Little Lane. Controls are in plac upgradient from wetlands.
