Docket No. 272 – Development and Management Plan Inspection

Segment 1b (Royal Oaks Bypass) Inspection

Date: December 26, 2007

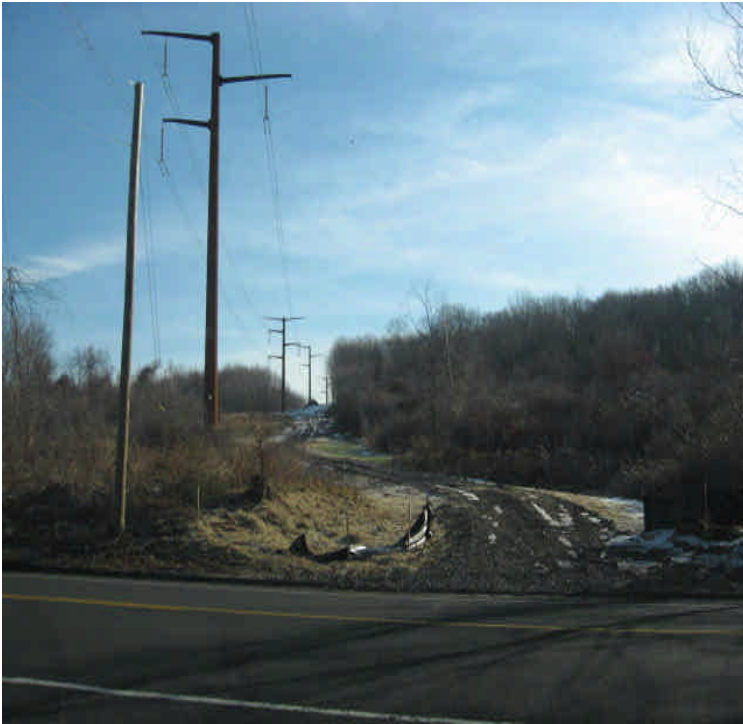
Entrance to the ROW off Rte. 17, looking to the east. Mulch and seed were in place in previously disturbed areas.

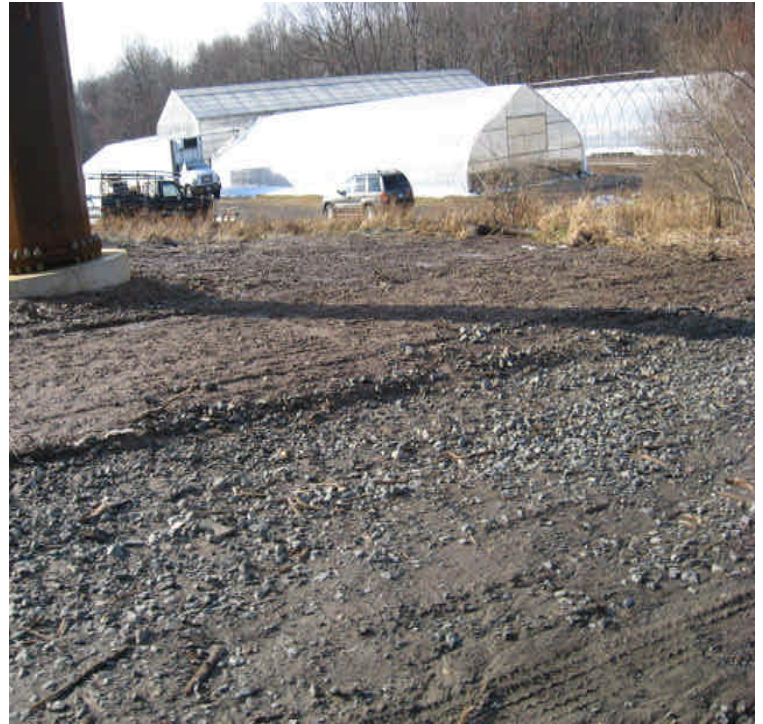
View of exposed pad area within the contractor yard. Begin stabilization within approved timelines.

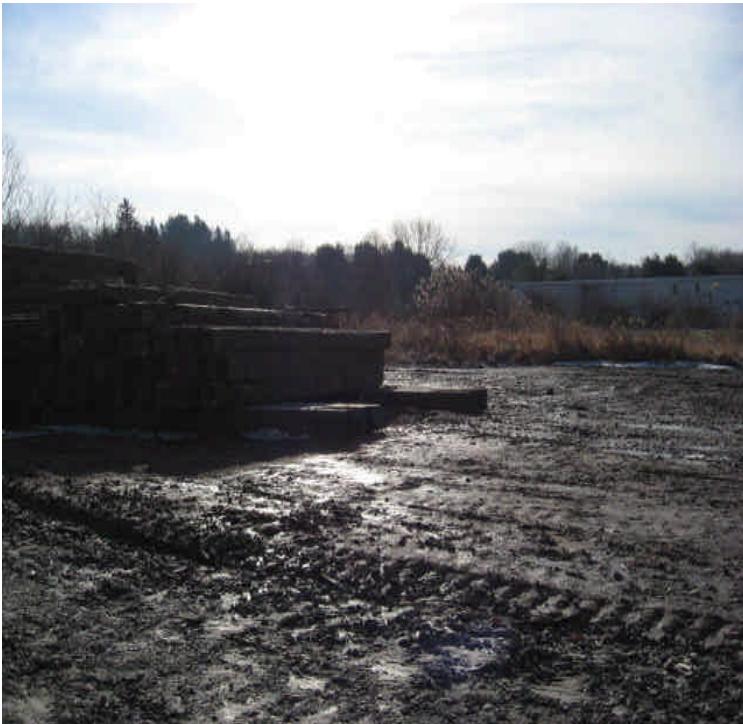
Timber mats stockpiled in an exposed area within the contractor yard. Begin stabilization within approved timelines.

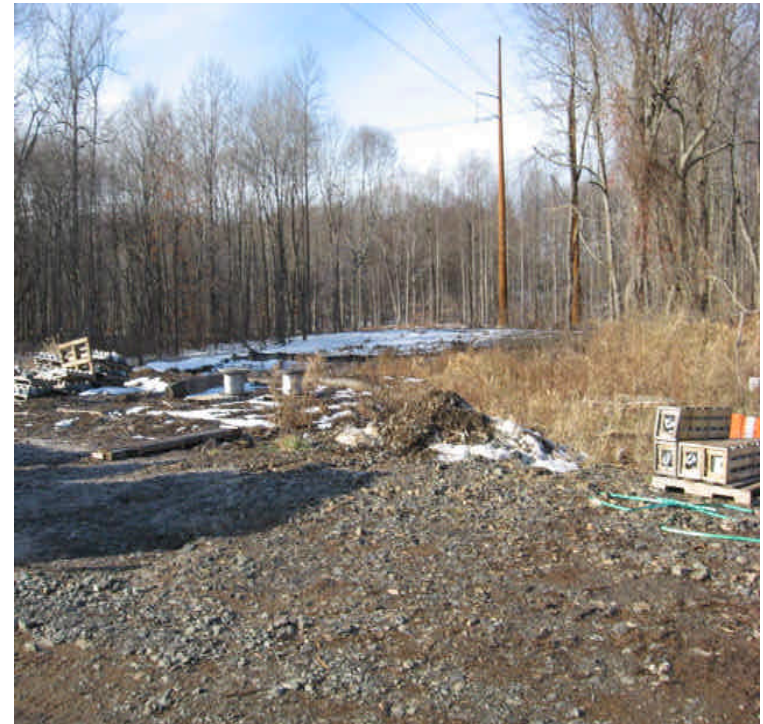
View of the turn in the ROW towards Little Lane. Controls are in place upgradient from wetlands.
