Docket No. 272 – Development and Management Plan Inspection

Segment 2a Inspection

Date: November 13, 2007

Location: Segment 2a – Beseck Switching Station to Cheshire/Hamden Town Line

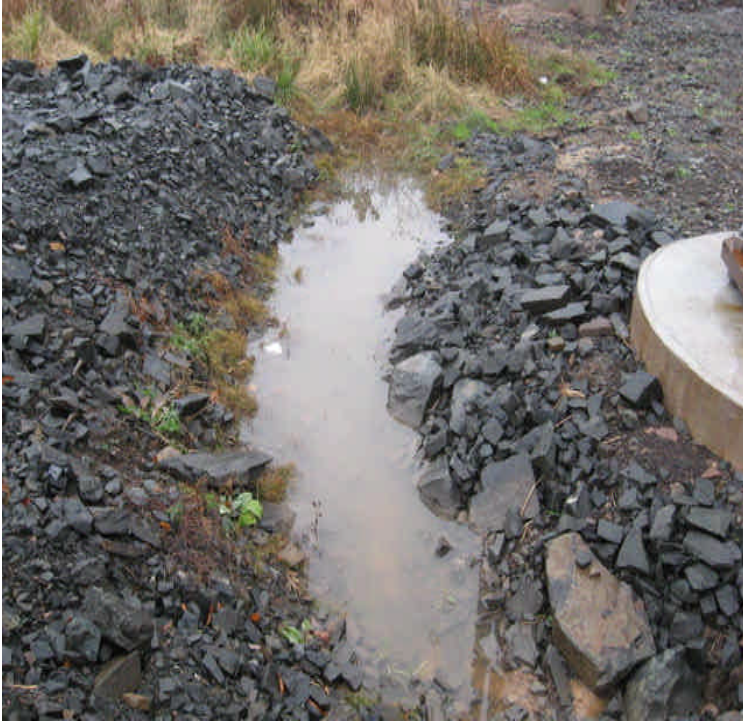
Carpenter Ln: Turbid water was observed within the wetlands during a rain event.

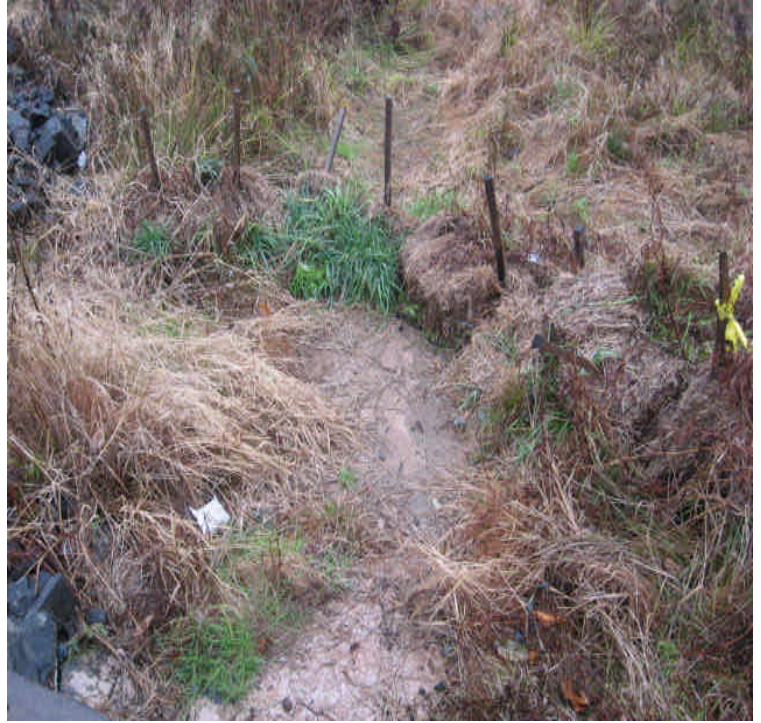
Erosion and sediment controls Carpenter Ln. to Rt. 68	<p>Sediment accumulation was noted here at controls (since 6/19). During rain events, turbid water continues to be noted within wetlands. Haybales have deteriorated and can no longer filter sediment. 11/6-11/13/07</p>	<p>Remove any accumulated sediment and stabilize the area. 6/19-11/13/07 Replace controls and reinforce them around disturbed areas along the wetlands and access roads. Any areas where work will not return for 21 days needs temp. stabilization. 11/6-</p>	<p>Needs attention <i>Temporary stabilization requires more than silt fence/haybales in place</i></p>

Carpenter Ln: Deteriorating controls and sediment accumulation was noted at the wetland outlet. This area still receives turbid run-off during rain events.

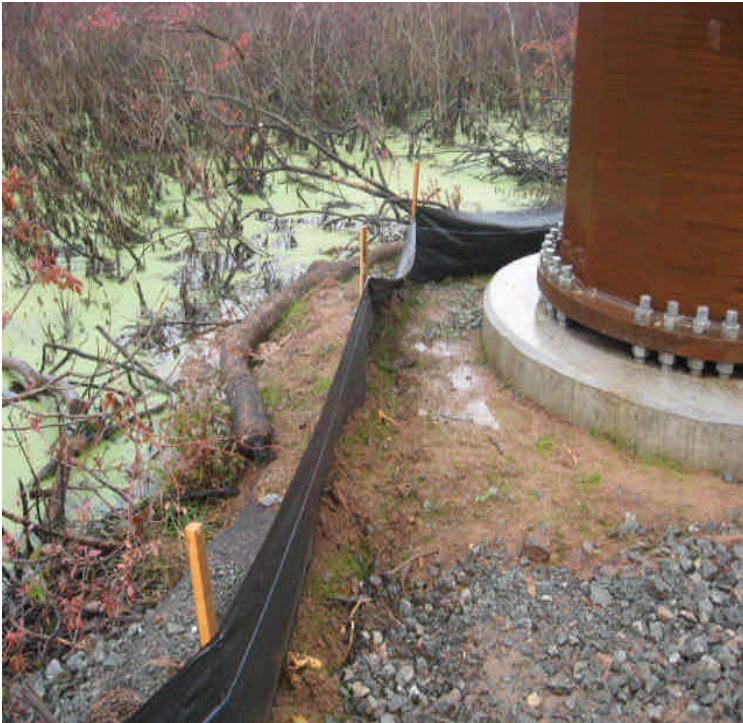
Tamarack Swamp Rd: The silt fence remains in place but the sediment that had been pushed beyond the original controls should be removed carefully.

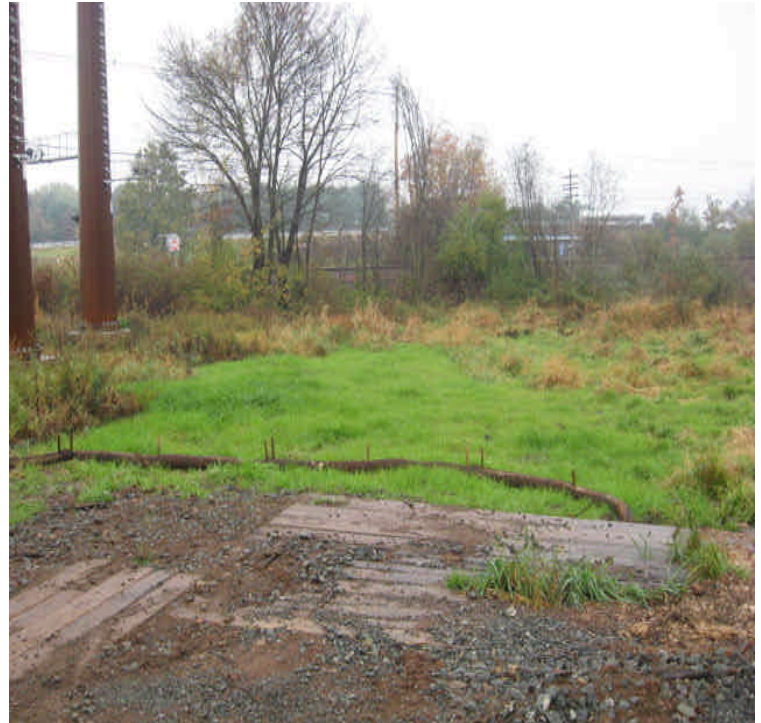
<p>Powers Rd. & Woodhouse Ave.</p>	<p>In the process of removing timber mats, sediment was pushed over some controls (8/28). Soils exposed by</p>	<p>Remove the stone from the wetlands to the extent feasible (recommended since 9/25) However, crews will be returning</p>	<p>Further attention is needed here during final stabilization.</p>

Powers Rd: The disturbed areas that were recently seeded have well-established grass cover. However, stone was not fully removed before the area was seeded and contractors are supposed to provide final restoration at this site when construction is complete.

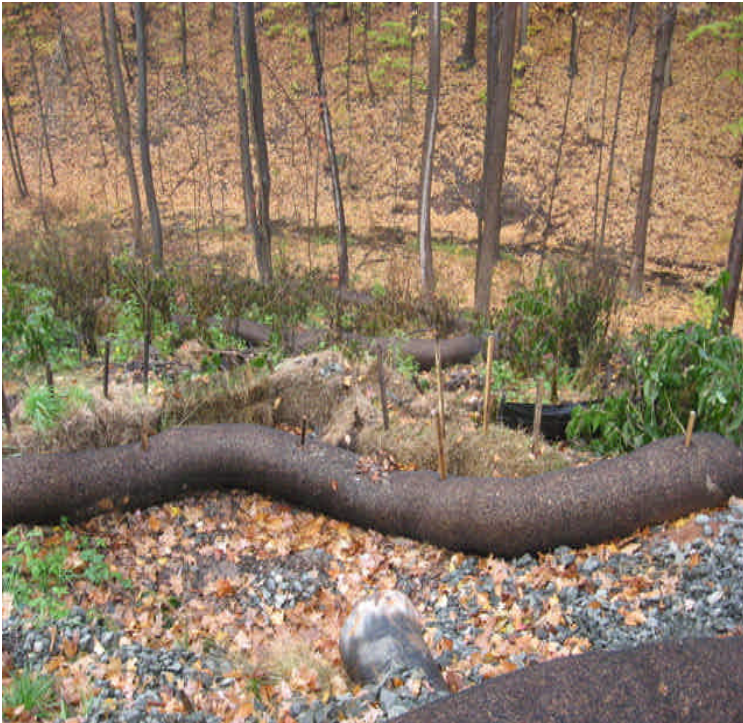
Harrison Rd: Controls at the eroded drainage ditch appear to be functioning well. However, continue to evaluate the gully and fully restore as feasible.

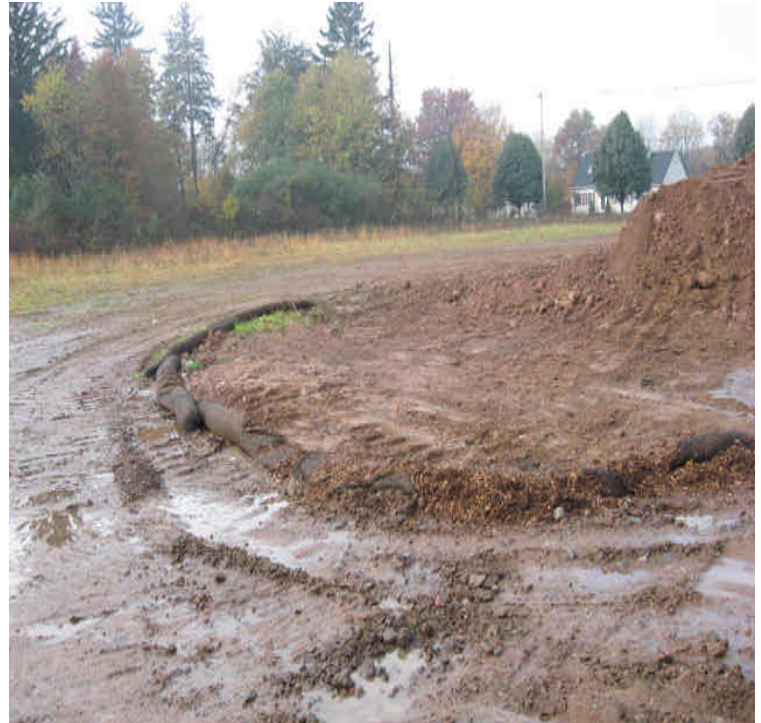
Pond Hill: Soil stockpiles from other sites are being stored here. Controls have been overwhelmed by sediment and vehicle traffic. Soil was being removed during the inspection.

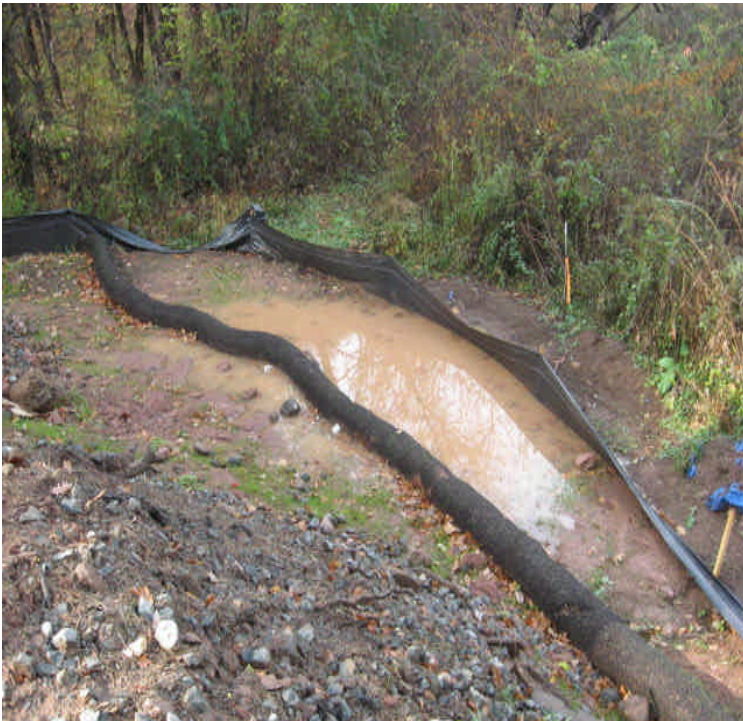
<p>Pond Hill Rd. & Docker Dr. (I 91 – Rte. 5)</p>	<p>Turbid water was noted ponding at the edge of the controls off Docker Dr. Large areas of exposed soils had previously been seeded but it appears most seed/mulch has washed away. 11/6-11/13/07</p>	<p>Maintain controls. Additional mulch may be needed this time of year to encourage stabilization 11/6-11/13/07</p>	<p>Needs evaluation.</p>
<p>Mansion Rd. to Tuttle Ave.</p>	<p>The water bars installed along the access road appear to be sufficient as no issues were noted. 11/13/07</p>	<p>Monitor new controls for effectiveness and reinforce as necessary to protect wetlands. 11/13/07</p>	<p>NA at this time.</p>
<p>Old Farms Rd.</p>	<p>Turbid run-off was noted again this week, flowing from exposed soil near structure #24209 into catch basins in the roadway and eventually to off-site wetlands. 11/6-11/13/07</p>	<p>Stabilize disturbed areas to the extent feasible. Add controls as needed to contain sediment and filter run-off. Monitor receiving catch basins controls. A culvert should be considered at driveway crossings to reduce run-off. 11/6-11/13/07</p>	<p>Needs attention</p>

Docker Dr: Turbid run-off was pooling against controls. Previously applied mulch and seed has largely washed away in this area.

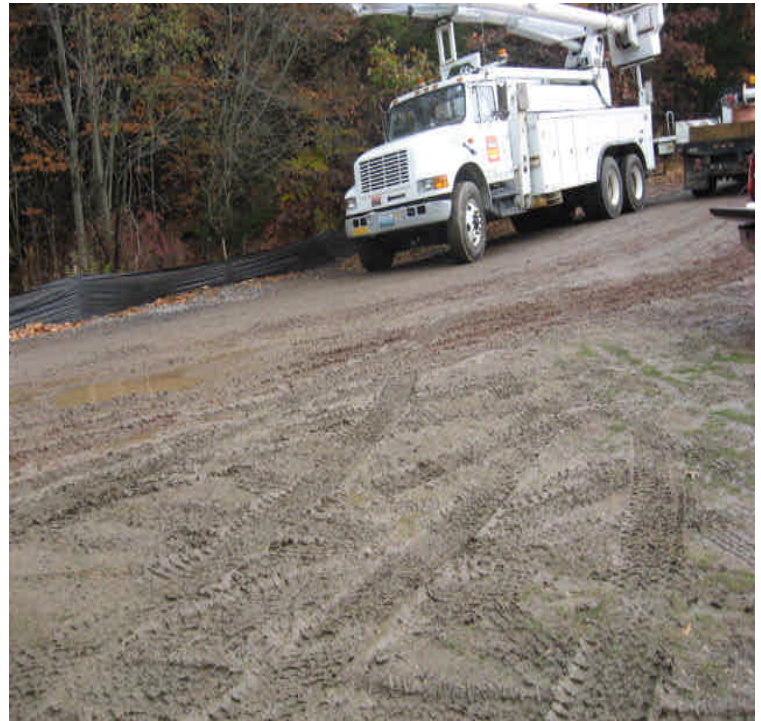
Areas of Inspection	Observation	Recommended Action	Corrected Action
Old Farms Rd. (115kV Underground trench-work)	<p>applied seed/hay appears to have washed away and turbid run-off was resulting 11/6-11/13/07</p> <p>Turbid water was noted flowing from exposed areas on the ROW into catch basins and off-site wetlands. Previously applied seed may have washed away in the run-off. 11/6-11/13/07</p>	<p>stabilization at this time of year. 11/13/07</p> <p>See erosion control section. Apply additional mulch with binders or erosion control mats as applicable to encourage stabilization at this time of year. 11/13/07</p>	Needs additional attention.
Dewatering	<p>Dewatering had previously been required at the foundations installed south of Carpenter Ln. Some slurry did migrate to the line of controls at the wetland. 5/8-11/13/07</p> <p>Foundation installed in wetlands off Tamarack Swamp required dewatering via pump truck but active dewatering was no longer occurring. 11/13/07</p>	<p>See erosion control section. 5/8-11/13/07</p> <p>Some sediment did migrate over controls within the wetland. See erosion control and wetlands sections 10/30-11/13/07</p>	<p>Needs evaluation and attention.</p> <p>Needs to be monitored</p>

Old Farms Rd: Turbid run-off was flowing from disturbed soils on the ROW and to a catch basin in the roadway. This catch basin drains to wetlands off-site.
