**Docket No. 272 – Development and Management Plan Inspection**

**Segment 2a Inspection**

**Date:** November 20, 2007

**Location:** Segment 2a – Beseck Switching Station to Cheshire/Hamden Town Line

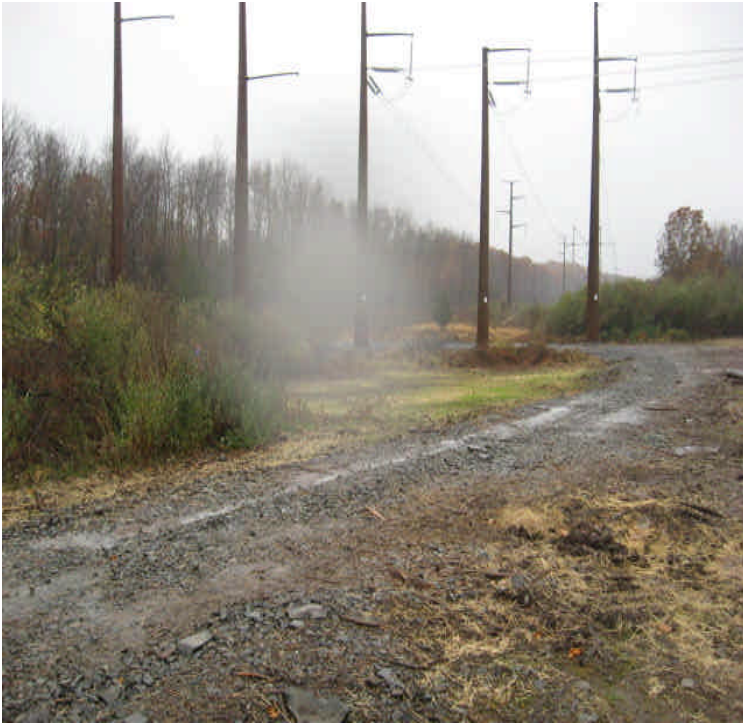
**Carpenter Ln: Disturbed soils remains upgradient from wetlands. Reinforced controls are needed here.**

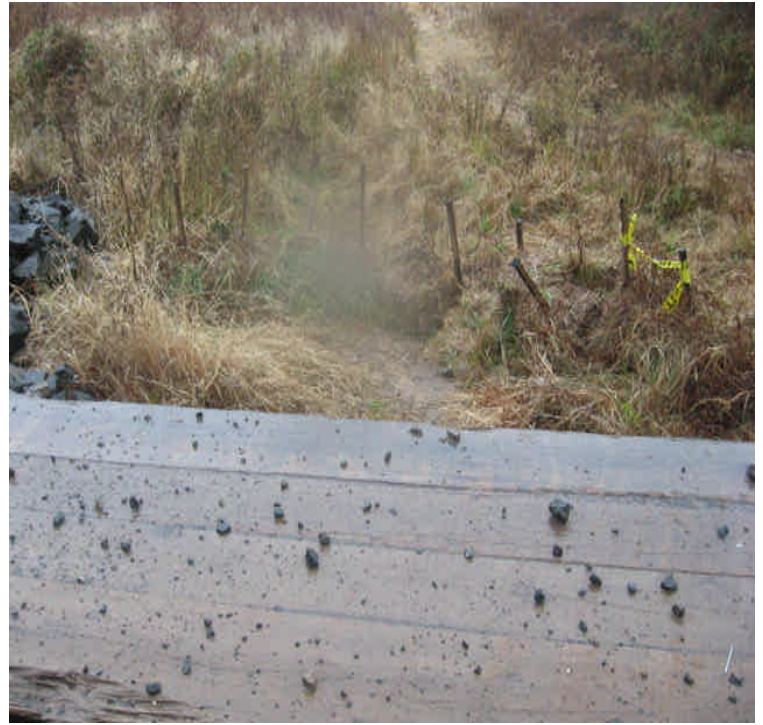
**Carpenter Ln: Deteriorating controls and sediment accumulation was noted at the wetland outlet. This area still receives turbid run-off during rain events.**

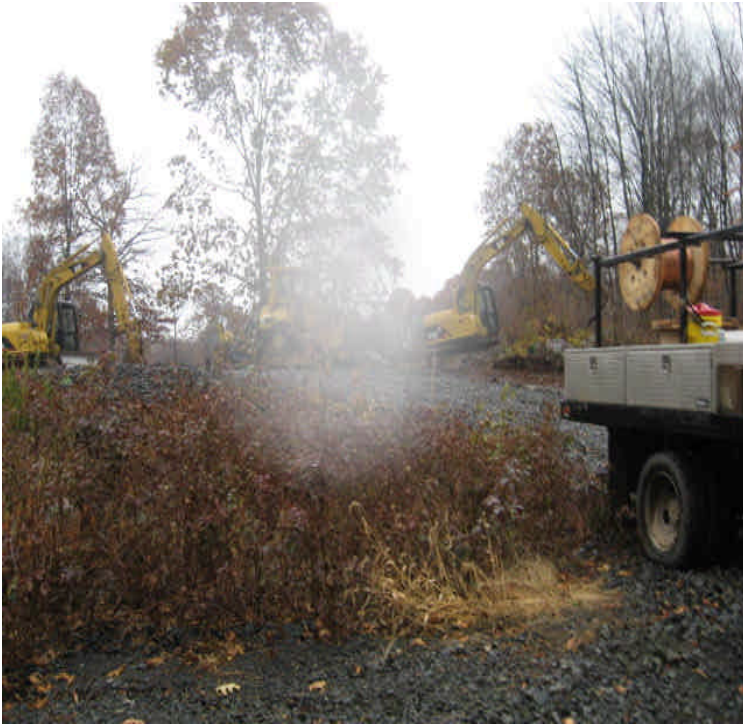
**Durham Rd: Crews were installing grounding wires.**

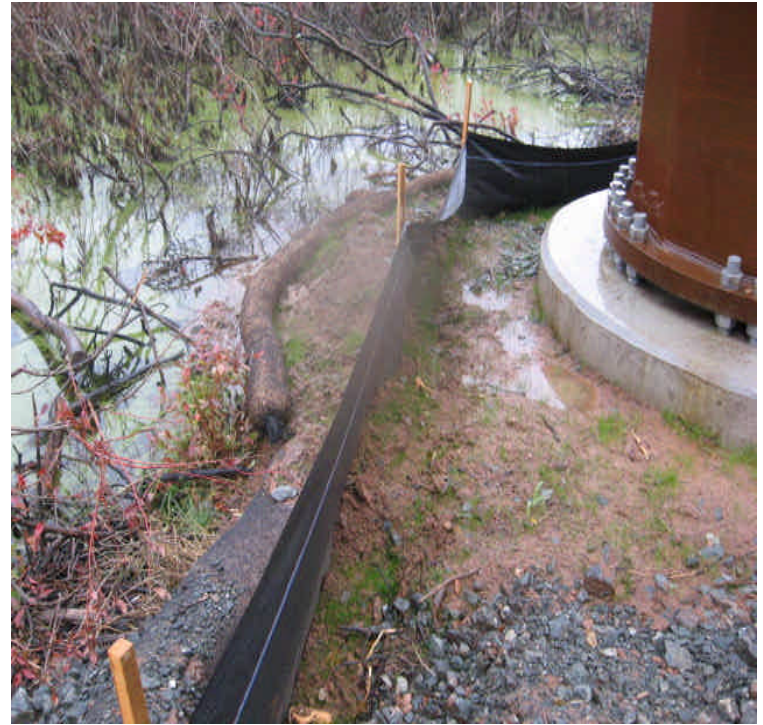
**Tamarack Swamp Rd: The silt fence remains in place but the sedimen that had been pushed beyond the original controls should be removed carefully.**

Tamarack Swamp Rd.	<p>A pad and foundation remain within wetlands with an adjacent area of standing water. Sediment from the foundation work</p>	<p>Carefully pull back and remove remaining sediment from beyond the silt fence as soon as possible. 10/30-</p>	<p>Additional attention is needed.</p>

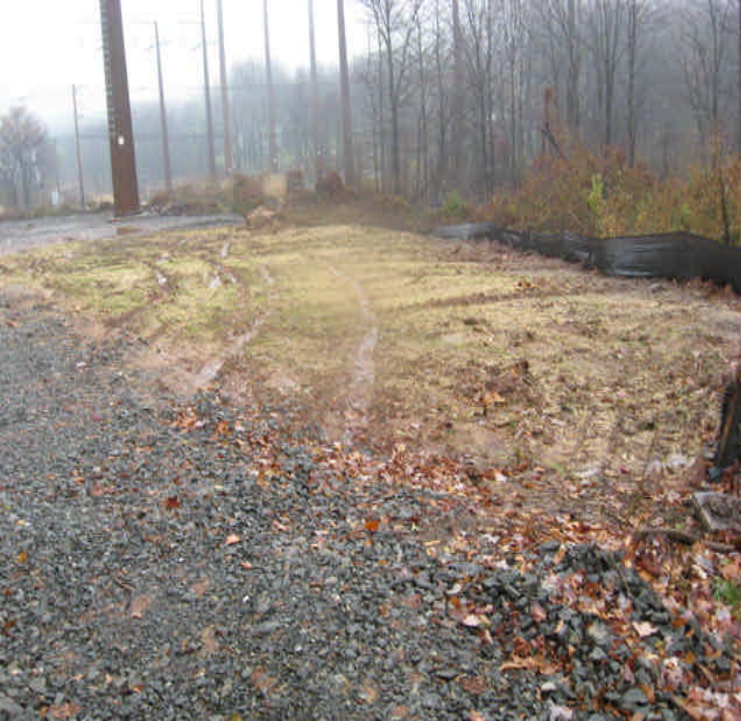
**Woodhouse Ave:** The disturbed area remains mulched and seeded. Minor grass growth was noted. Ensure the area is sufficiently stable for winter months.

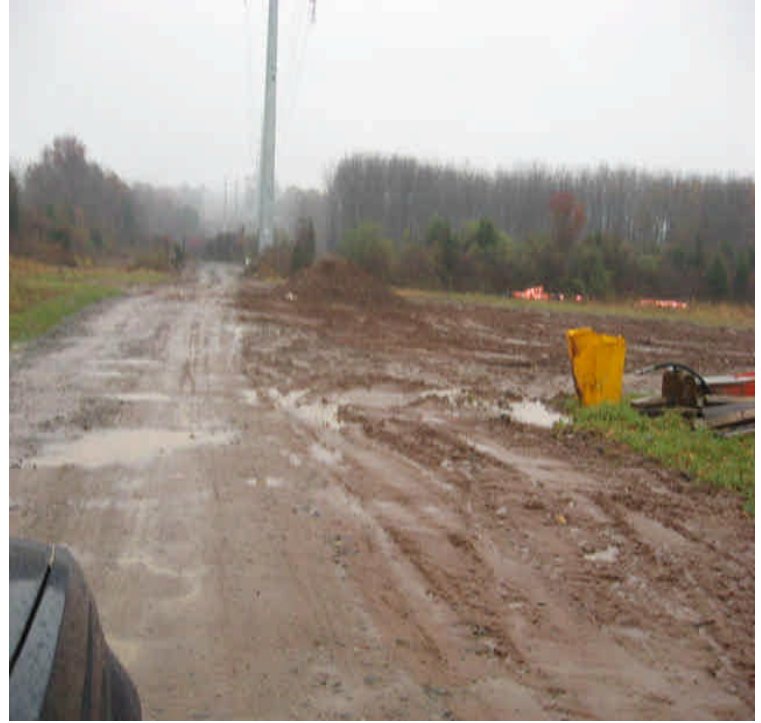
**Pond Hill:** The soil is being removed from the stockpile on site as it is needed. Monitor controls and stabilize disturbed soils.

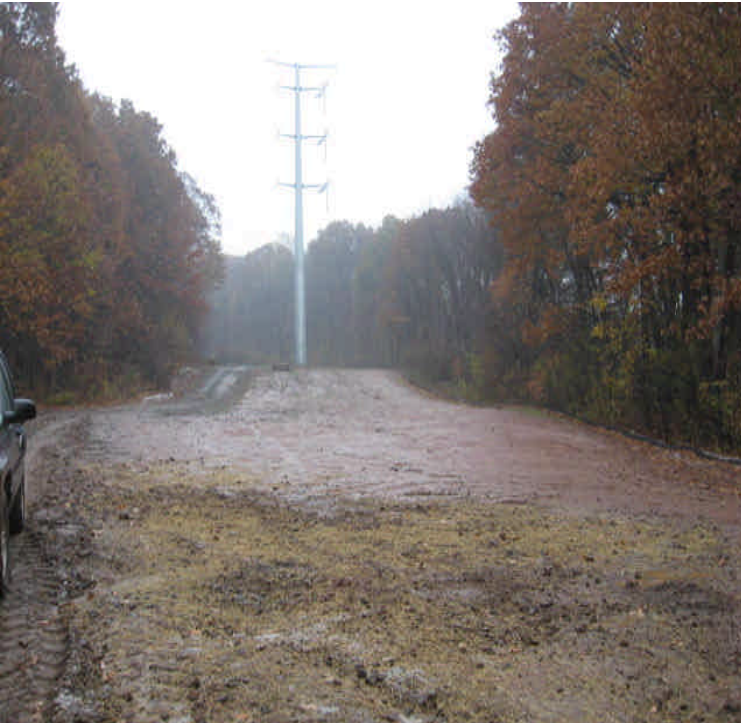
**Docker Dr:** View of the large disturbed area. Previously applied seed and mulch has washed away. Additional attention is needed here to stabilize the area for the winter months.

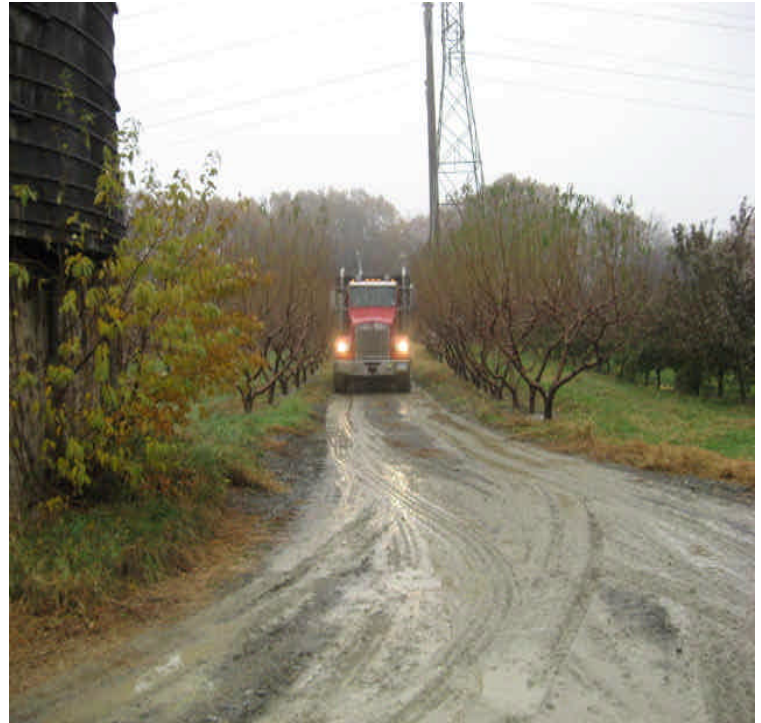
**Orchard off Mansion Rd:** Crews were reclaiming portions of the pad site.
