Docket No. 272 – Development and Management Plan Inspection

Segment 2a Inspection

Date: December 18, 2007

Location: Segment 2a – Beseck Switching Station to Cheshire/Hamden Town Line

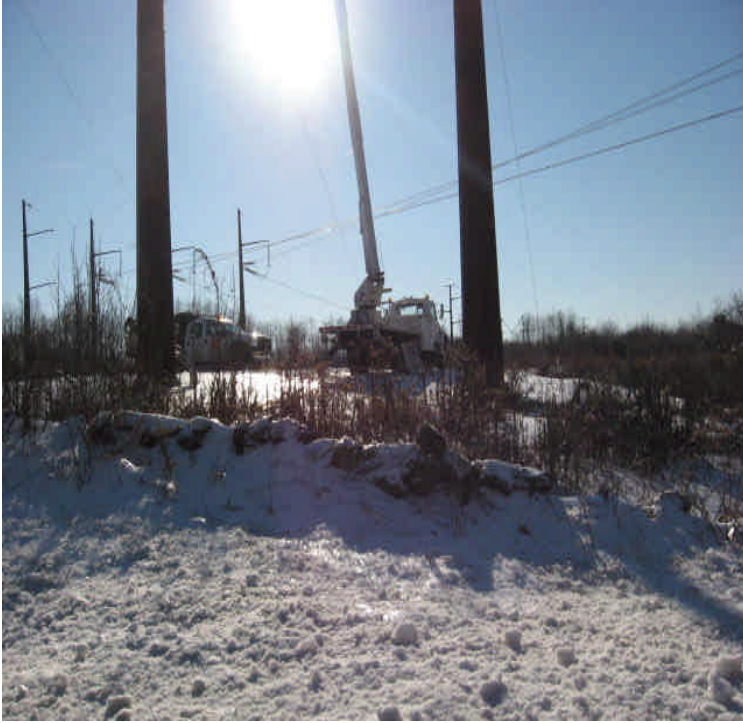
Carpenter Lane: Line work was underway from Beseck to Durham Rd.

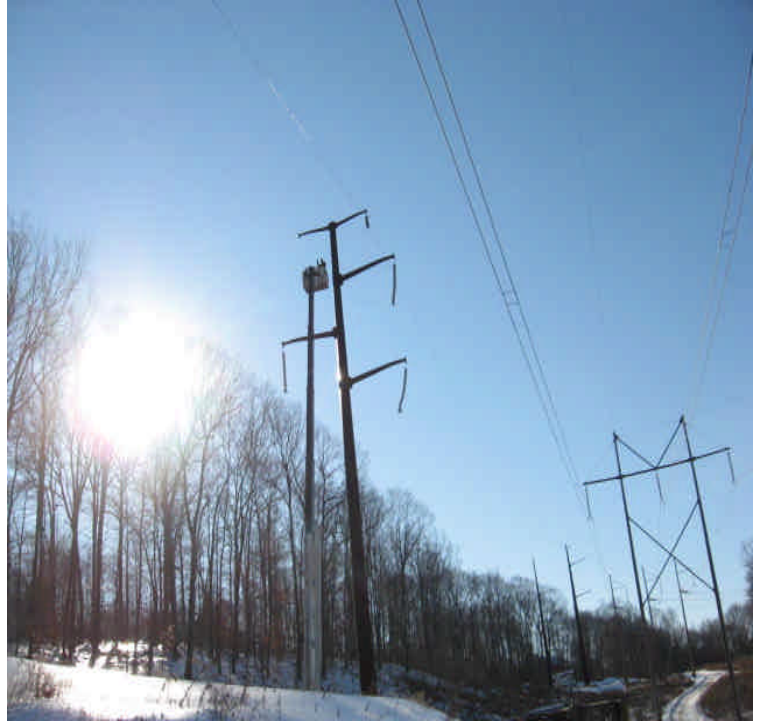
High Hill Rd: Line work underway.

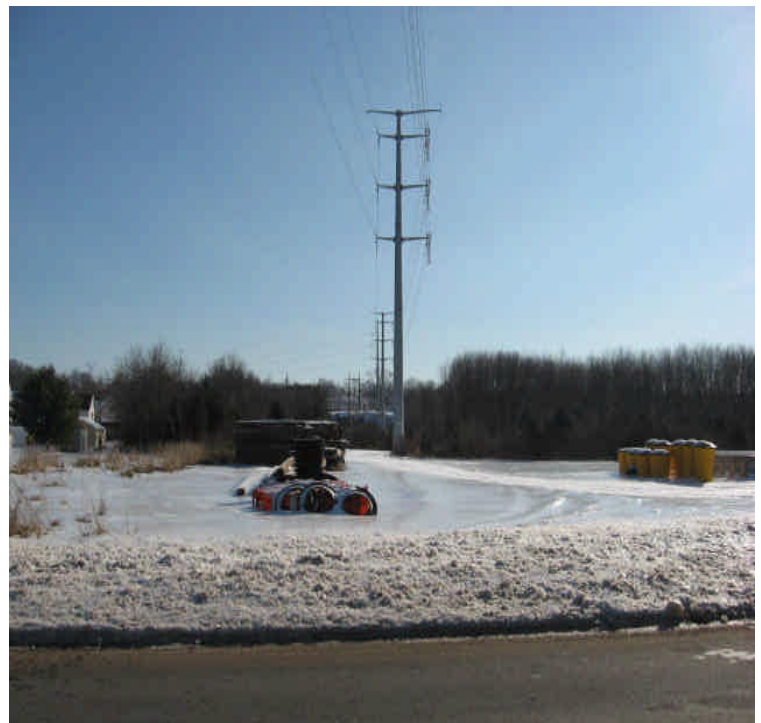
Pond Hill Rd: View of the previously disturbed area where the stockpile had been. Seed and mulch were applied prior to the snow cover.

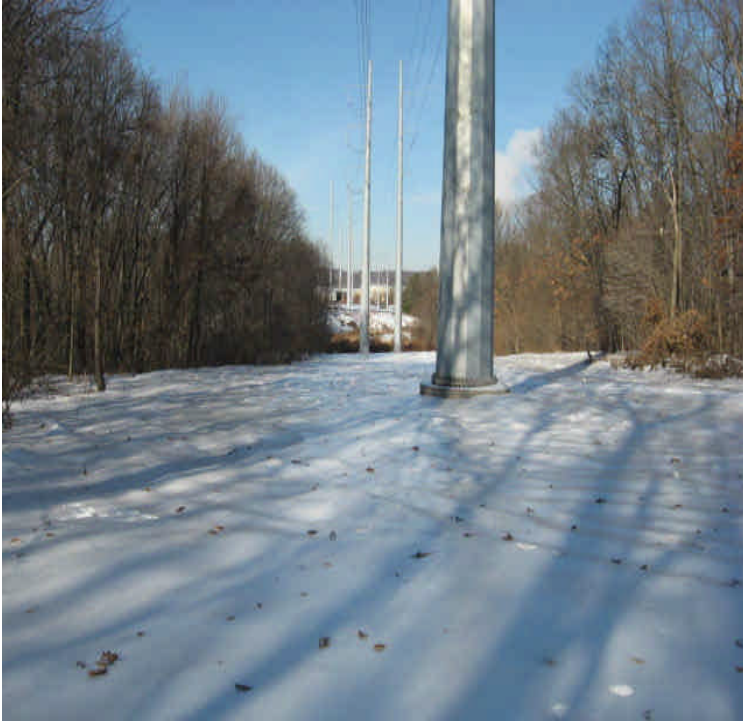
Docker Dr: View of the area with regular ATV disturbance and ruts. More stabilization measures will be necessary here when snow cover is gone.

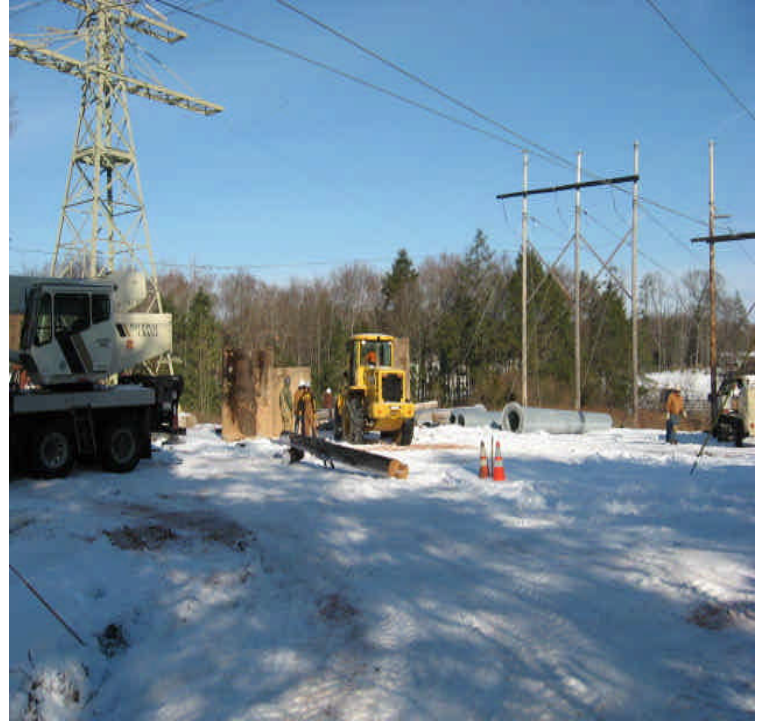
Old Farms Rd: Foundation and structure installation is underway.

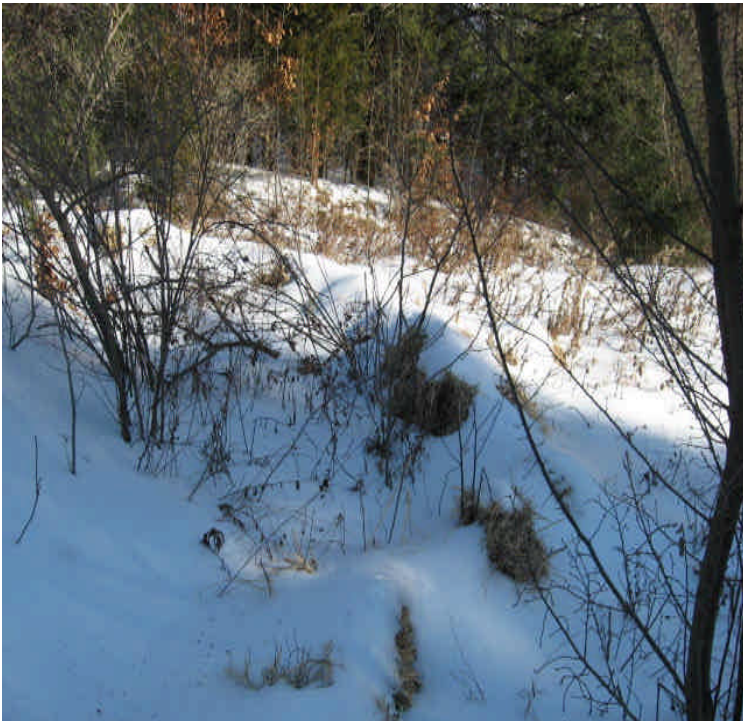
Areas of Inspection	Observation	Recommended Action	Corrected Action
Old Farms Rd.	<p>drilling and stored equipment during the construction process. 12/18/07</p> <p>Soil continues to be stockpiled upgradient of the wetlands but controls have been installed. 12/18/07</p>	<p>prevent repeated problems. Always contain and control stockpiles as soon as possible. 12/18/07</p> <p>Continue to keep storage materials away from wetlands. See erosion control section. 12/18/07</p> <p>Avoid storing concrete washout upgradient from wetlands as well. 12/18/07</p>	<p>Controls were installed at the stockpile.</p>
Additional Observations	None 12/18/07	None

Old Farms Rd: Controls installed at the base of soil stockpiles prior to snow cover.

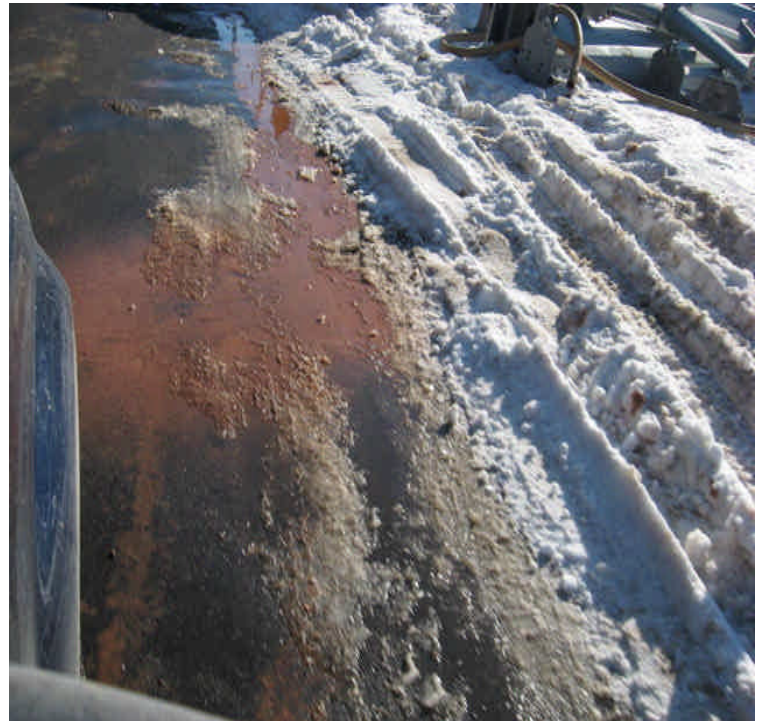
<p>Old Farms Rd.</p>	<p>Turbid water was noted ponding at the edge of the controls off Docker Dr. (from 11/6-12/4) Large areas of exposed soils had previously been seeded but it appears most seed/mulch has washed away or been disturbed by ATVs. 11/6-12/18/07</p> <p>Turbid run-off was noted between 11/6-11/27, and on 12/11, from work near structure #24209. This week, sediment was noted on the snow, access roads, and roadway. Soils were stockpiled upgradient from wetlands onsite and silt fence and fiber rolls were installed at the base of the stockpile. 12/18/07</p>	<p>Maintain controls. Additional mulch is needed this time of year to encourage stabilization 11/6-12/11/07 Measures may be needed to prevent ATV traffic. 12/4-12/18/07</p> <p>Stabilize disturbed areas to the extent feasible. Add controls as needed to contain sediment and filter run-off. Monitor receiving catch basins controls. A culvert should be considered at driveway crossings to reduce run-off. 11/6-12/18/07</p>	<p>Needs evaluation/attention.</p> <p>Controls installed around the stockpile. One CB has new controls but more are needed.</p> <p>Sediment needs attention.</p>

Old Farms Rd: Sediment tracking and turbid run-off noted from active areas.
