Docket No. 272 – Development and Management Plan Inspection

Segment 2a Inspection

Date: December 26, 2007

Location: Segment 2a – Beseck Switching Station to Cheshire/Hamden Town Line

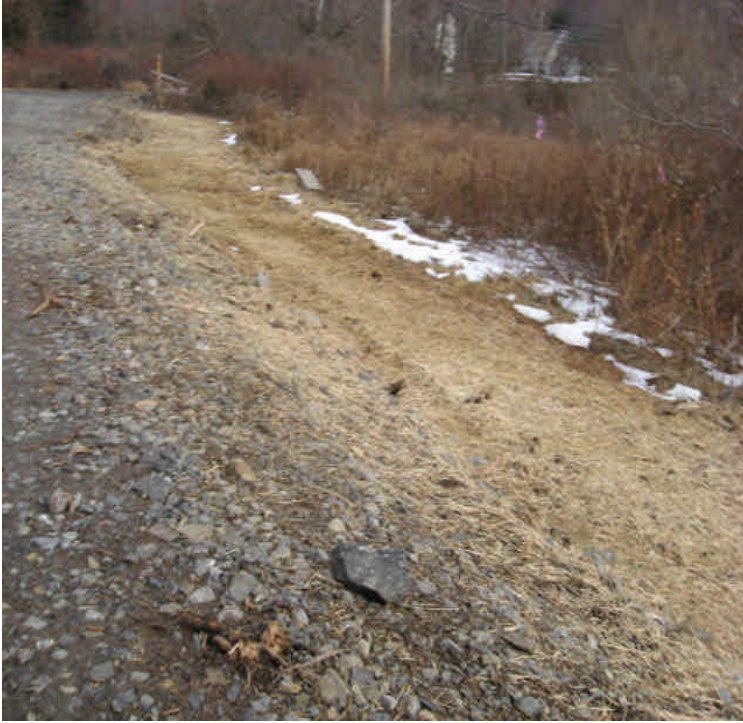
Carpenter Lane: Hay mulch and seed remain over exposed soil upgradient from the wetland.

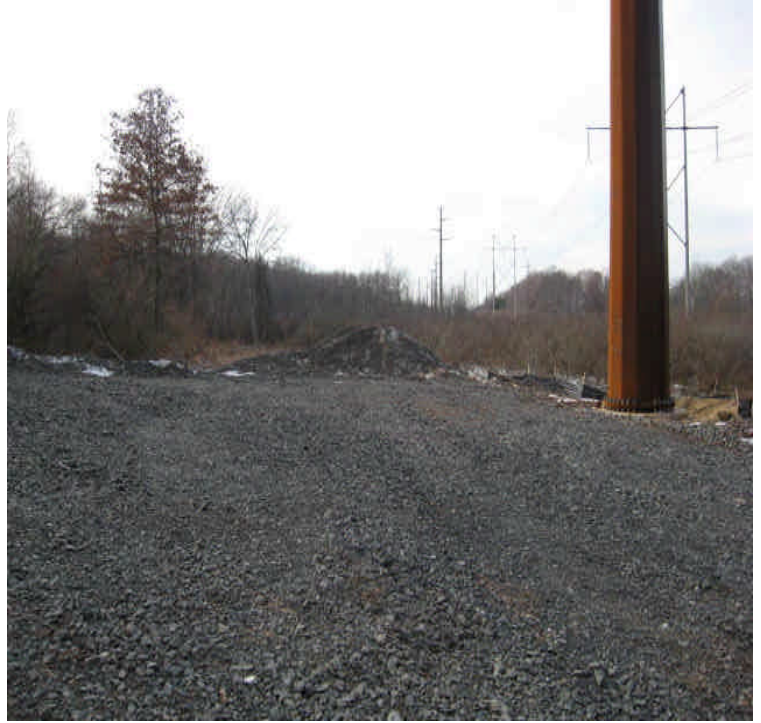
Tamarack Swamp Rd.: Snow and associated sediment had been plowed up to the boundary of the wetland. Snowmelt could result in the deposition of sediment.

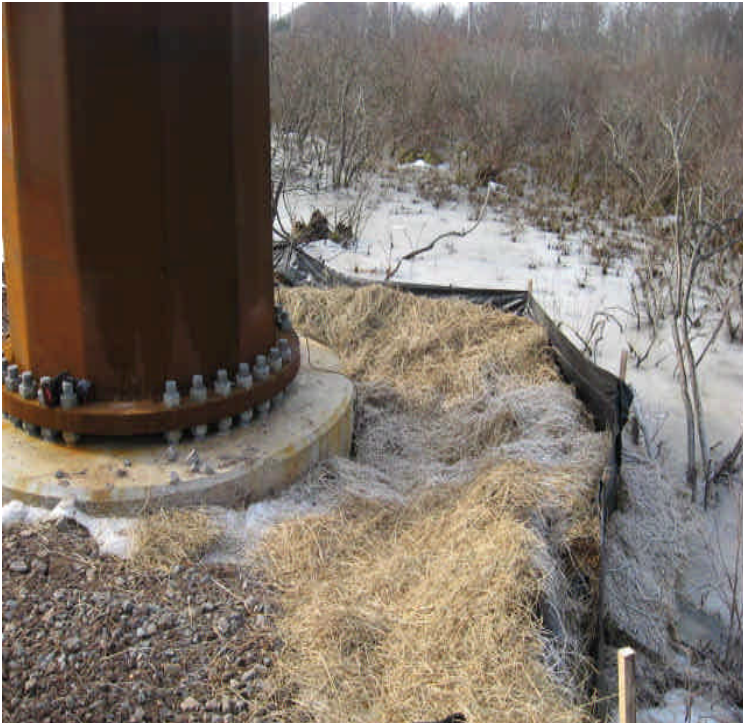
Tamarack Swamp Rd.: New controls were installed to encompass the soil after grounding crews had damaged the existing silt fence. Evaluate whether the activities here caused additional encroachment.

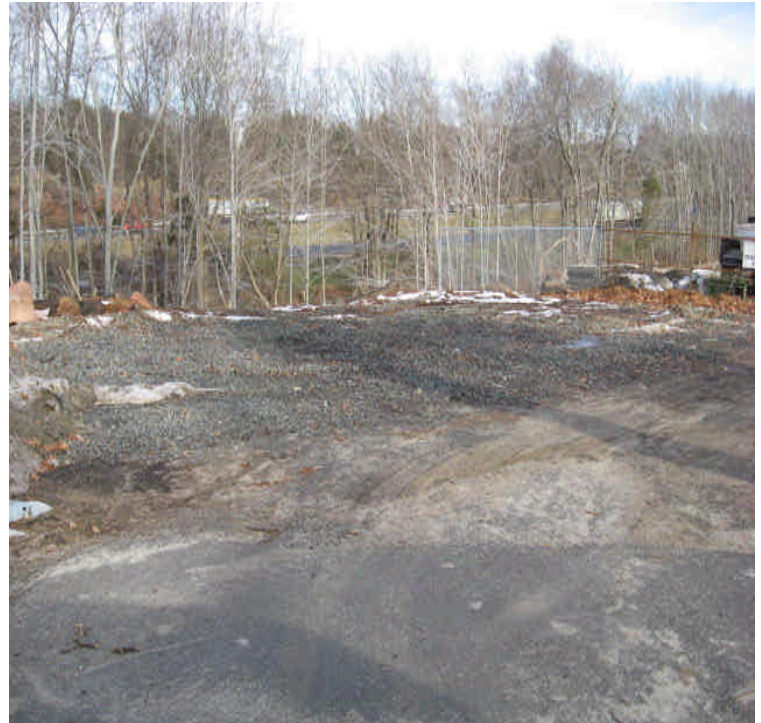
Harrison Rd.: The area where the stockpile had been removed is temporarily stable. Restore when feasible during the growing season.

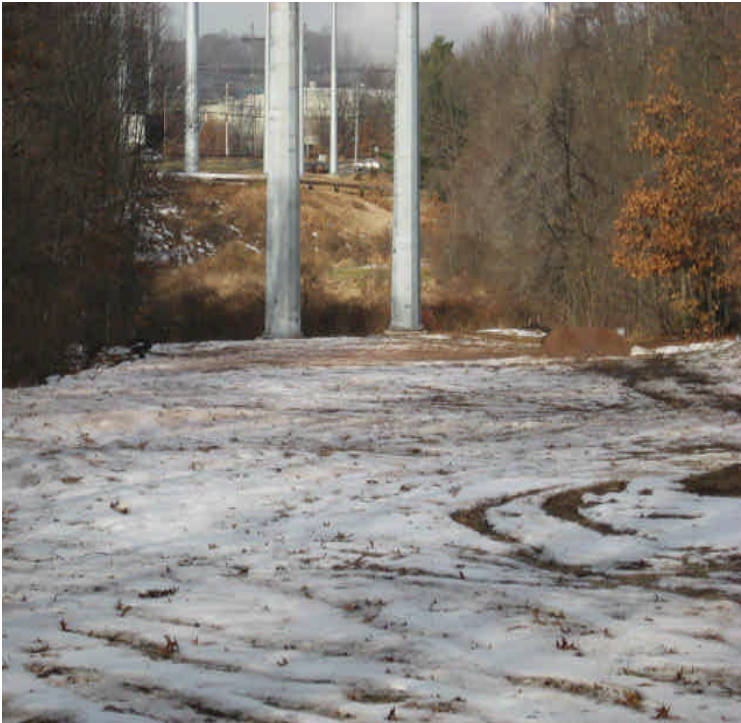
Docker Dr: Previously reclaimed areas are exposed again through ATV ruts/tracking and mulch and seed have washed away.

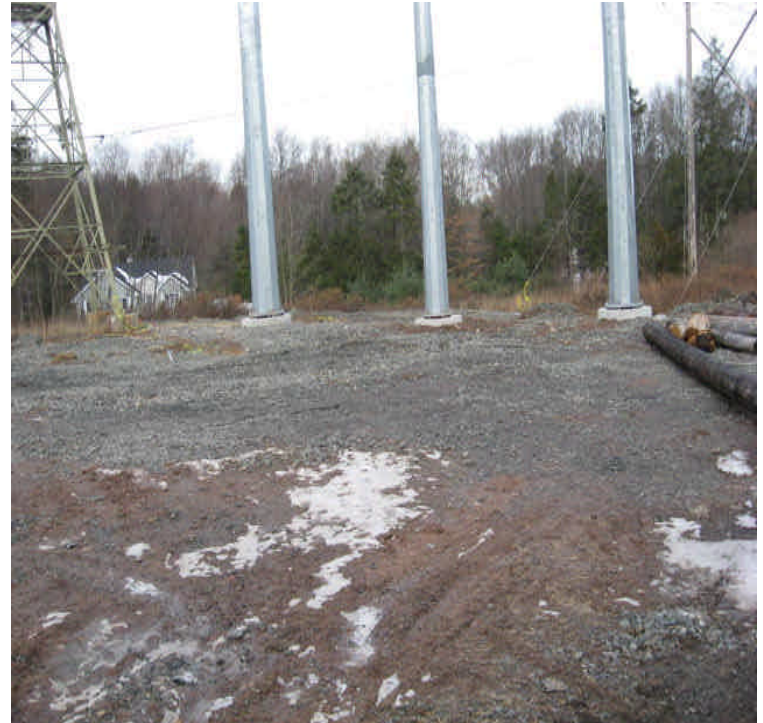
Old Farms Rd: Foundation and structures are installed. Work on temporary stabilization within approved timelines.

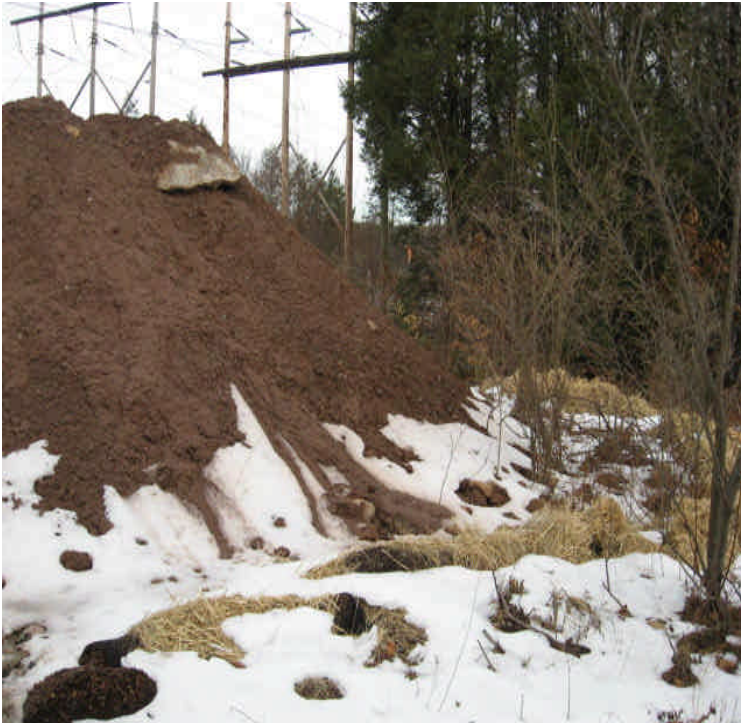
Old Farms Rd: Controls are in place at the base of the soil stockpile but the amount of soil has the potential to overwhelm them. Remove soil from this area when feasible.

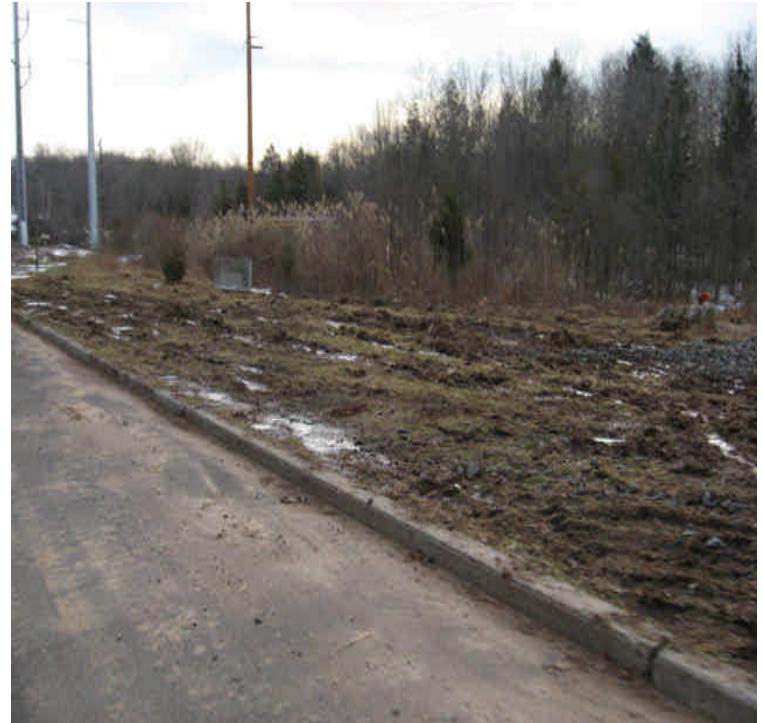
Old Farms Rd: Sediment tracking and turbid run-off noted. The area that was previously stabilized along the roadway shoulder had been disturbed and rutted from equipment. Provide additional temporary stabilization until the growing season.
