**Docket No. 272 – Development and Management Plan Inspection**

**Segment 2a Inspection**

**Date:** December 31, 2007

**Location:** Segment 2a – Beseck Switching Station to Cheshire/Hamden Town Line

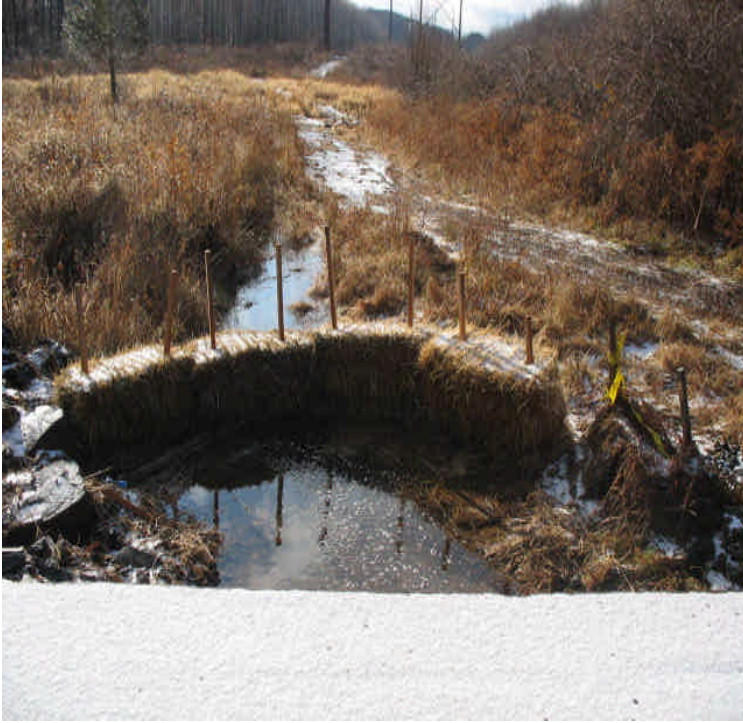
**Carpenter Lane: New haybales remain at the wetland outlet. Previously accumulated sediment should be removed prior to restoration.**

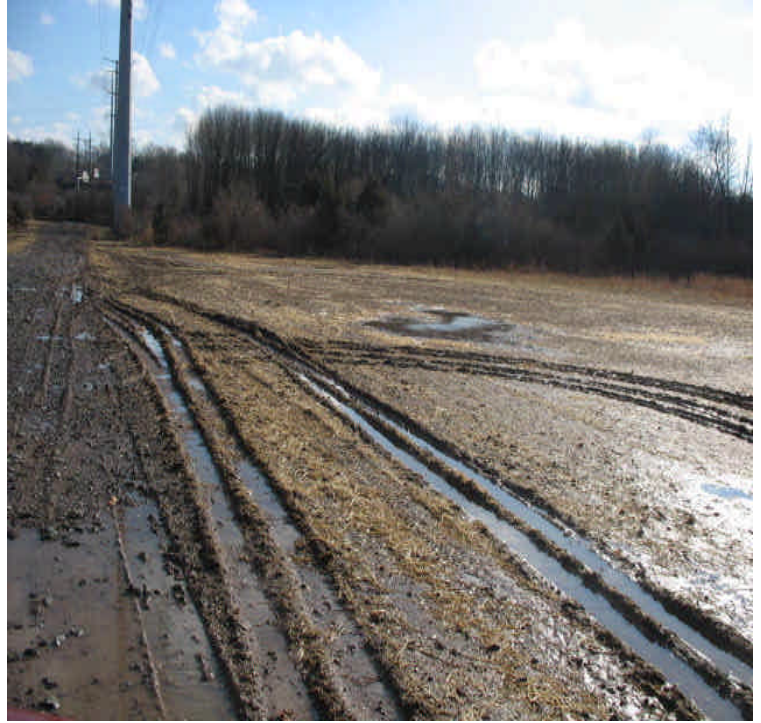
**Pond Hill Rd: Recently reclaimed area is experiencing disturbance and tracking from ATV traffic.**

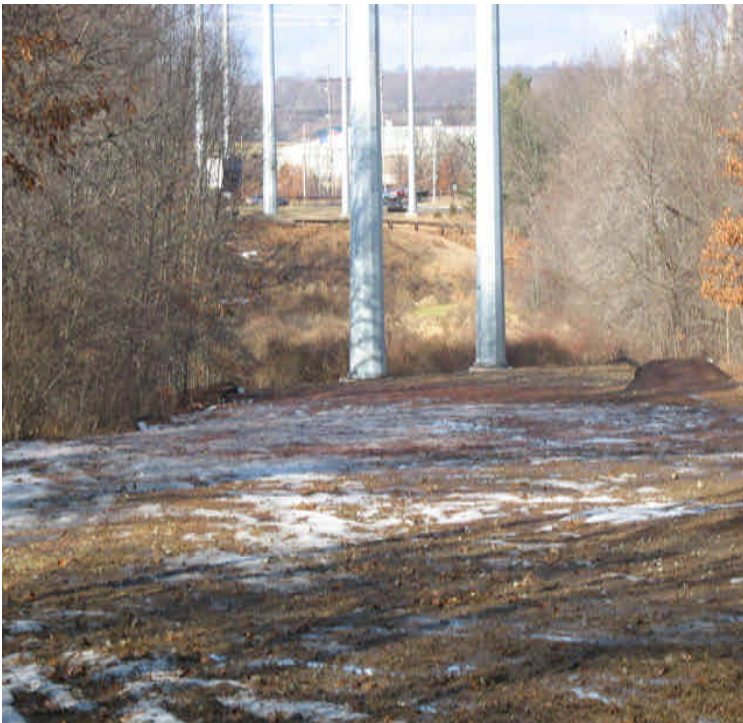
**Docker Dr: Previously reclaimed area is also being disturbed by ATVs. Seed and mulch has washed away and should be reapplied.**

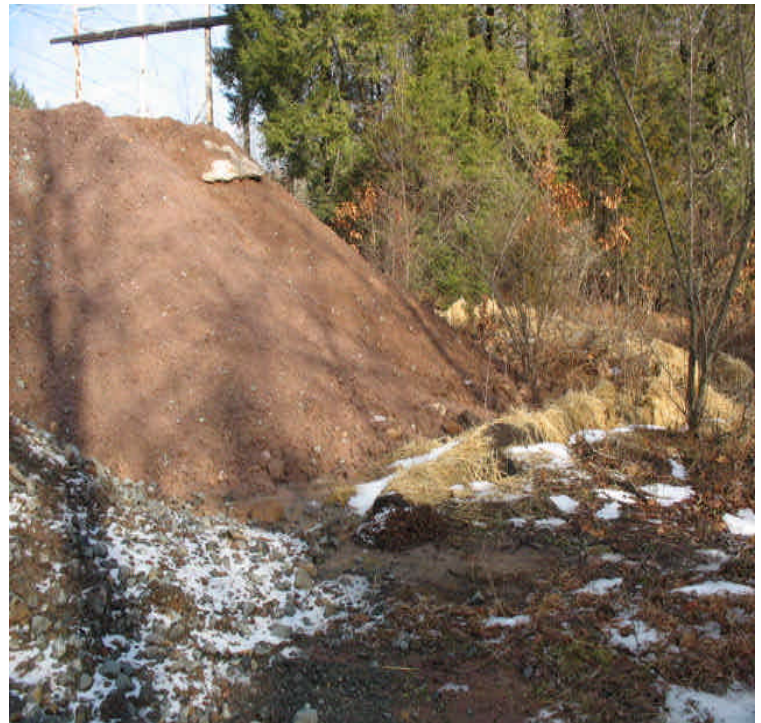
**Old Farms Rd: Stockpile remains upgradient from wetlands with controls in place at its base. Remove soil when feasible as it has the potential to overwhelm the controls.**

<b>Old Farms Rd.</b>	<b>Soil continues to be stockpiled upgradient of the wetlands but controls remain in place. However the amount of soil has the potential to overwhelm the controls. 12/26-12/31/07</b>	<b>Continue to keep storage materials away from wetlands. Remove soil when feasible. See erosion control section. 12/26-12/31/07</b>	<b>Needs to be monitored.</b>
	<b>A drill rig parked on the ROW is leaking hydraulic fluid on the ground. No controls are in place at this time. 12/31/07</b>	<b>Add controls to contain the leak and repair equipment as soon as possible. Clean and remove affected soil. 12/31/07</b>	<b>Needs attention.</b>
<b>Additional Observations</b>	<b>None 12/31/07</b>	<b>None</b>

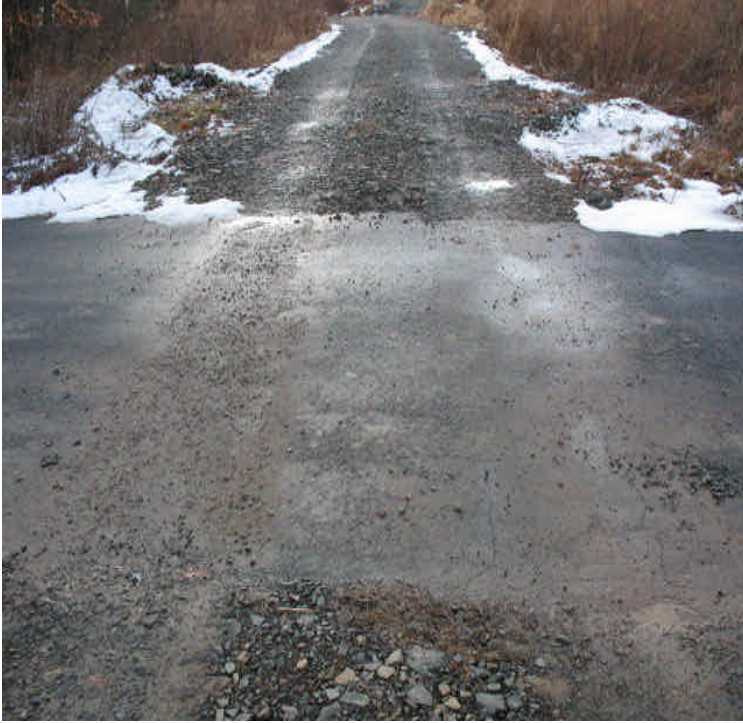
**Old Farms Rd: Sediment tracking noted across private driveways.**

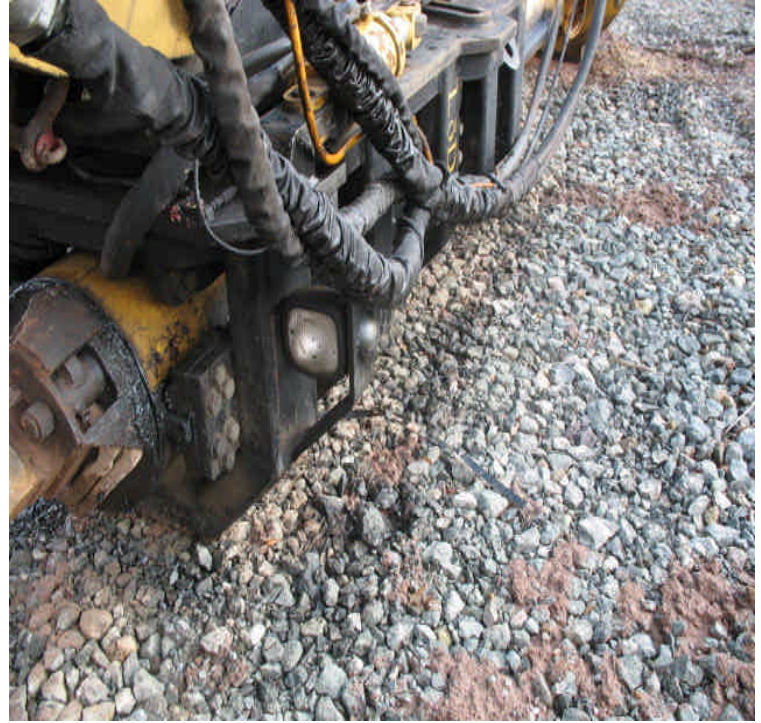
**Old Farms Rd: Drill rig leaking hydraulic fluid. Repair the equipment and remove affected stone.**

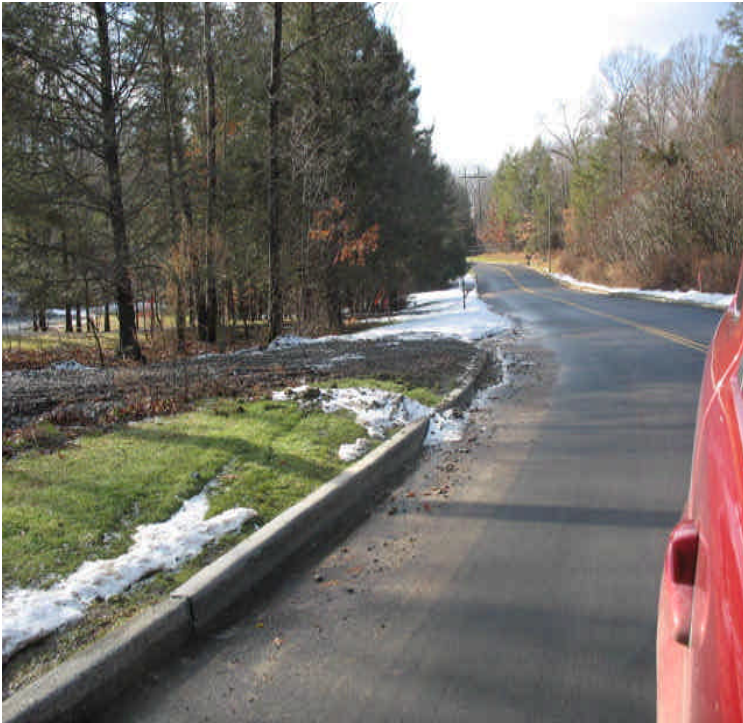
**Old Farms Rd: Sediment tracking from previously active work areas.**

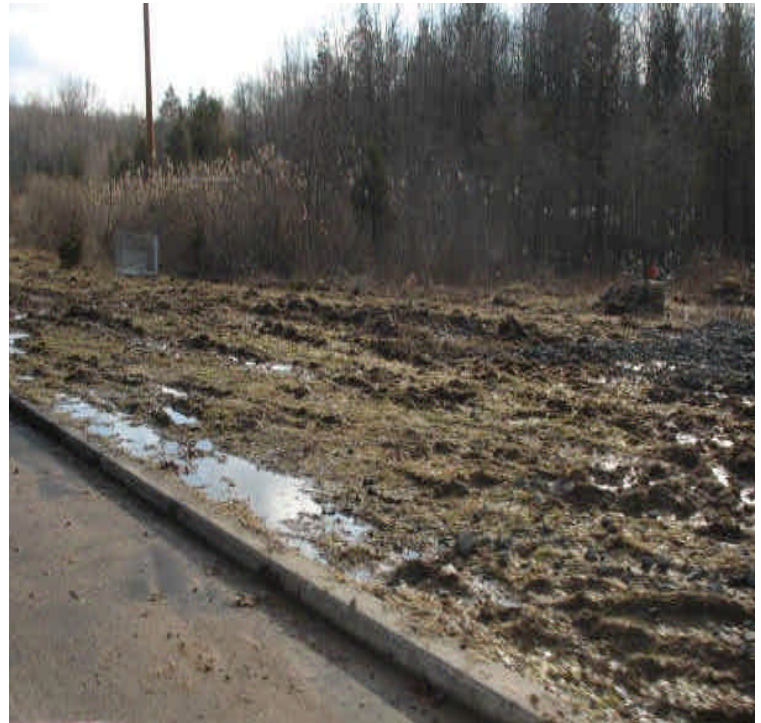
**Old Farms Rd: Sediment tracking and turbid run-off noted. The previously stabilized area along the roadway shoulder was disturbed with equipment ruts.**
