**Docket No. 272 – Development and Management Plan Inspection**

**Segment 2b Inspection**

**Date:** November 16, 2007

**Location:** Segment 2b – Cheshire/Hamden Town Line to East Devon Substation

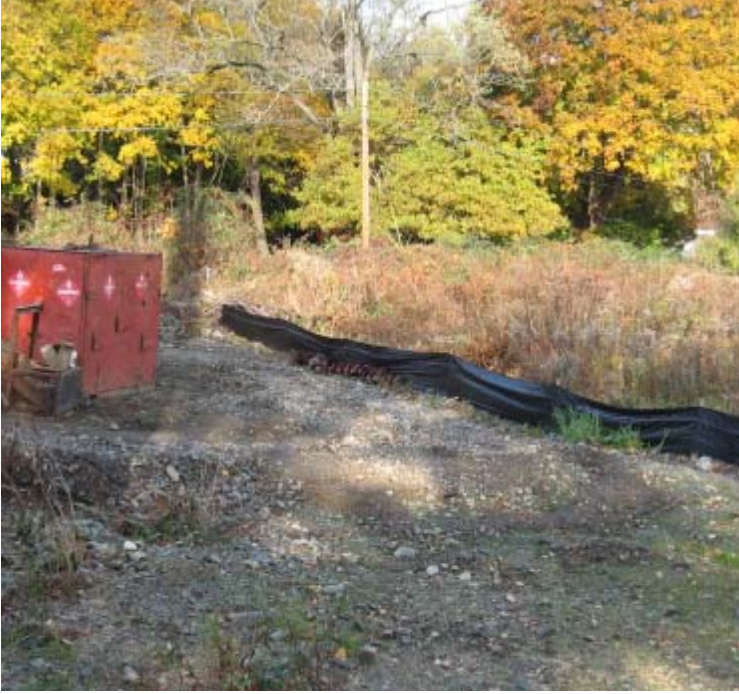
Oronoque Rd North (Milford): 345 kV foundation work is active in this area. Proper erosion controls are in place.

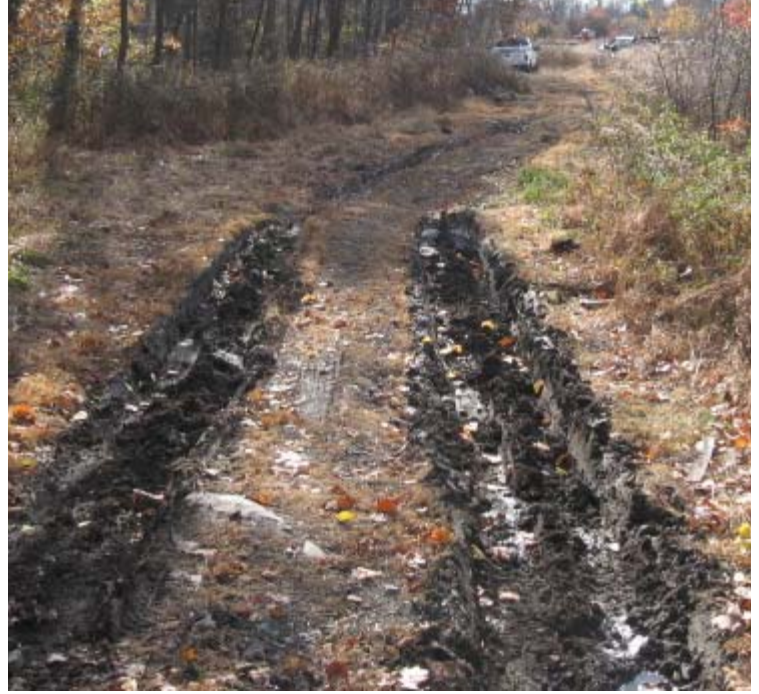
Pease Rd (Woodbridge): Tire ruts were noted within the wetland along the abandoned ROW. The vehicle seen in the distance is not parked in a wetland.

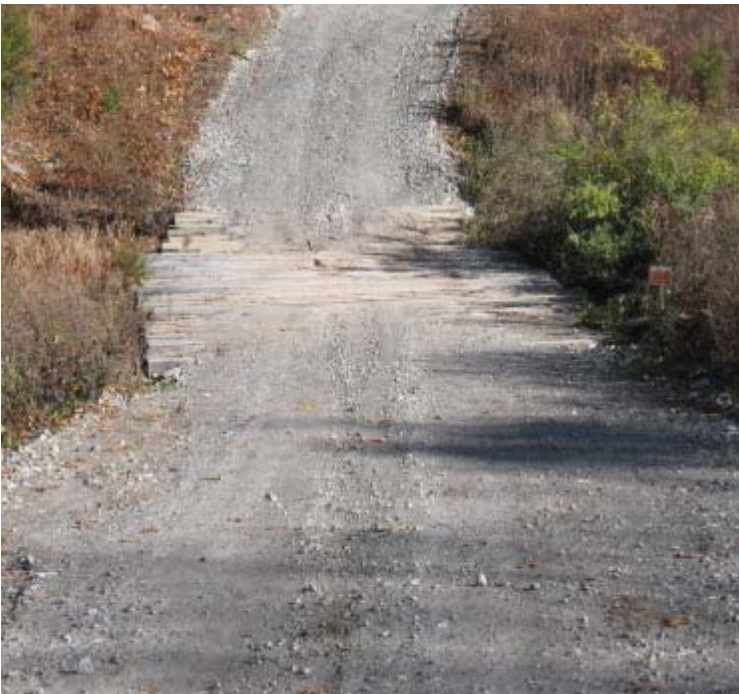
Brooksvale Ave (Hamden): Excess sediment has accumulated on the timber mat crossings within the access road at wetland #100.

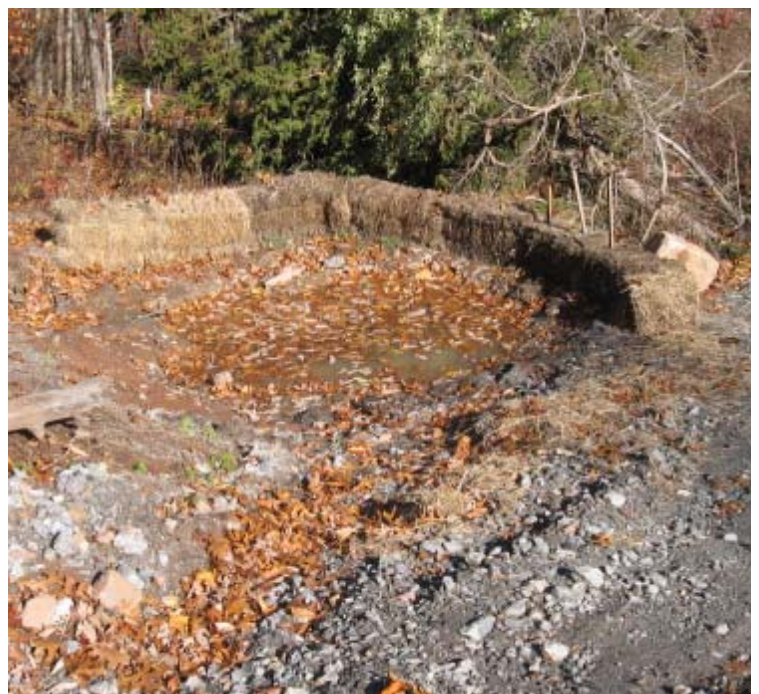
Brooksvale Ave: The haybale detention basin, located to the south of wetland #100, is functioning properly.
