Docket No. 272 – Development and Management Plan Inspection

Segment 2b Inspection

Date: November 20, 2007

Location: Segment 2b – Cheshire/Hamden Town Line to East Devon Substation

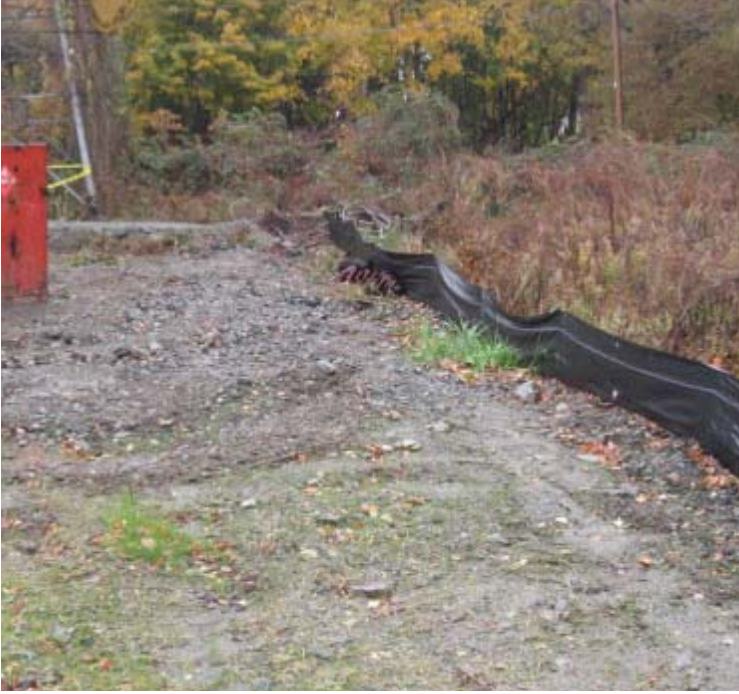
Oronoque Rd North (Milford): 345 kV foundation work is active in this area. Proper erosion controls are in place.

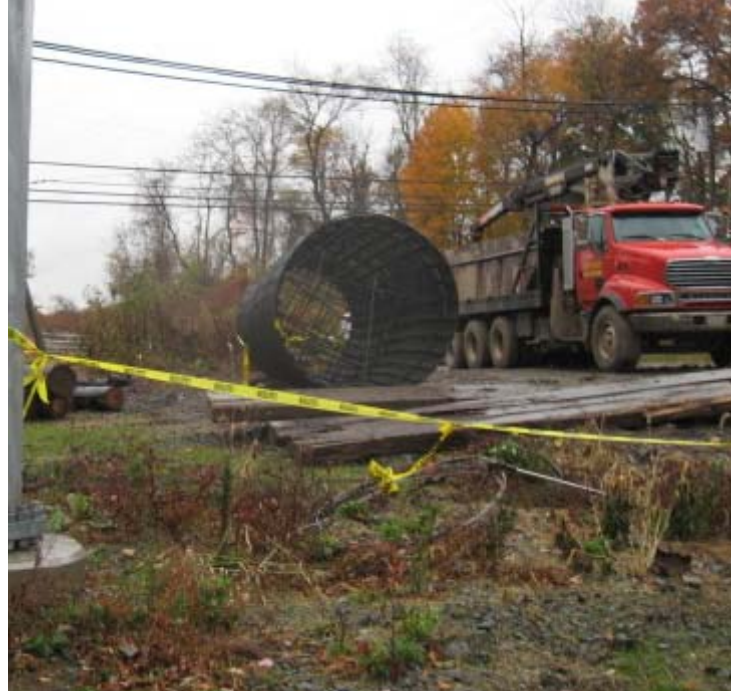
Oronoque Rd North: Spoils are being removed from wetland areas and stored in upland areas.

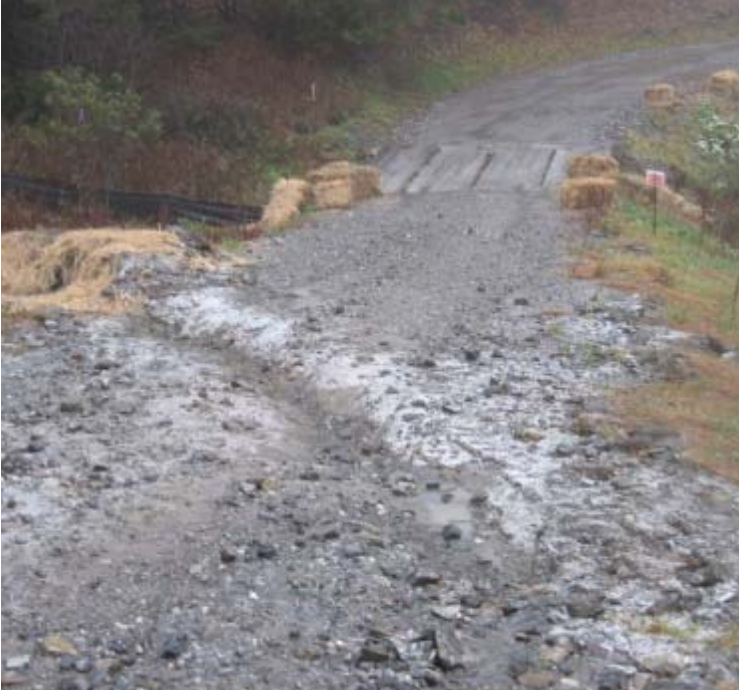
Litchfield Turnpike (Bethany): The recently installed water-bars are preventing sediment migration from the access road to the wetlands.

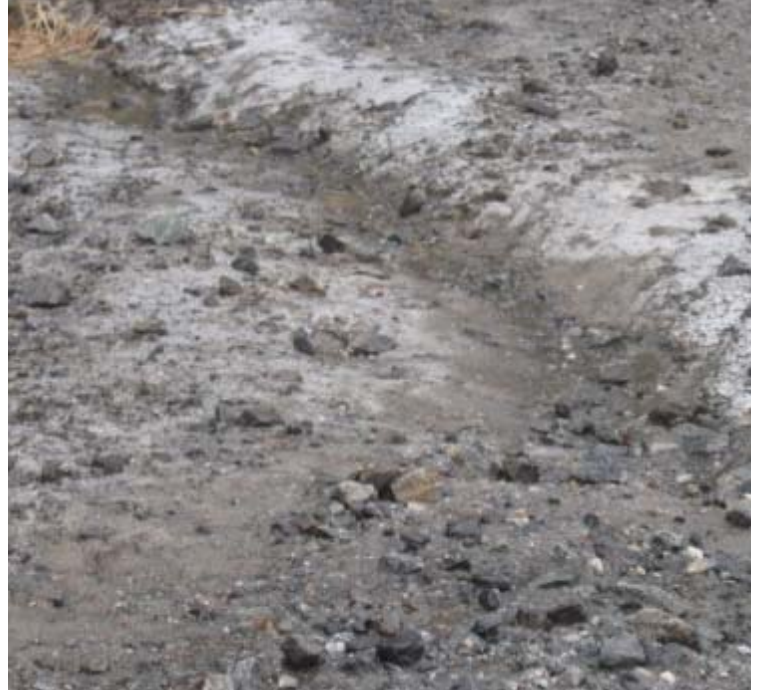
Litchfield Turnpike: An additional view of one of the recently installed water-bars.
