Docket No. 272 – Development and Management Plan Inspection

Segment 3 Underground Line

Date: November 28, 2007

Location: East Devon Substation to the Housatonic River Crossing

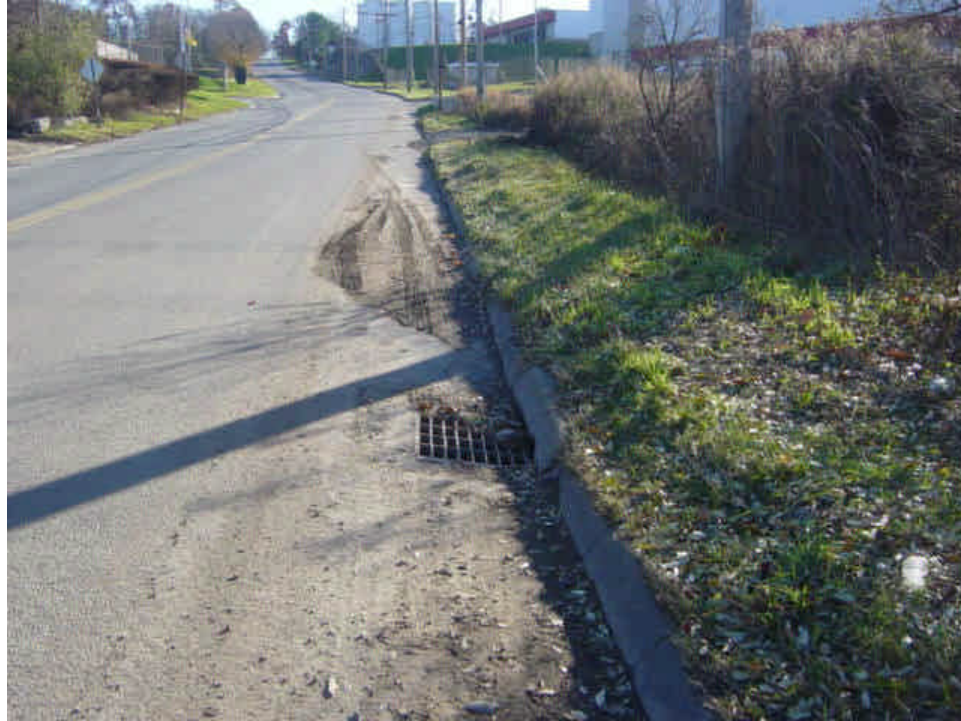
Sediment accumulation continues along Caswell Street and the catch basin is not protected. The tracking is not associated with this portion of the project. This responsibility should be coordinated with overhead contractors. See the 2B report.

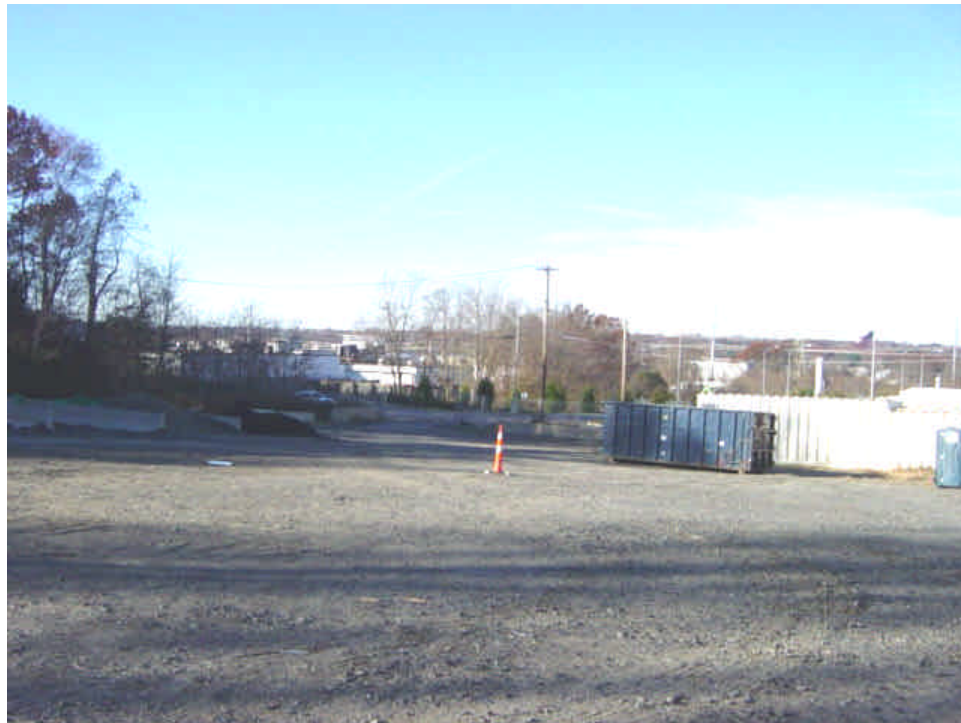
Shelland Street yard remains inactive as work has shifted to other areas of the project. Work in this segment is expected to return within the next few weeks.
