Docket No. 272 – Development and Management Plan Inspection

Segment 3 Underground Line

Date: December 12, 2007

Location: East Devon Substation to the Housatonic River Crossing

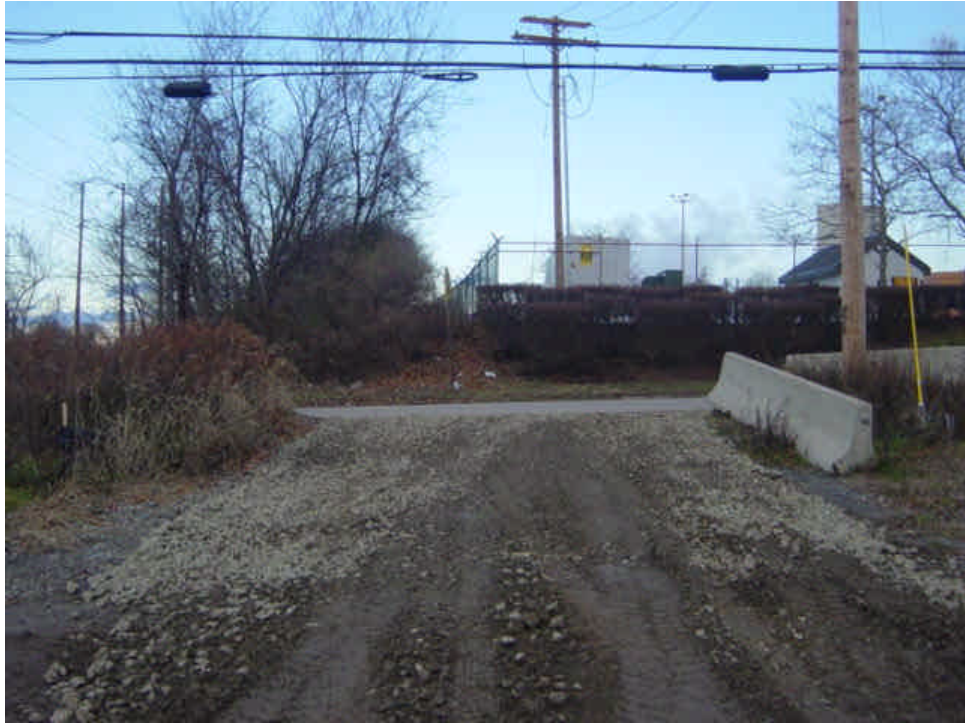
The stone has been refreshed at the construction entrance off of Caswell Street near station 1080. Overhead contractors are working in the ROW in this area.

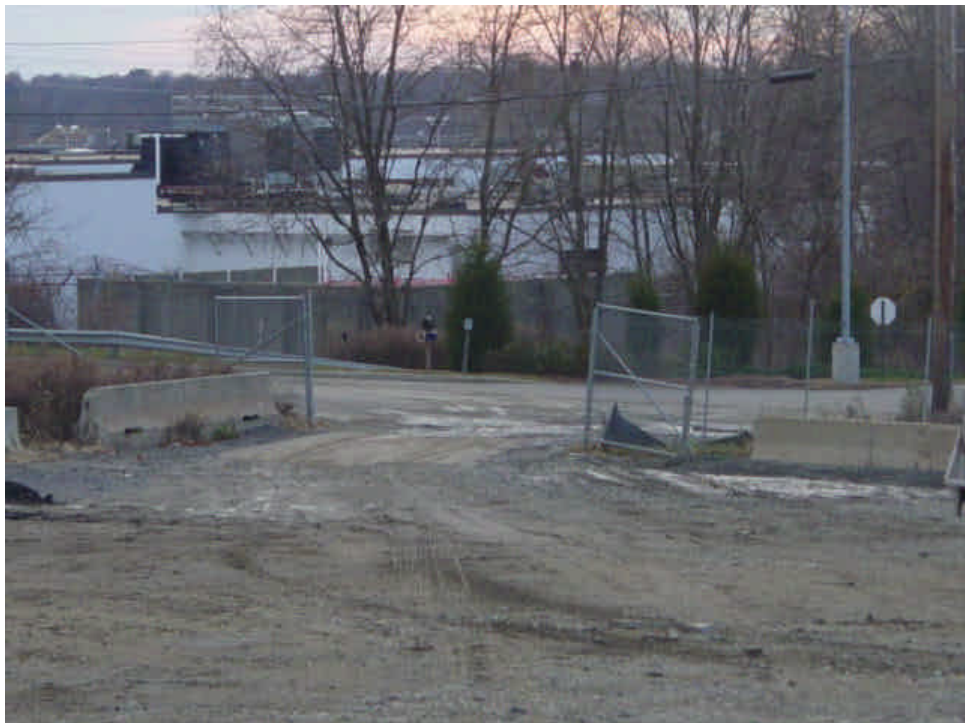
Minor tracking was observed at the entrance to the Shelland Street lay-down yard. Sweep as needed.
