Docket No. 272 – Development and Management Plan Inspection

Segment 4a Underground Line

Date: December 12, 2007

Location: Singer Substation to Fairfield/Westport Town Line

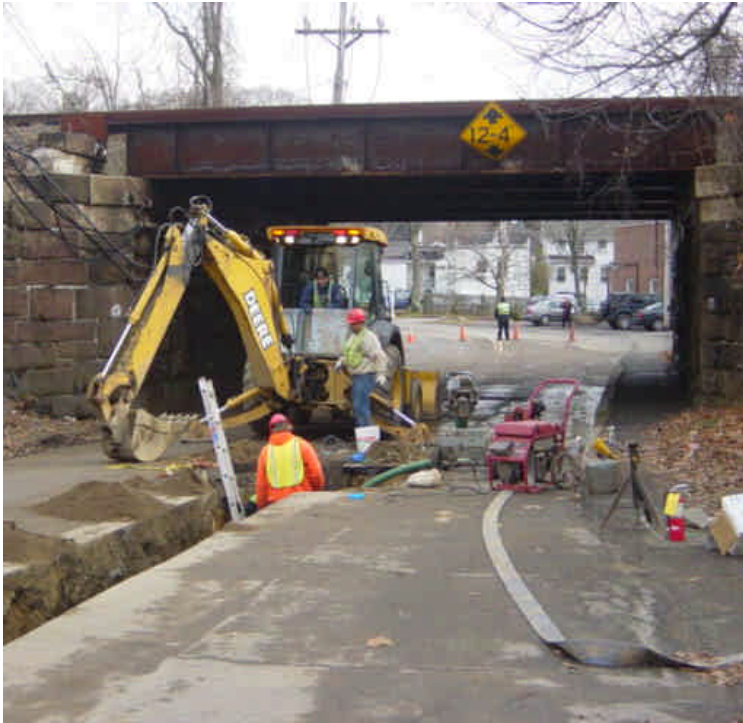
Gas main was being relocated near sta. #478-479 by Anthony Julian Railroad Construction Co. Catch basin did not appear to be protected.

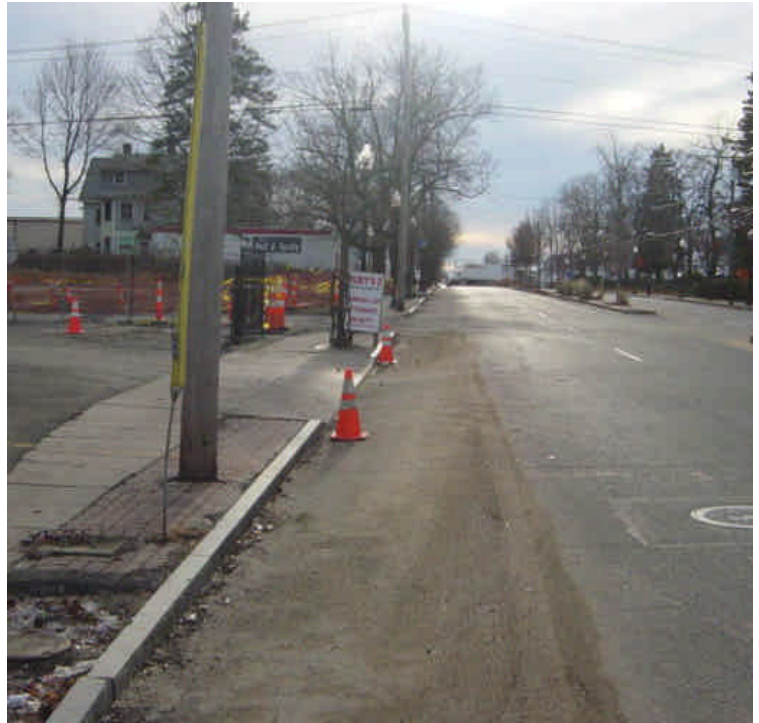
Heavy sediment accumulation was observed along the shoulders and median of Fairfield Ave. near sta. #696. The source of the sediment was apparently due to a house fire.

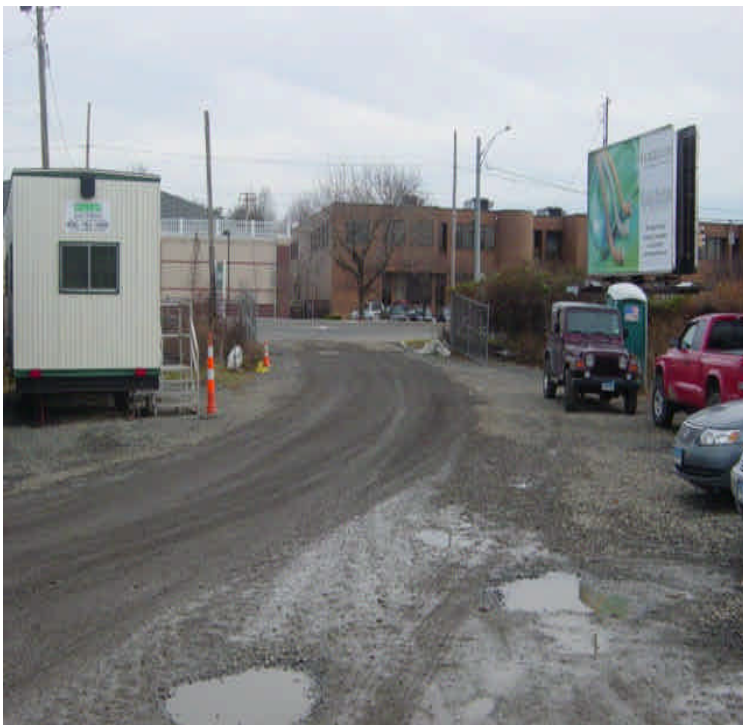
Kings Highway Lay-down Yard (Off Kings Highway, near Rt. 1 rotary)	<p>Perimeter controls remain in place. Sediment tracking was observed at the entrance to the yard. 12/12/07</p>	<p>Continue to monitor and maintain controls, sweep the roadway as necessary See spills/material storage section. 12/12/07</p>	<p>Needs regular attention.</p>
Bostwick Ave. Lay-down Yard	<p>Perimeter controls remain in place. Neither sediment tracking nor dust migration were an issue this week. 12/12/07</p>	<p>Continue to monitor and maintain controls, sweep the roadway when necessary. 12/12/07</p>	<p>Needs regular attention.</p>

Perimeter controls remain in place around the Kings Highway lay down yard. Sediment tracking was observed. Debris material was also observed near the yard entrance.

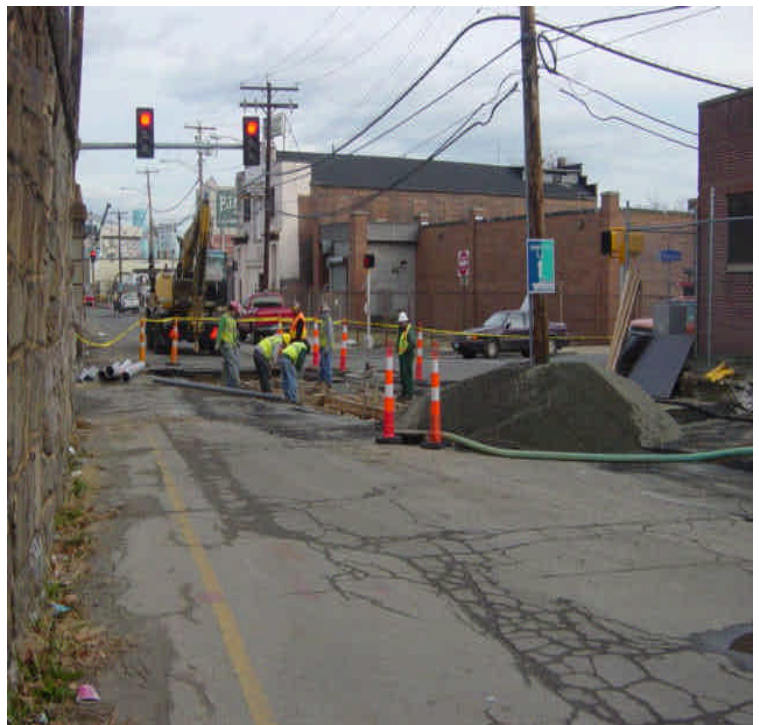
Trenching activities continue along Railroad Avenue near sta. #791-792.
