Docket No. 272 – Development and Management Plan Inspection

Segment 4a Underground Line

Date: December 21, 2007

Location: Singer Substation to Fairfield/Westport Town Line

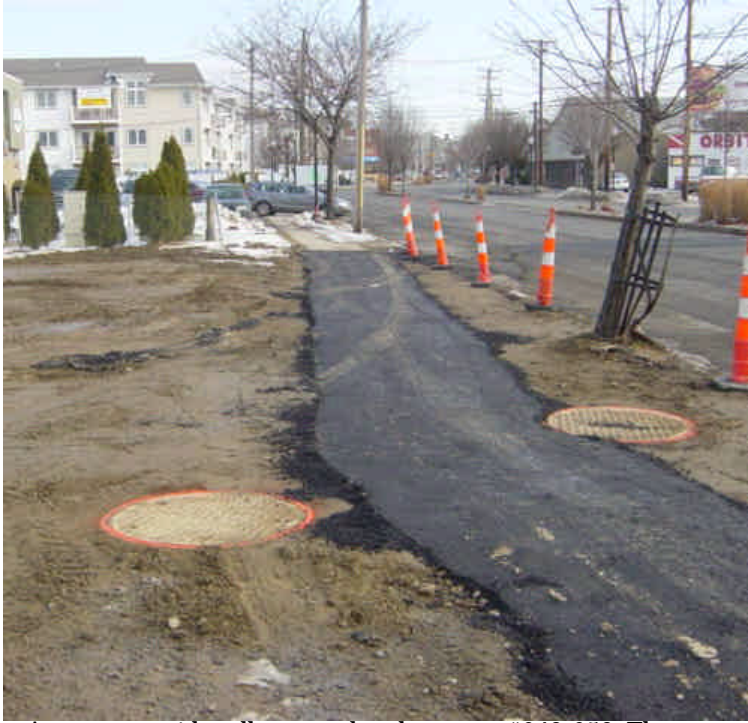
| Areas of Inspection | Observation | Recommended Action | Corrected Action |
|---|---|---|---|
| Bridgeport | <p>An area of exposed soil is adjacent to the work zone near sta. #649-650. Tracking was not observed this week but remains a potential issue. A temporary sidewalk was installed. 12/21/07</p> | <p>Continue to contain work area and avoid traveling through the exposed soils. Stabilize sufficiently for winter months as soon as active work is complete. 12/21/07</p> | <p>Tracking was not observed this week. Needs attention when active work is complete.</p> |

A temporary sidewalk was replaced near sta. #649-650. The adjacent lot remains exposed but some work is still needed here. The area will be stabilized when active work is complete.

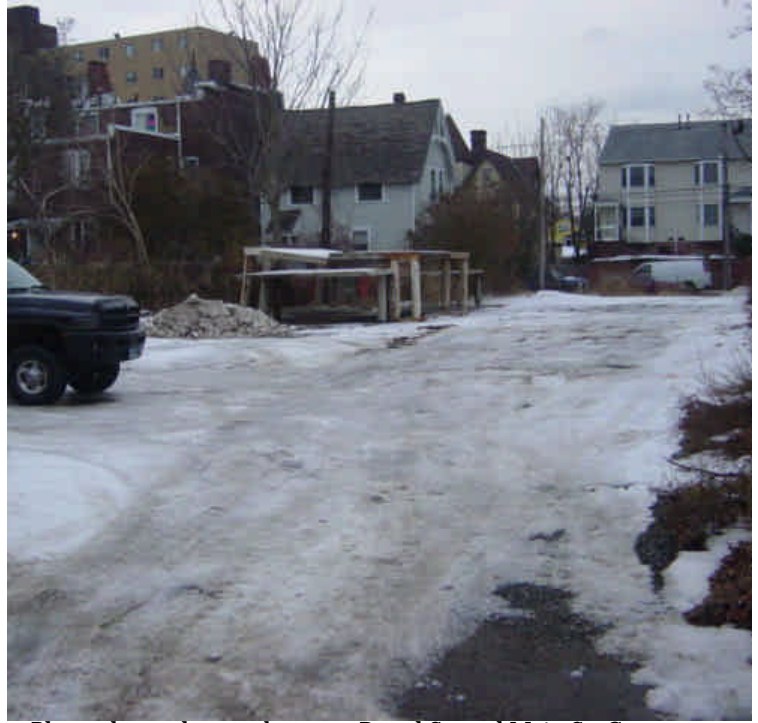
Photo shows the area between Broad St. and Main St. Contractors from Singer Substation are parking in this area and have stated they will be responsible for stabilization at the end of the work. Neither tracking, nor ruts were issues here.

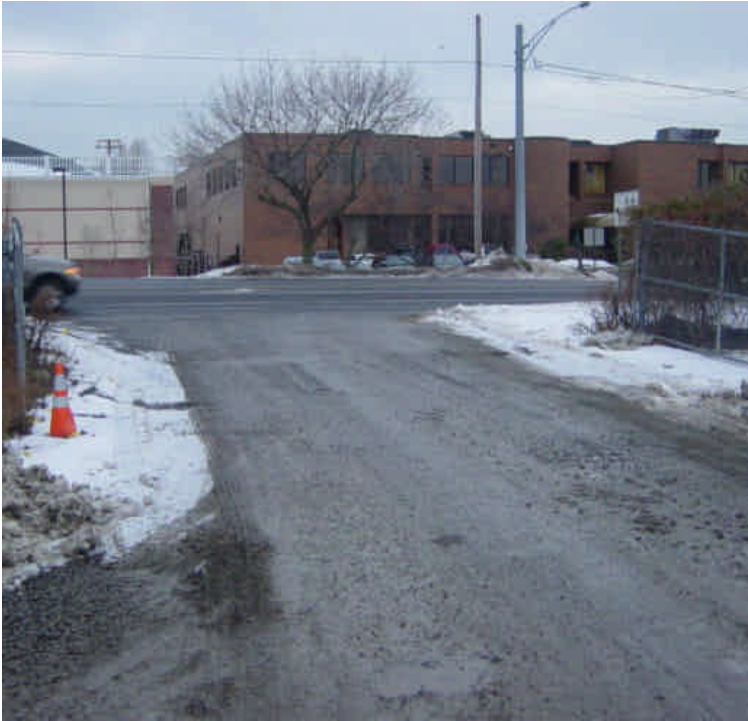
| Areas of Inspection | Observation | Recommended Action | Corrected Action |
|--|--|---|---|
| Kings Highway Lay-down Yard (Off Kings Highway, near Rt. 1 rotary) | was no longer noted, likely due to snow plowing. 12/21/07<br><br>Perimeter controls remain in place. In past weeks, minor sediment tracking was observed near the entrance to the yard. 12/21/07 | Continue to monitor and maintain controls, sweep the roadway as necessary See spills/material storage section. 12/21/07 | Needs regular attention. |

Perimeter controls remain in place around the Kings Highway lay down yard. Sediment tracking was not an issue as the work was shutting down for a 2-week holiday break.

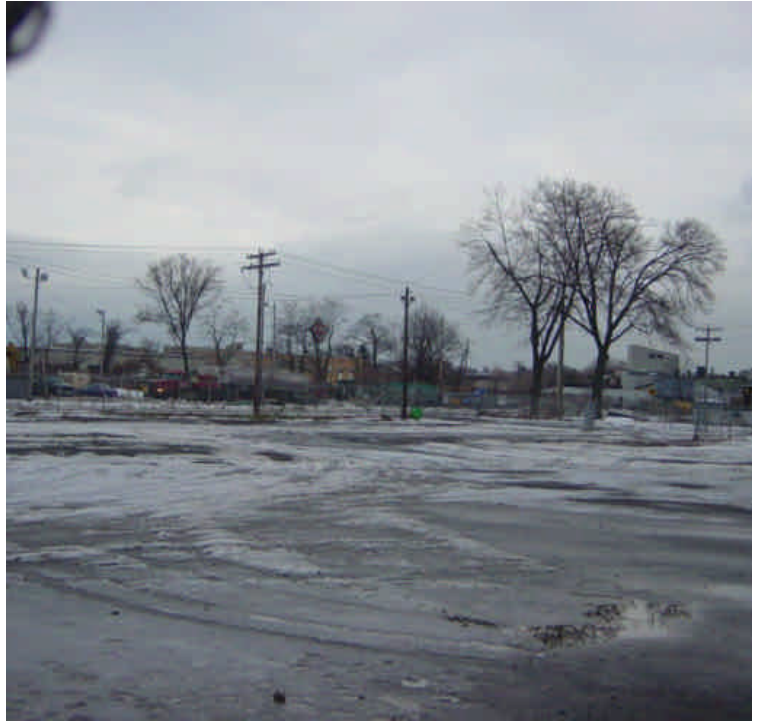
| Areas of Inspection | Observation | Recommended Action | Corrected Action |
|--|--|---|---|
| Bostwick Ave. Lay-down Yard | All materials and equipment had been demobilized/ removed from this area. The contractor stated it will no longer be used. 12/21/07 | None at this time. 12/21/07 | The yard was demobilized. |

The Bostwick Ave lay-down yard was currently closed. All material and equipment had been removed.
