Docket No. 272 – Development and Management Plan Inspection

Segment 4a Underground Line

Date: December 31, 2007

Location: Singer Substation to Fairfield/Westport Town Line

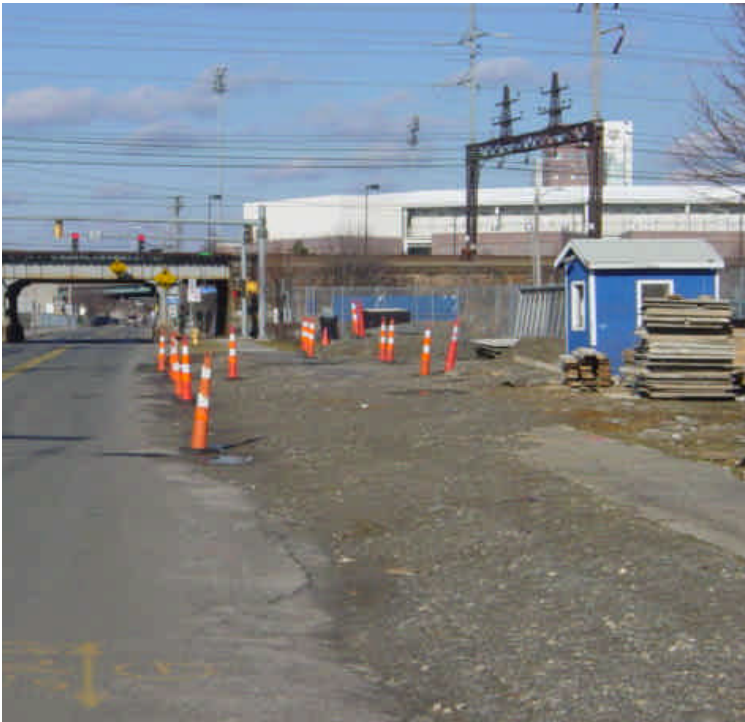
Exposed soil along the shoulder near sta. #801-803 continues to migrate into the roadway.

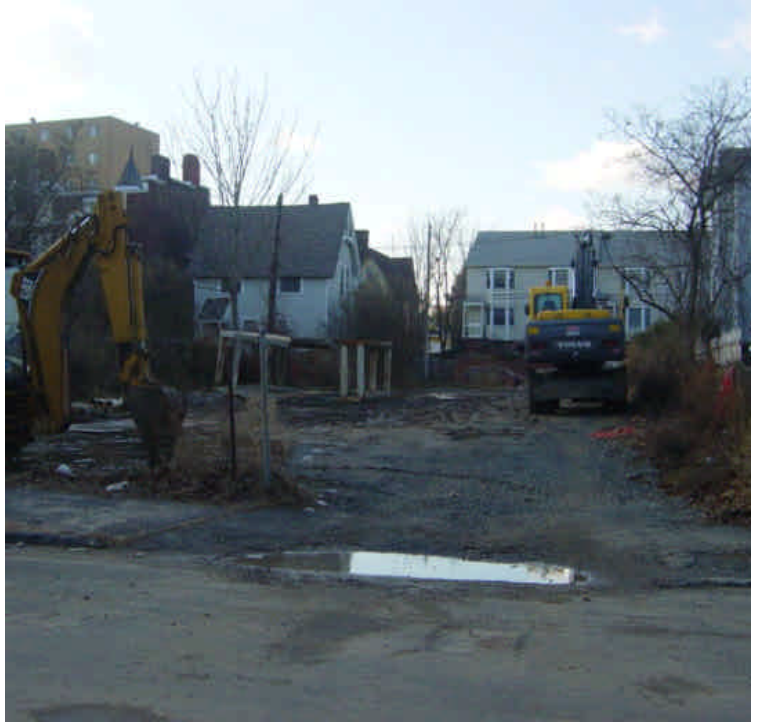
Contractors from Singer Substation project continue to store materials and equipment in the area between Broad St. and Main St. Neither tracking, nor ruts were issues here. They have stated they will be responsible for final restoration here when their access needs are complete.

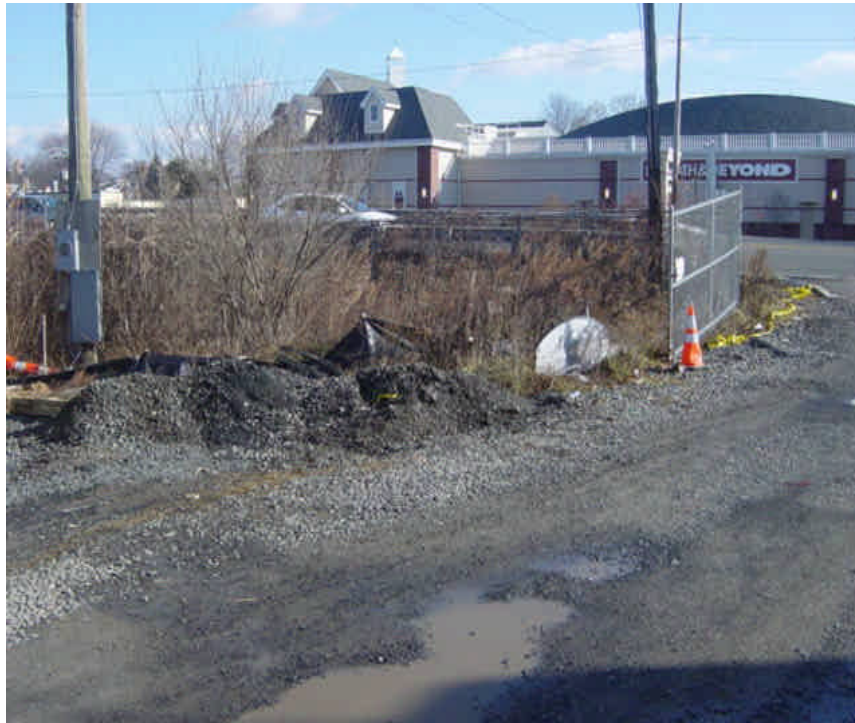
Perimeter controls remain in place around the Kings Highway laydown yard. Sediment tracking was not an issue as the work has shut down for a 2-week holiday break. Crushed stone which was previously spread throughout the yard has been plowed to the perimeter controls during snow removal activities and should be re-spread.
