Docket No. 272 – Development and Management Plan Inspection

Segment 4b Underground Line

Date: December 21, 2007

Location: Fairfield/Westport Town Line to Westport Avenue in Norwalk

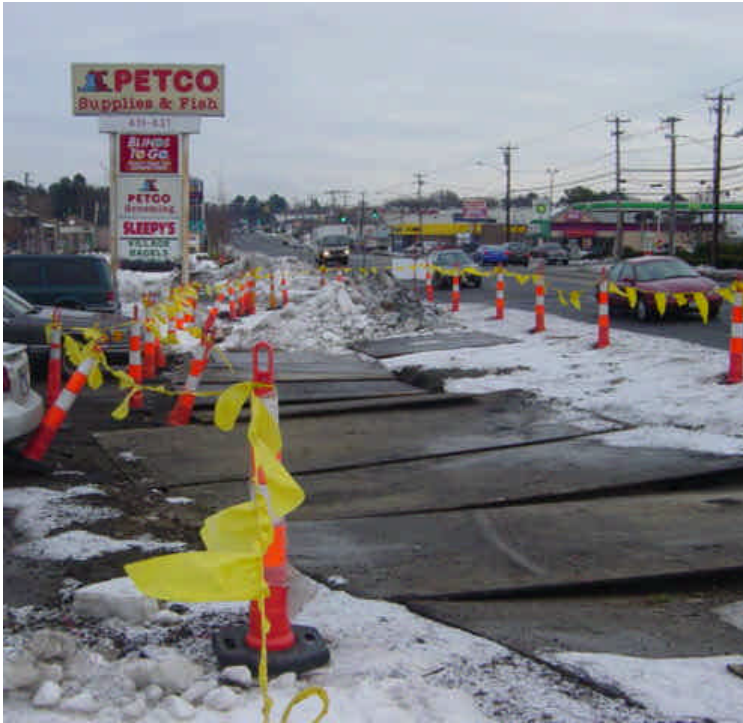
Vault tie-in work continues near sta. #144-146. Steel plates are in place.

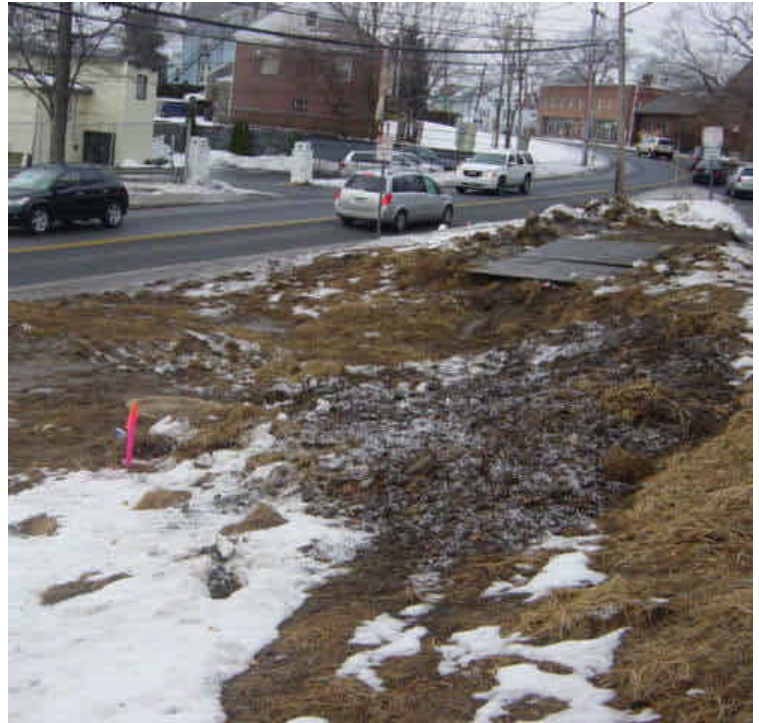
Silt fence was removed from the curb line near sta. #81 (vault #5) either due to construction or snow plowing. Exposed soils were partially mulched with hay. Continue to stabilize and sweep minor amounts of sediment along the curb.

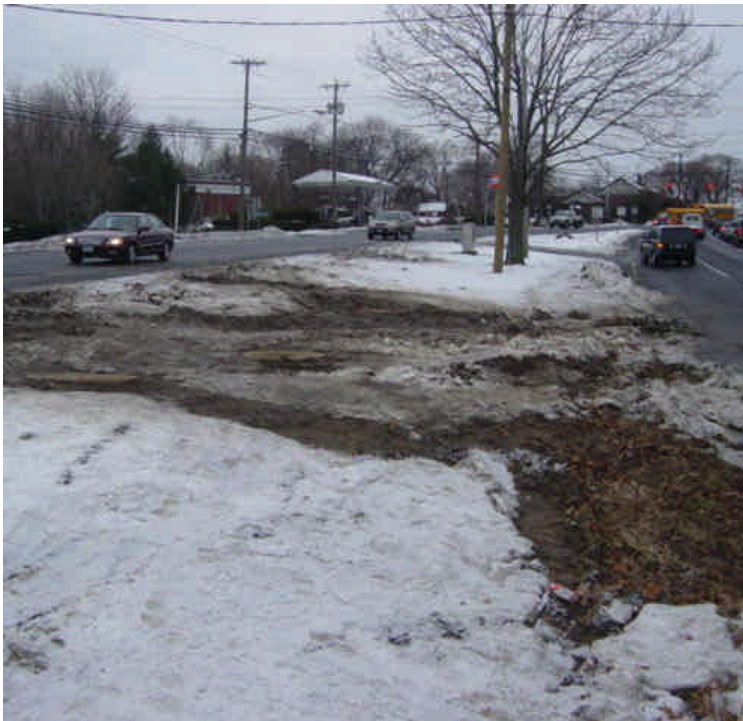
Heavy rutting continues within the median near sta. #316-318. Snow/sediment was encroaching on the roadway slightly. This area needs to be stabilized as soon as feasible.

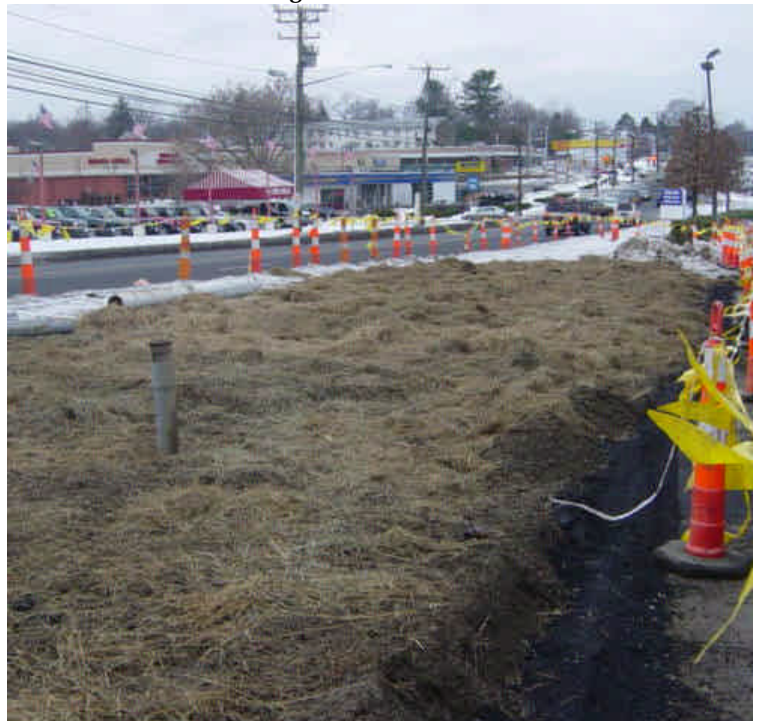
Backfilled soil near sta. #129-131 had been mulched with hay. A bituminous curb was installed but minor sedimentation was noted in the adjacent parking lot. 12/21/07	Sweep area if necessary and continue to monitor for stabilization. 12/21/07	Area was mulched and a curb was installed.
	Sediment accumulation was previously observed on the roadway near sta. #146 (vault #9). Landscaped areas/ exposed soils adjacent to the work site have the potential to erode. (Since 11/08) Active work has returned to this general area. 12/21/07	Provide additional stabilization, sufficient for winter months, to adjacent landscaped areas and work site once active work is complete in an area. 12/21/07	Needs attention to stabilize any completed areas.
Sediment tracking and heavy rutting was observed in the island near sta. #316-318. Hay mulch was previously	Remove the sediment accumulated along the gutter and sweep the roadway as necessary. Regrade and apply	Needs attention.

The area between #129-131 has been backfilled and mulched with hay. A temporary bituminous curb was installed but slight sedimentation had occurred within the parking lot. Sweep as needed.
