**Docket No. 272 – Development and Management Plan Inspection**

**Segment 4c Underground Line**

Date: November 28, 2007

Location: Westport Avenue to the Norwalk Substation in the City of Norwalk

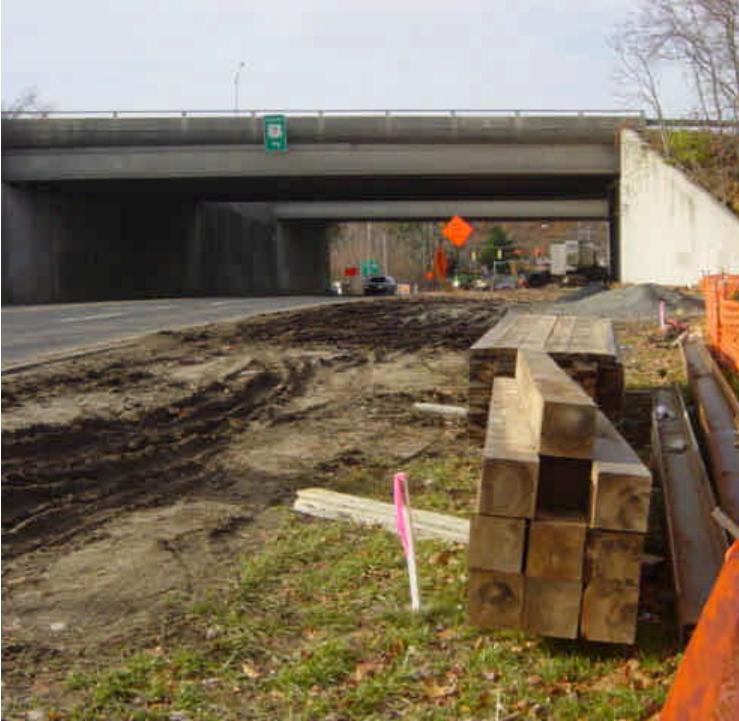
Construction stakes have been placed between sta. #15-16 in preparation for trench work. Some materials were also being stored here. Heavy rutting was observed along the shoulder with minor sediment tracking on the roadway.

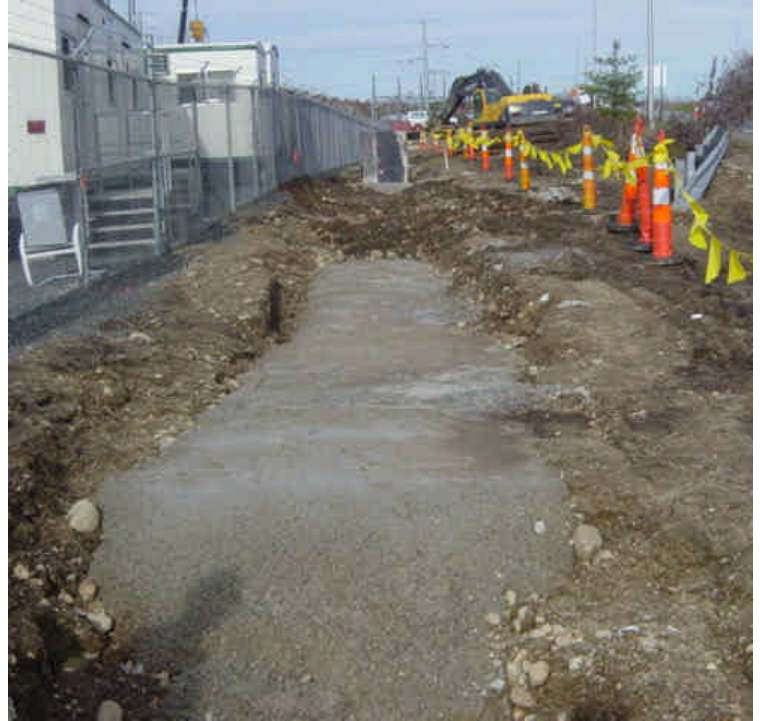
Flowable fill has been placed in the trench near sta. #5

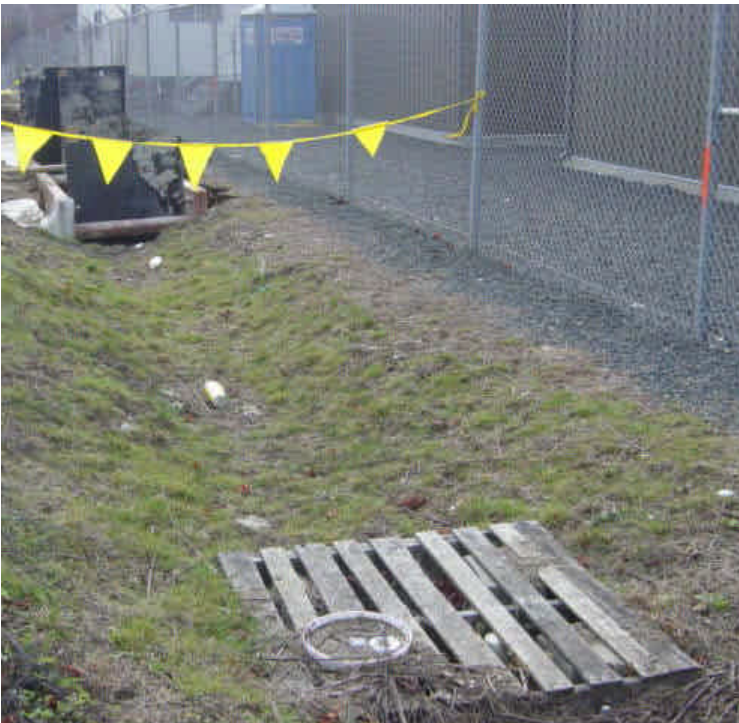
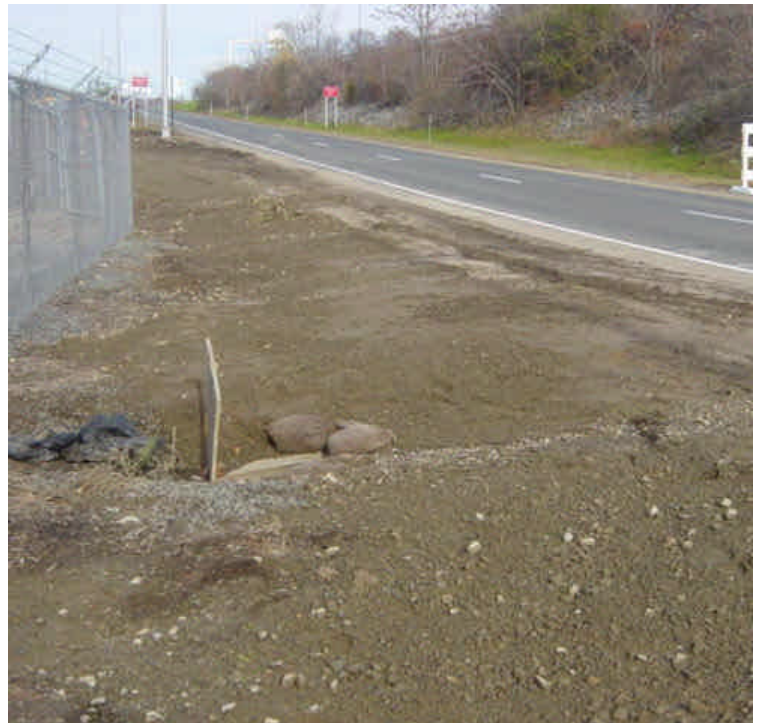
Existing drainage swale near sta. #5 (photo on left) appears to have run along the shoulder of the off ramp and drain into the inlet structure (photo on right). Trench work has altered the grades in this area and the drainage swale has not been reestablished. Inlet was protected, but sediment has still accumulated inside the structure. The drainage swale is not addressed in the D&M plan but efforts need to be made to ensure appropriate drainage. Exposed soils along the off-ramp have the potential to erode and need stabilization sufficient for winter months.

<p>Trenching activities have been completed/ backfilled between sta. #6-10 leaving a large area of exposed soils along the shoulder of the Rt. 7 off-ramp. 11/28/07</p>	<p>Temporarily stabilize areas of exposed soils in a way that is sufficient for winter months. Attend to this within timelines approved by the D&amp;M. 11/28/07</p>	<p>Needs attention.</p>
Norwalk Norwalk lay-down yard	<p>The yard does not appear to be fully active at this time. One side of the yard is lined with perimeter erosion controls (silt fence and haybales). The area adjacent to the Norwalk River is protected by an existing concrete dock. 11/28/07</p>	<p>Install barrier controls between the Norwalk River in locations that runoff may flow from the yard to the River before materials are brought to site. The existing concrete slab/dock provides a good barrier. 11/28/07</p>	<p>Continue to monitor.</p>
P:\Prj\8931203\Reports\Segment 4c\November 2007\20071128 4c report.doc	<p>A small asphalt berm remains at the one tank</p>	<p>Continue to monitor to ensure run-off is fully</p>	<p>NA</p>
