Docket No. 272 – Development and Management Plan Inspection

Segment 4c Underground Line

Date: December 5, 2007

Location: Westport Avenue to the Norwalk Substation in the City of Norwalk

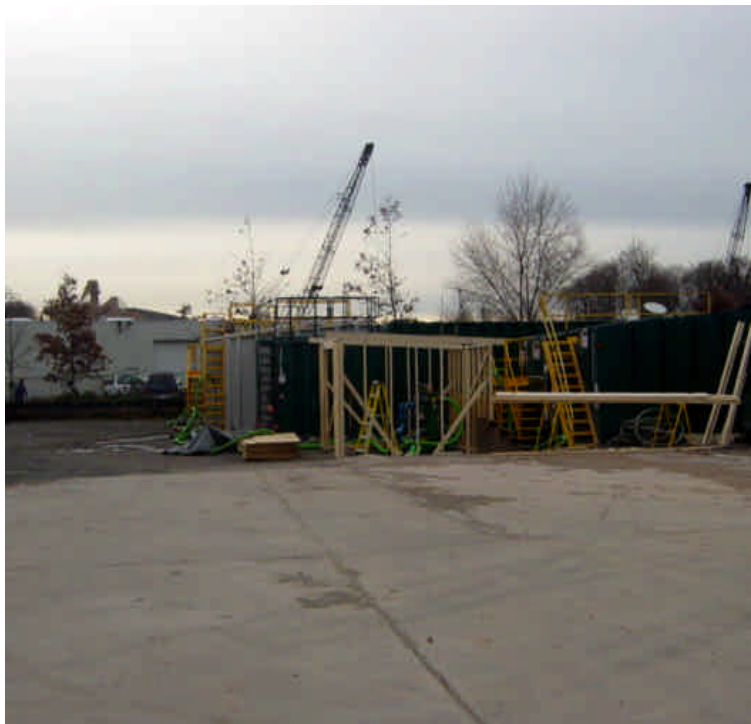
Contractor lay-down yard located on Smith Street in Norwalk is primarily being used to store frac tanks. No equipment or materials are being stored in the yard at this time.

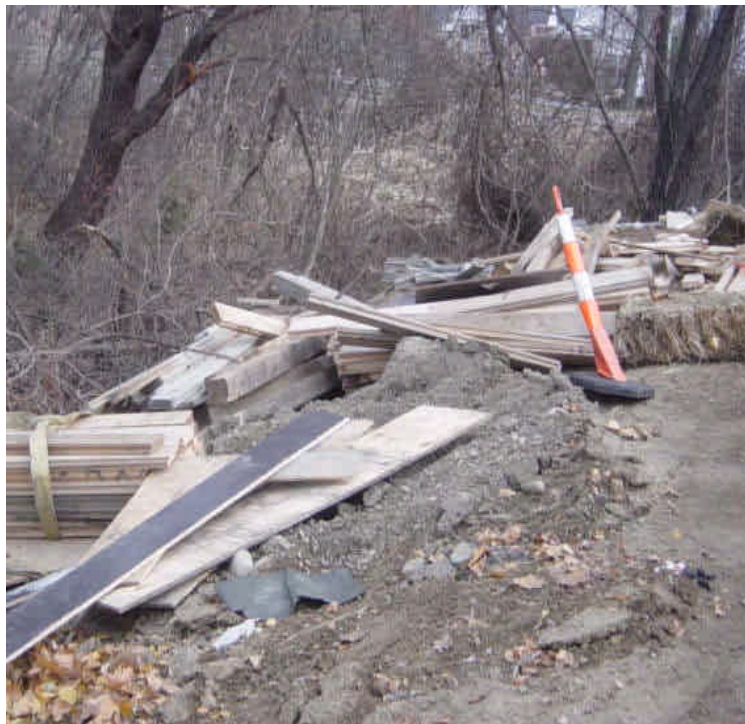
Areas of Inspection	Observation	Recommended Action	Corrected Action
	<p>Haybales previously placed along the down gradient side of the slope near sta. #18 have been moved, no longer forming a continuous barrier. Lumber materials were piled here. Soils remain exposed since 11/21. 12/05/07</p> <p>Silt fence has been proactively installed along the base of the slope near sta. #15-16 during trench work. In several places, the soil has piled up and is overtopping the fence. 12/05/07</p> <p>A drainage inlet near sta. #9+50 was further protected with silt fence and hay bales, however accumulated sediment remains. 12/05/07</p> <p>The inlet at #9+50 was associated with a pre-construction drainage swale. Trench work has modified the grades in the area (removing the swale) and the inlet no longer appears to function, but was not identified on the D&M plan. 11/28-12/05/07</p> <p>A large area of backfilled soil remains exposed between sta. #6-10 along the shoulder of the Rt. 7 off-ramp since 11/28. Minor rutting was observed in this area but tracking was not an issue at this time. 12/05/07</p>	<p>Reset haybales along the base of the slope and stake to secure bales in place. Provide temporary stabilization for exposed soils within approved timelines. 12/05/07</p> <p>Remove soils which have overtopped the silt fence and reinforce fence. Use caution during future work to minimize unnecessary impacts to the surrounding areas. 12/05/07</p> <p>Remove accumulated sediment from the drainage inlet. Continue to monitor controls. From past observations during the Bethel-Norwalk project, this inlet receives high velocity run-off. 12/05/07</p> <p>Further evaluation is required here. Contractors must ensure that drainage meets pre-existing conditions and does not cause issues on the roadway. The drainage swale will likely require restoration. 11/28-12/05/07</p> <p>Temporarily stabilize areas of exposed soils in a way that is sufficient for winter months. Attend to this within timelines approved by the D&M. 11/28-12/05/07 From past experience with Bethel-Norwalk, this area has a high potential</p>	<p>Needs attention.</p> <p>Needs attention.</p> <p>Silt fence and haybales installed to protect inlet. Sediment needs additional attention.</p> <p>Needs attention and further evaluation.</p> <p><i>(See Norwalk 9S Phasing and Erosion Control Plan rev. 10/30/03 from the Bethel-Norwalk project as reference)</i></p> <p>Needs attention.</p>

Haybales previously placed along the downgradient side of the slope near sta. #18 have been moved and no longer form a continuous barrier. Exposed soils remain. Materials were being stored in the area but it is unclear whether the lumber is project-related

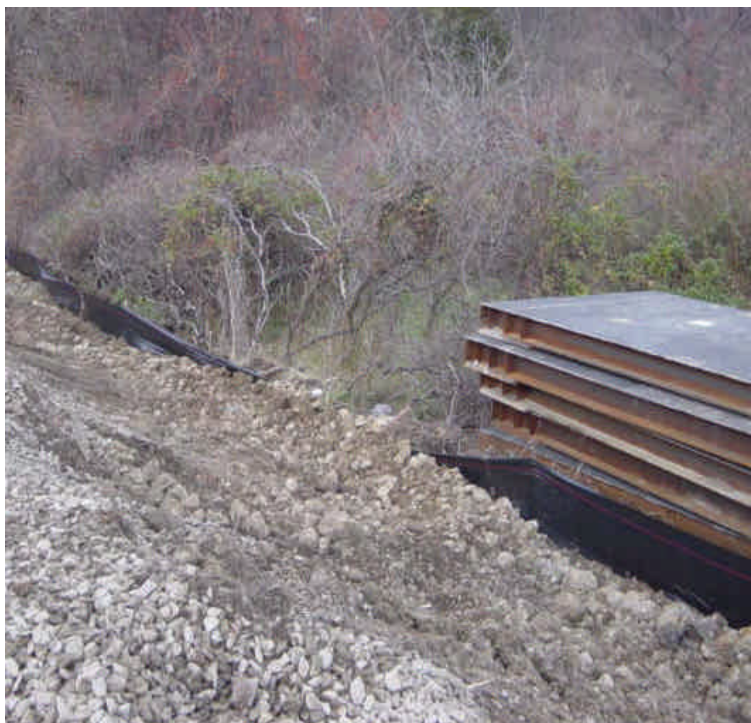
Trench plates were noted beyond the silt fence at sta. #15. 12/05/07	Remain aware of limits of work and remove materials as construction progresses away from the area. 12/05/07	Needs regular attention.
Additional Observations	None. 12/05/07	None. 12/05/07	NA

Silt fence has been proactively installed along the base of the slope near sta. #15-16. In several places, the soil/stone had piled up and was overtopping the fence. Plates were also being stored beyond the barrier.

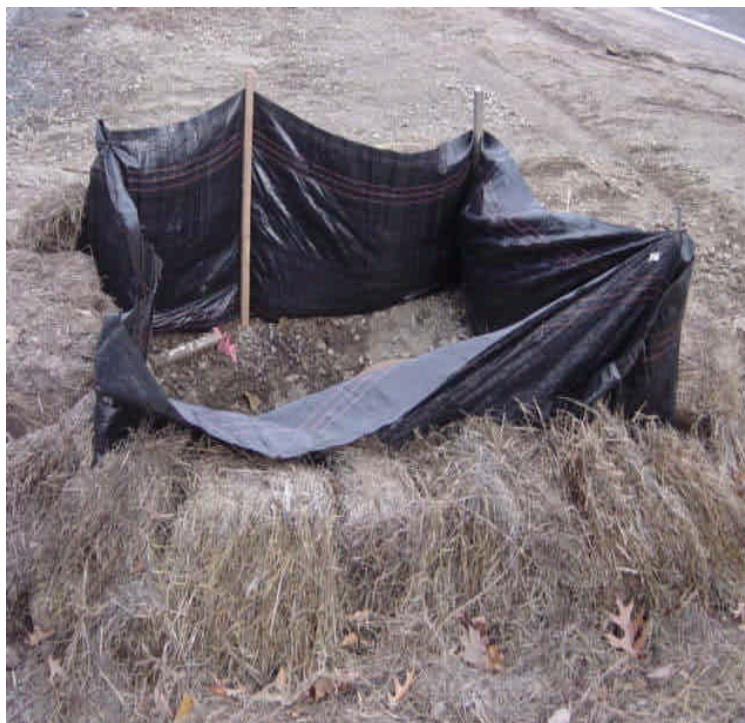
Drainage inlet near sta. #9+50 has been protected with silt fence and haybales, however accumulated sediment remains. The structure was associated with a pre-construction drainage swale which was not re-established after trenchwork altered the area. Efforts need to be made to ensure appropriate drainage.
