Docket No. 272 – Development and Management Plan Inspection

Segment 4c Underground Line

Date: December 31, 2007

Location: Westport Avenue to the Norwalk Substation in the City of Norwalk

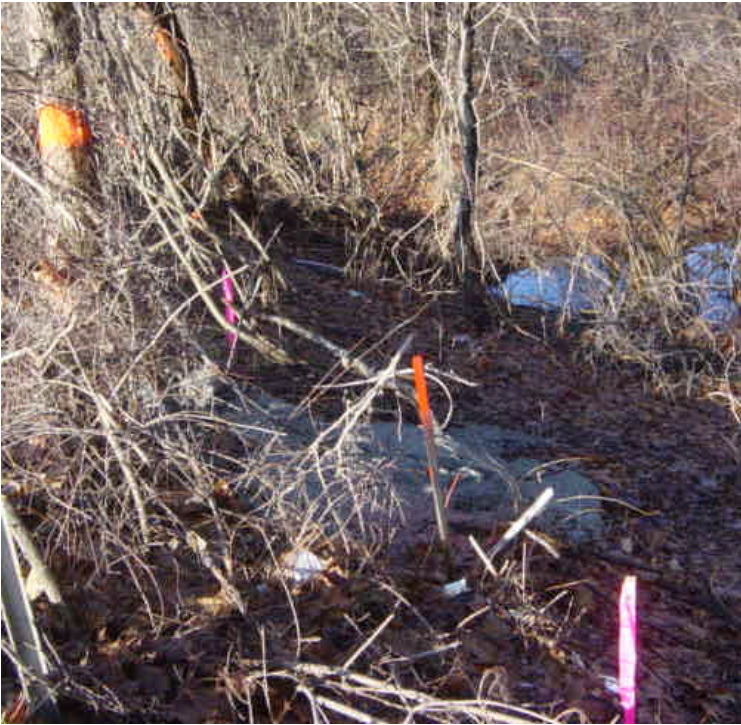
Some lumber materials were noted, stored on the slope at sta.# 16-18. 12/12-12/31/07 An uncontained concrete washout had occurred at the slope here. Controls were not in place and what appears to be a resource area is located down-gradient. 12/21-12/31/07	Remove materials as construction progresses away from the area. Stabilize exposed soils. Remove the concrete material, install controls and ensure future washouts are contained in an appropriate location. 12/21-12/31/07	Needs attention.
	Concrete washouts remain in the vicinity of vault #1. Material had run-off down the slope to the silt fence at sta. #15. 12/21-12/31/07	Remove the concrete material and ensure future washouts are contained in an appropriate location. 12/21-12/21/07	Needs attention.
Additional Observations	None. 12/31/07	None. 12/31/07	NA

A concrete washout remains on the slope near the work at sta. #16-18. Haybales have not been reset and there are no controls between the work and what appears to be a resource area down-gradient. Trees were marked for removal in this area.

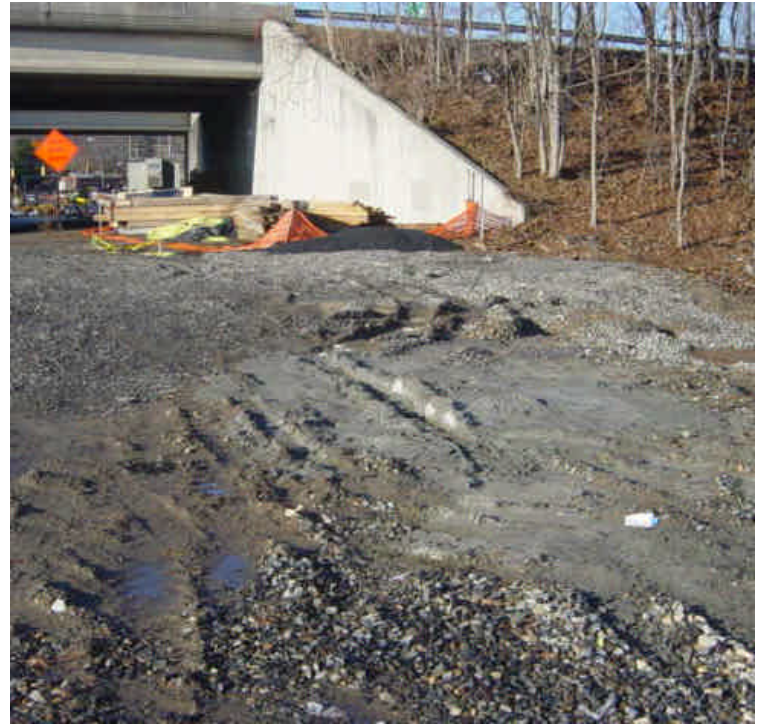
Concrete washout remains near sta. #15 along the shoulder of the roadway. Ruts through this area appear to be recent and therefore due to other vehicles, since work has shut down for two weeks.

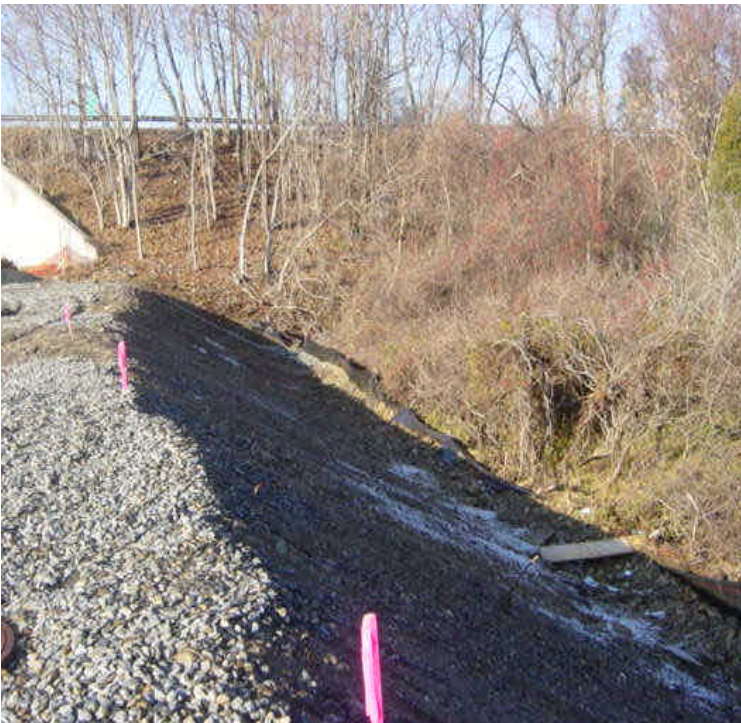
View of the slope near sta #15 (vault #1) The silt fence here was still overtopped with stone and needs repair. A concrete washout was also observed along the slope with run-off to the silt fence. The concrete washout needs to be removed and future washouts need to be properly contained.

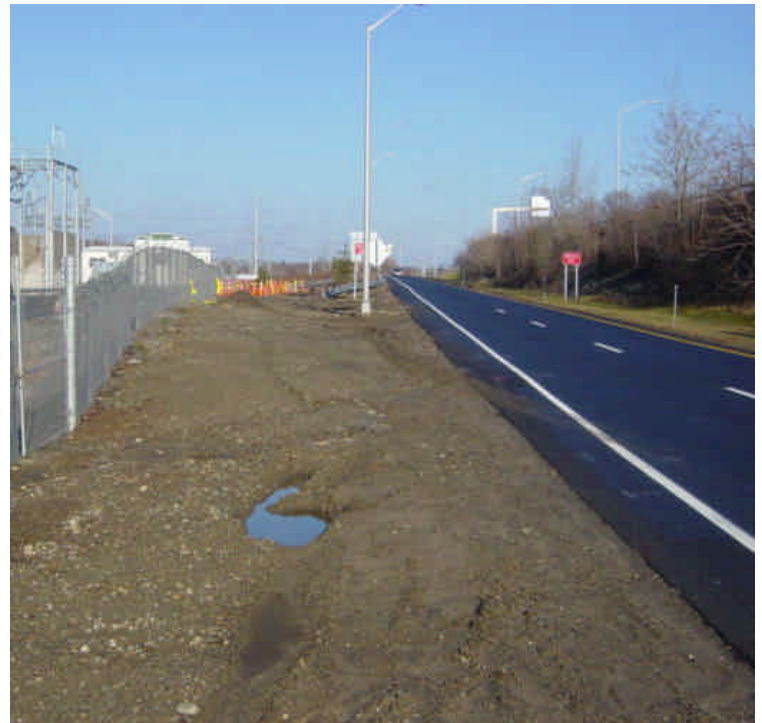
Trenching will continue in the area of sta # 5-7 near the Rt. 7 off-ramp. Portions have been backfilled. The contractor stated that they would reestablish the pre-construction drainage swale once work is complete in this area.
