Docket No. 272 – Development and Management Plan Inspection

Beseck Switching Station Inspection

Date: January 8, 2008

Location: Beseck Switching Station

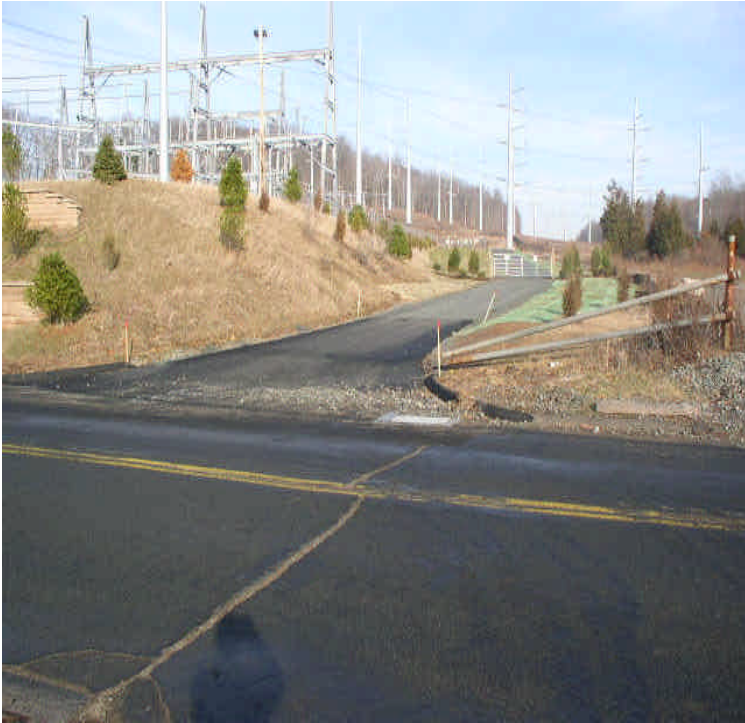
Areas of Inspection	Observation	Recommended Action	Corrected Action
Access roads and adjacent roadways	Erosion control mats and seed remain in place over previously disturbed soil shoulders along the eastern site access. 1/8/08	Continue to monitor for turbid run-off until the site is at final stabilization with established vegetative cover. Add controls as needed to contain sediment. 1/8/08	Not Applicable (NA) at this time.
	1A contractors are now accessing the ROW from the western access off Carpenter Ln. Sediment tracking from Beseck is no longer an issue (as of 11/27) as the access roads are paved and the site is covered in stone. 1/8/08	As all areas are at final cover at the station, responsibility for sweeping the roadway falls largely to 1A & 2A contractors. 1/8/08	NA. See 1A/2A report for more details.
	Erosion control mats remain in place along the shoulders of the western site access. Curbing at this drive also helps to detain water. A small area of exposed soil was noted along the western access curbing, likely as a result of plowing. 12/26-1/8/08	Stabilize the small area of newly disturbed soils as needed. 12/26-1/8/08	Needs to be monitored.

View along the eastern site access from Carpenter Lane. Some stone was migrating into the driveway from the 1A access point.

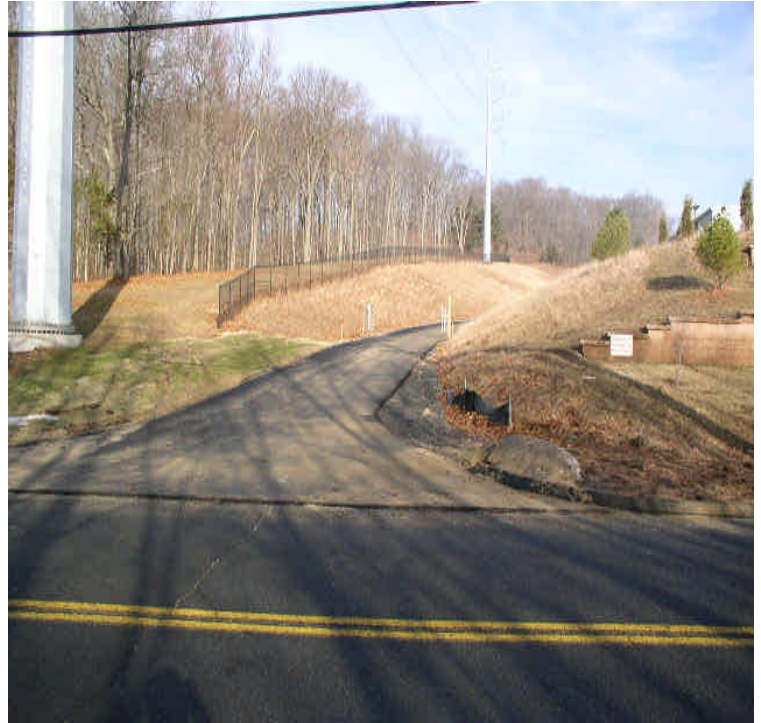
Hay mulch and seed remain on exposed soils at the old western driveway as well as a soil	Ensure there is sufficient stabilization for winter months. Replace controls across the entrance if	NA at this time.

View along the western site access from Carpenter Lane.

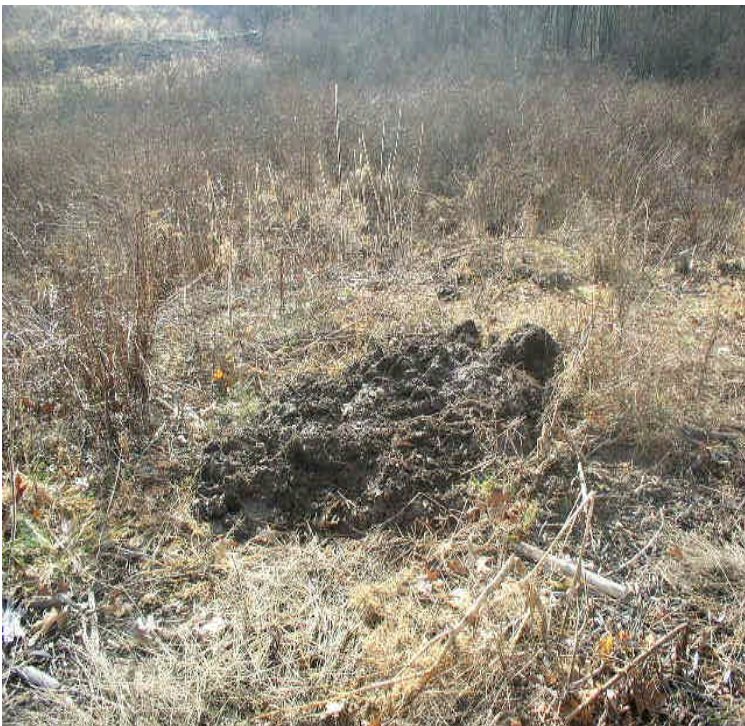
Accumulated sediment was removed from the wetlands and culvert across Carpenter Ln. and spread appropriately in an upland

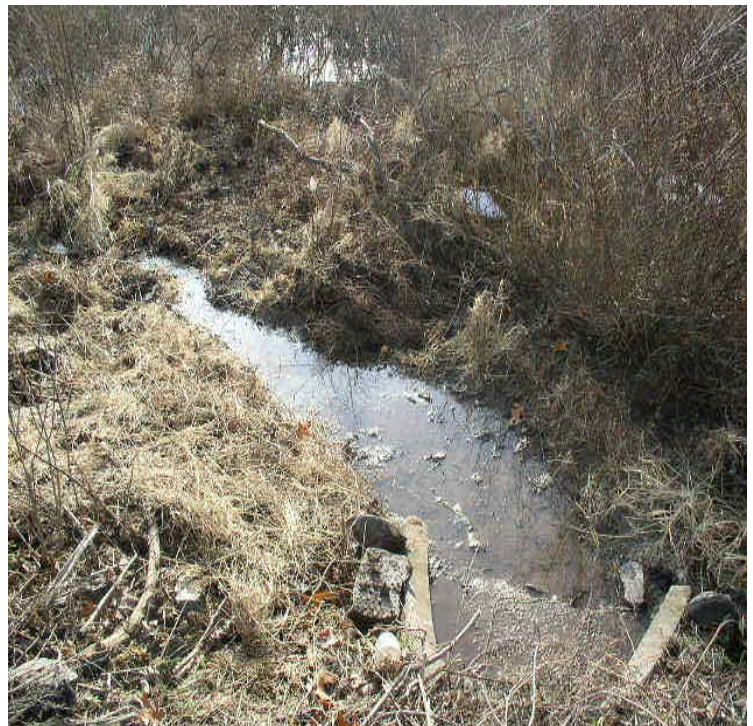
<p>Inland Wetland and Watercourse encroachment and mitigation</p>	<p>Accumulated sediment from within the wetland and outlet has been removed. 1/8/08</p>	<p>Continue to monitor the wetland for any turbid run-off until the area has full vegetative cover in the growing season. 1/8/08</p>	<p>Sediment was removed from the wetland.</p>
<p>State species of concern, threatened and endangered species.</p>	<p>According to the D&M plan, state-listed species are not located in this work area. 1/8/08</p> <p>Several different species of frogs, turtles, and salamanders have been noted in wetlands south of Carpenter Ln. and east of Beseck during the last two springs. 1/8/08</p>	<p>None. 1/8/08</p> <p>Although these species were not state-listed, it indicates good habitat. Continue to make good efforts to reduce impacts to these wetlands to the extent possible. 1/8/08</p>	<p>NA</p> <p>NA</p>

Accumulated sediment has been removed from the wetlands and culvert. Mulch was placed over exposed areas to reduce possible erosion or run-off.
