Docket No. 272 – Development and Management Plan Inspection

Beseck Switching Station Inspection

Date: January 16, 2008

Location: Beseck Switching Station

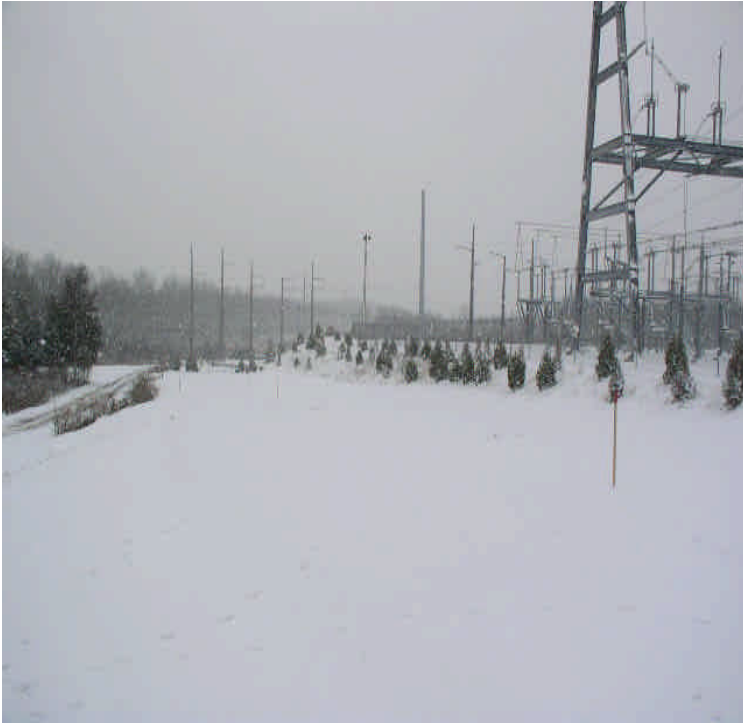
View along the eastern site access towards Carpenter Lane. The site is under snow cover.

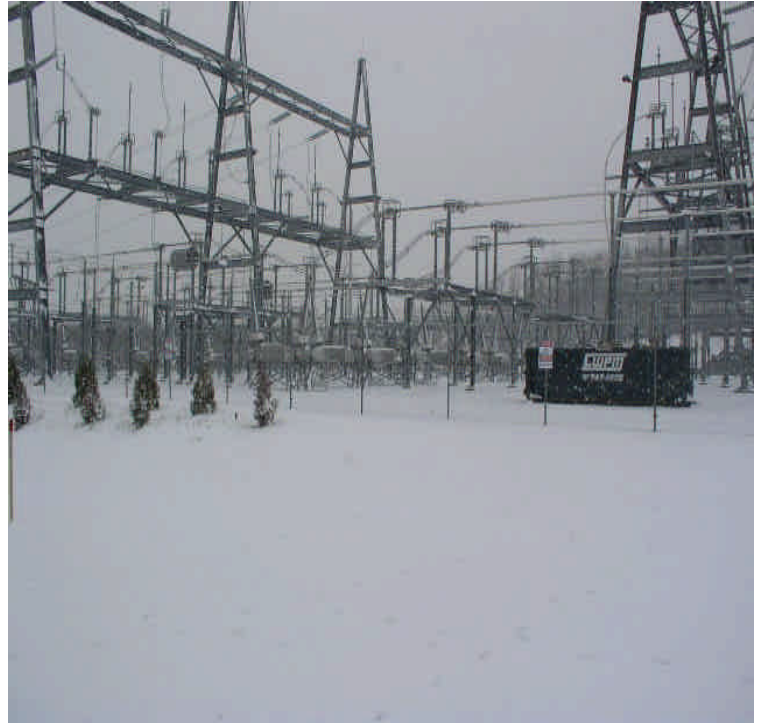
View of the switching station looking from the east to the west.

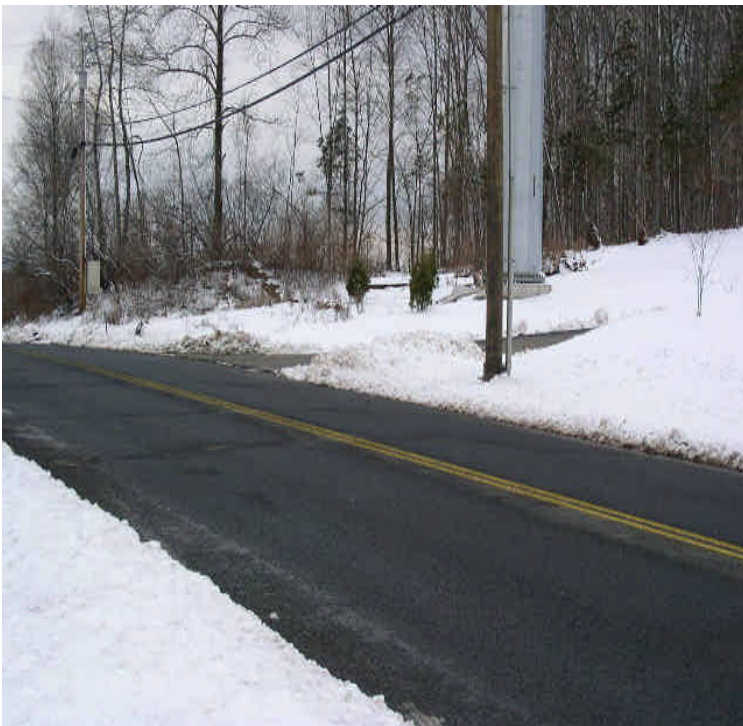
View of the western site access.

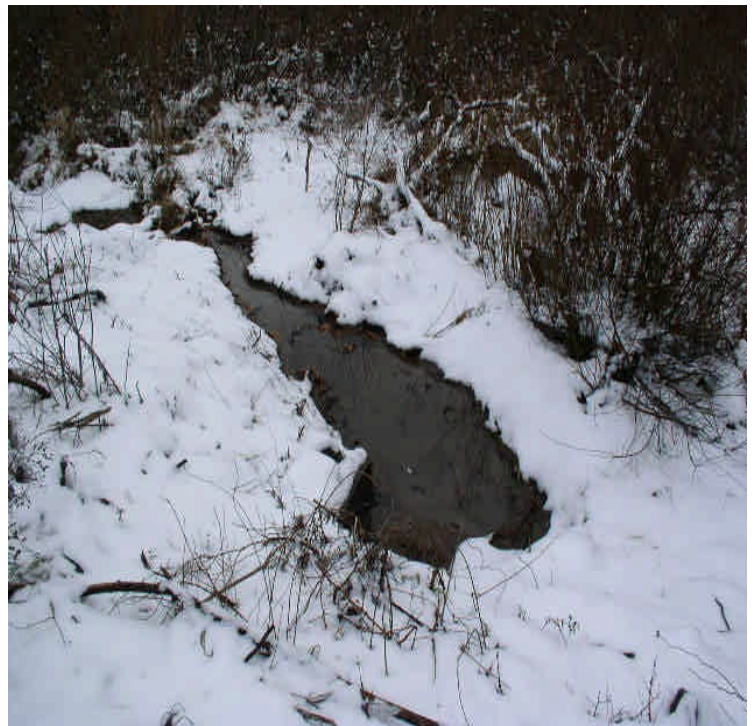
Wetlands were under snow cover. Turbidity was not observed following the removal of the accumulated sediment here.
