Docket No. 272 – Development and Management Plan Inspection

East Devon Substation Inspection

Date: February 15, 2008

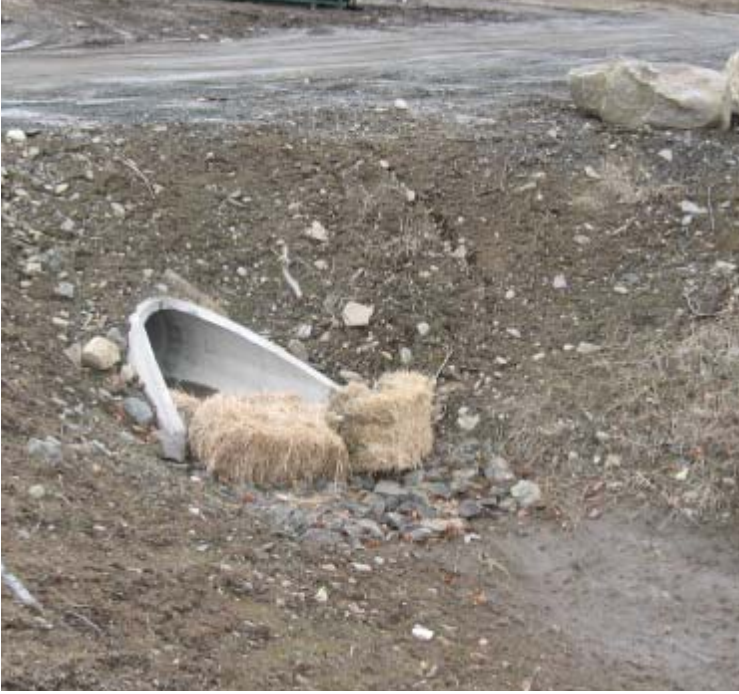
East Devon Substion (Milford): Haybale controls have been installed at a culvert outlet within the drainage swale located along the eastern boundary of the substation.

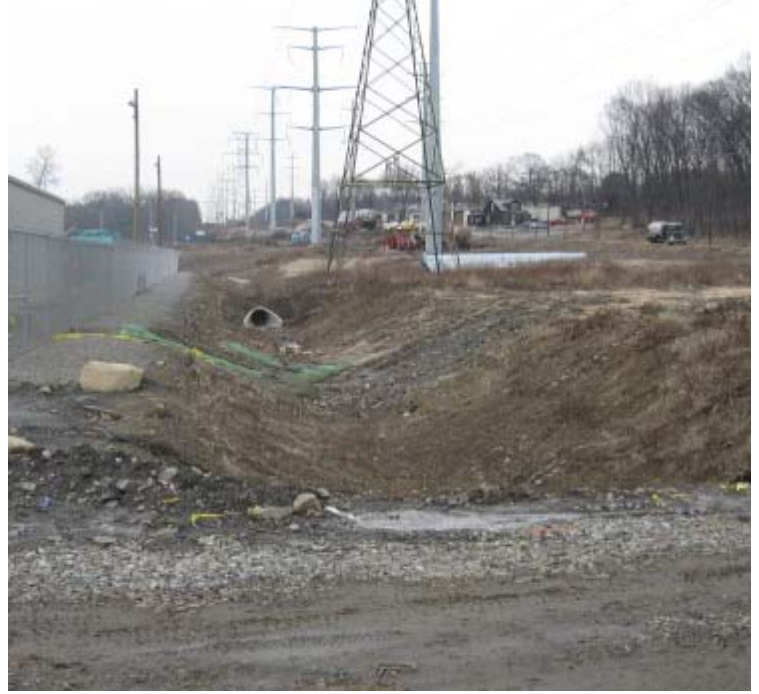
East Devon Substation: Exposed soils have been temporarily stabilized with mulch within the drainage swale.
