Docket No. 272 – Development and Management Plan Inspection

East Devon Substation Inspection

Date: February 29, 2008

Location: East Devon Substation

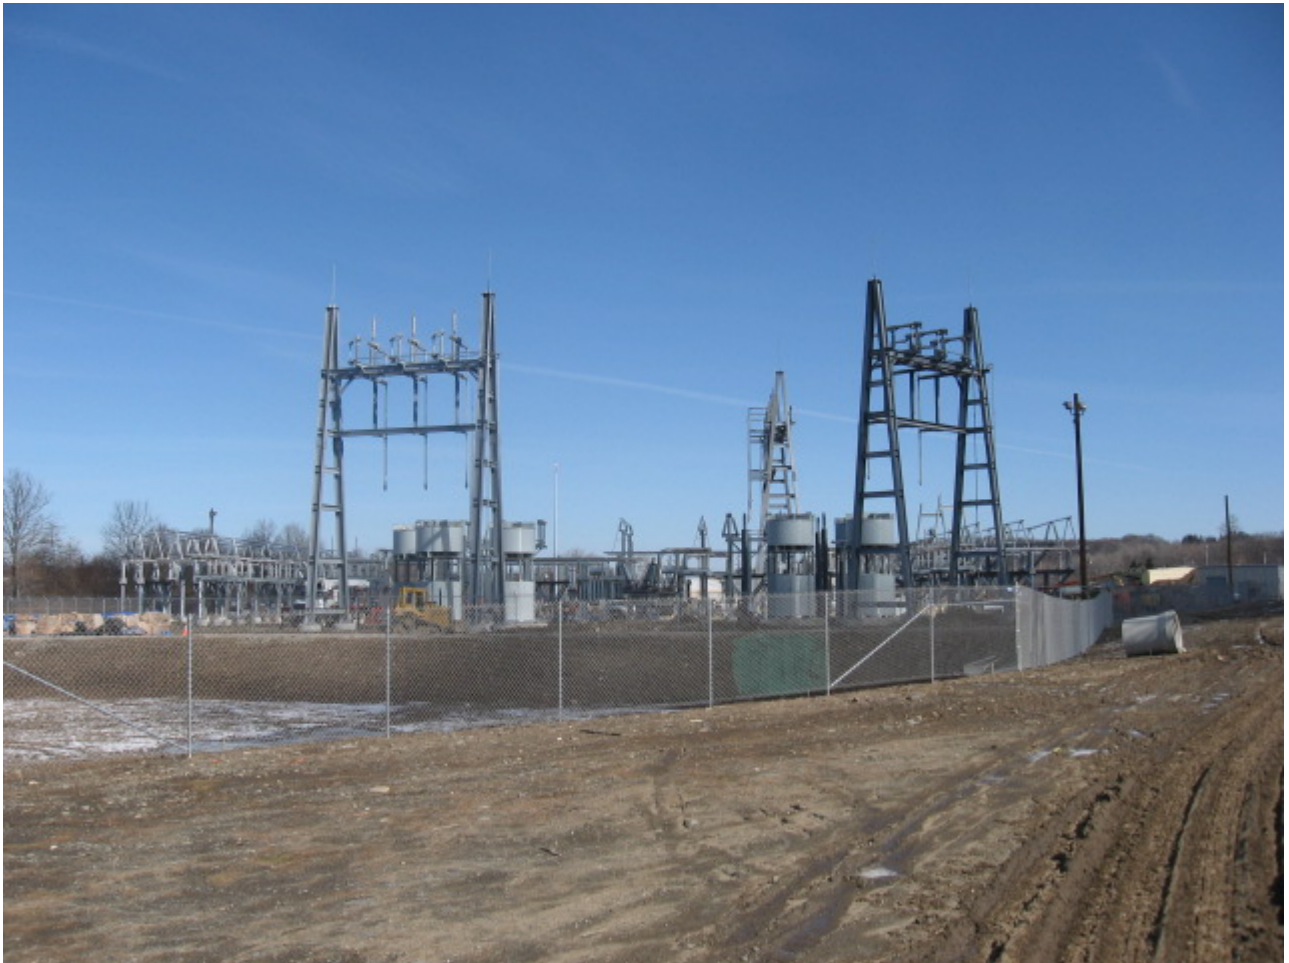
East Devon Subststion (Milford): A general view of construction at the substation.
