Docket No. 272 – Development and Management Plan Inspection

East Devon Substation Inspection

Date: March 21, 2008

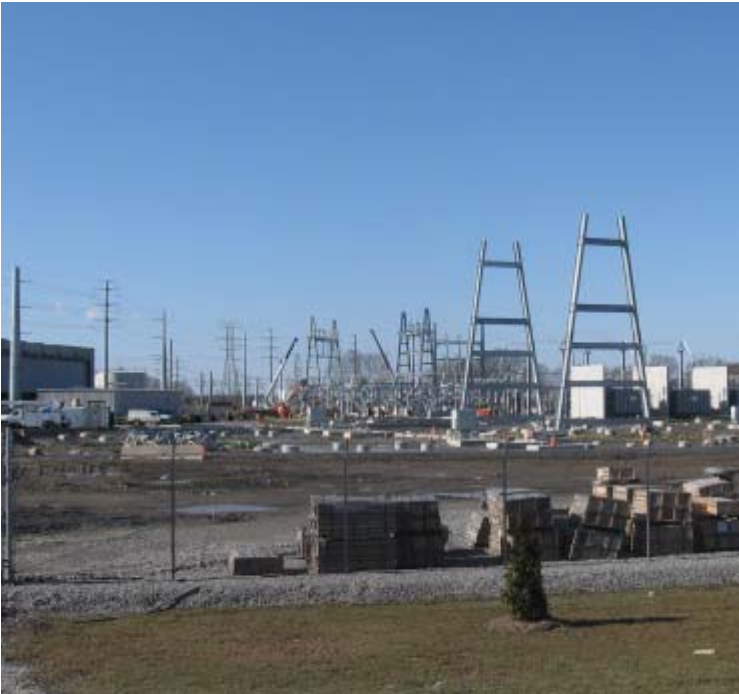
East Devon Substation (Milford): A general view of construction at the substation.

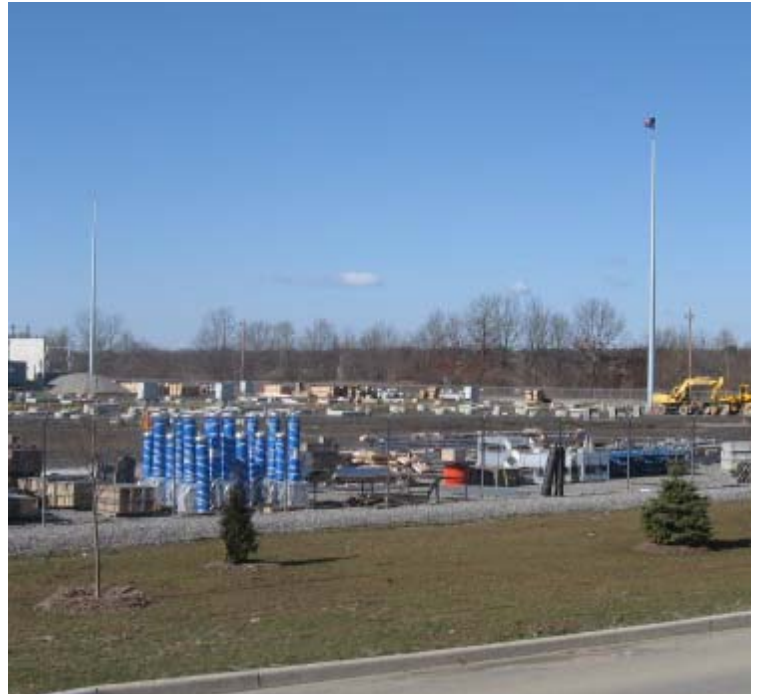
East Devon Substation: An additional view of the construction at the Substation.

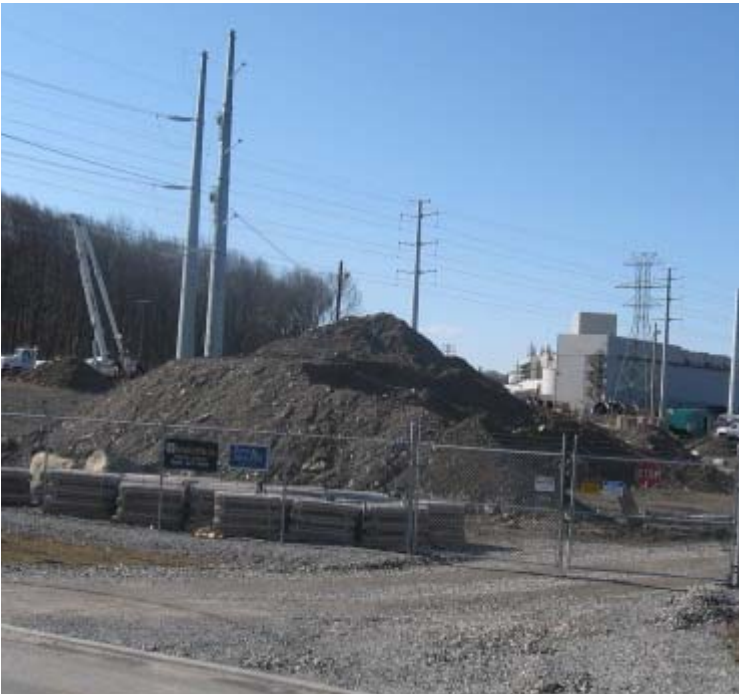
| Areas of Inspection | Observation | Recommended Action | Corrected Action |
|---|---|--|---|
| Spills, Soils and Material Storage | <p>Construction materials and equipment are kept on the substation site and at the receiving yard located to the east of Shelland Street. 3/21/08</p> <p>All spoils from foundation work are being stored in the northeast corner of the substation site. Soils appear to be contained on site. 3/21/08</p> | <p>In general, store materials and equipment appropriately. Ensure that vehicles are equipped with spill kits and maintain them when needed. All construction vehicles should be parked at least 100 feet from a wetland or waterbody when feasible. 3/21/08</p> <p>Continue to monitor and remove spoils when feasible. 3/21/08</p> | <p>NA</p> |

East Devon Substation: The spoil pile remains in the northeast corner of the substation site.

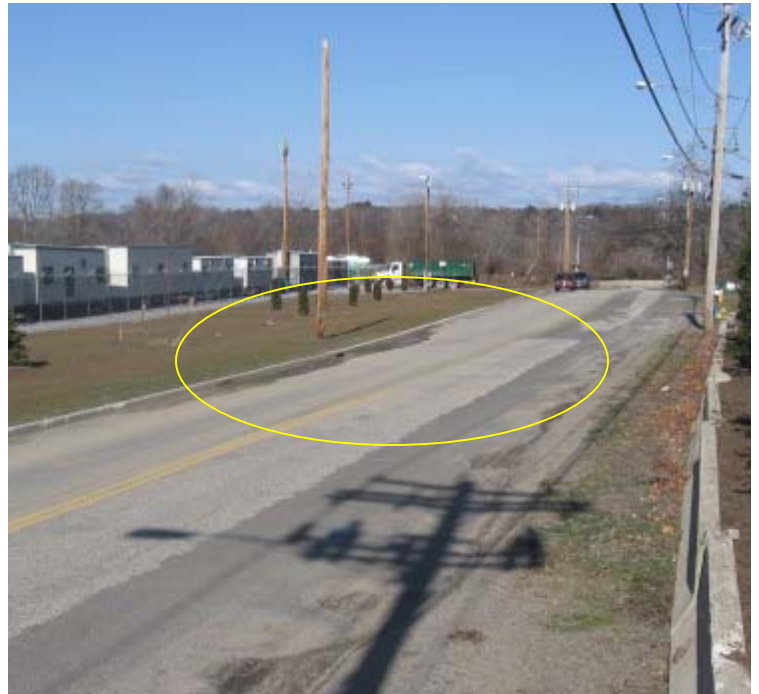
| Areas of Inspection | Observation | Recommended Action | Corrected Action |
|---|--|--|---|
| Access Roads and Adjacent Roadways | Sediment tracking from the substation onto Plains Rd was evident this week. Sediment is accumulating around the catch basins on Plains Rd. 3/21/08 | Continue to monitor for sediment tracking, sweep roadways as necessary, and maintain stone access pads at the entrances to reduce tracking. 3/12/08 | Not Applicable (NA) |

Plains Rd (Milford): Sediment tracking from the substation was evident this week. Sediment is accumulating around the catch basins.

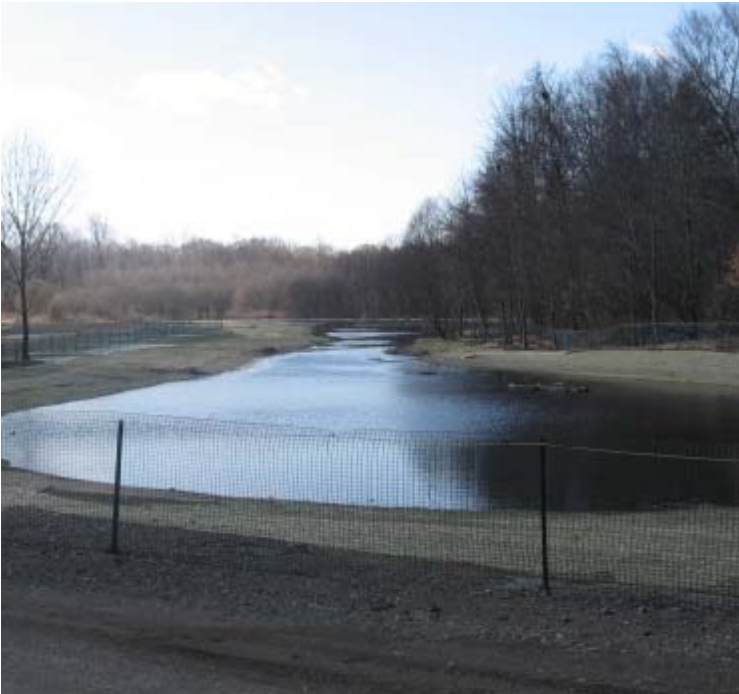
| Areas of Inspection | Observation | Recommended Action | Corrected Action |
|---|---|--|--|
| <p>Inland Wetland and Watercourse encroachment and mitigation</p> | <p>Two wetlands, 300 A and 300B, were cleared and filled during the construction process, as permitted. Construction of the associated wetland mitigation area appears to be complete near structure #3839 in Eisenhower Park at this time. 3/21/08</p> <p>Scouring from Wepawaug River floodwaters was observed along the bank of the mitigation area. 2/15-3/21/08. At this time, it does not appear that sediment from the mitigation site has migrated into the Wepawaug River. 3/21/08</p> | <p>Continue to monitor mitigation areas until final stabilization is achieved. 3/21/08</p> <p>Stabilize with appropriate material and re-grade during the dry season if necessary. 3/21/08</p> | <p>All disturbed areas have been temporarily stabilized with erosion control blankets.</p> <p>Woody debris has been added to create wildlife habitat.</p> <p>Needs attention when feasible</p> |

Eisenhower Park (Milford): A general view of the substation mitigation wetland.

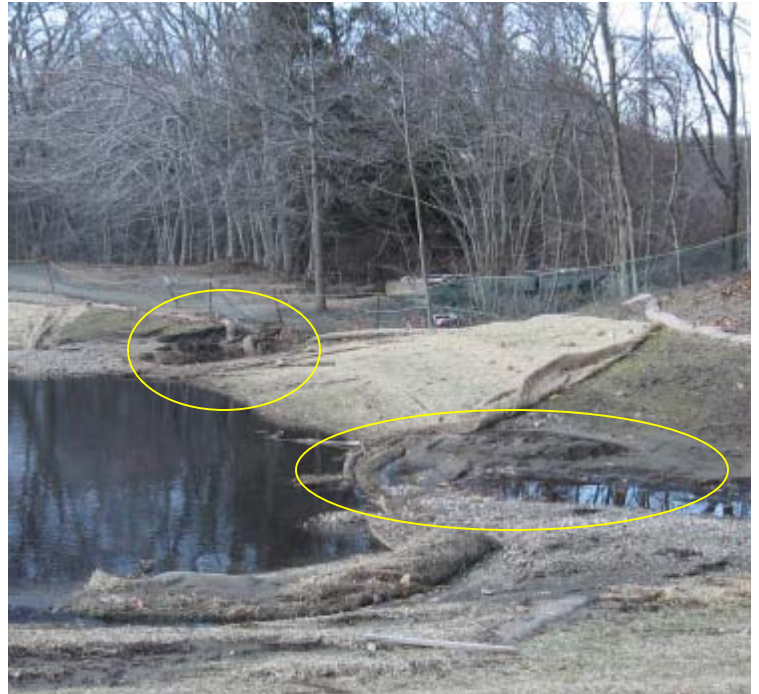
Eisenhower Park: Floodwaters from the Wepawaug River have created two erosive gullies along the bank of the mitigation site.

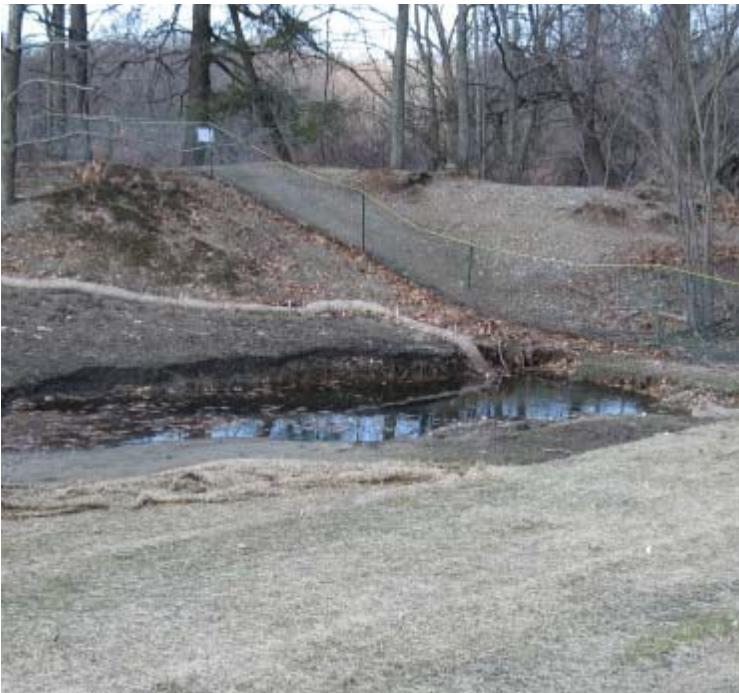
Eisenhower Park: A view of the erosive gully located just west of the access road.

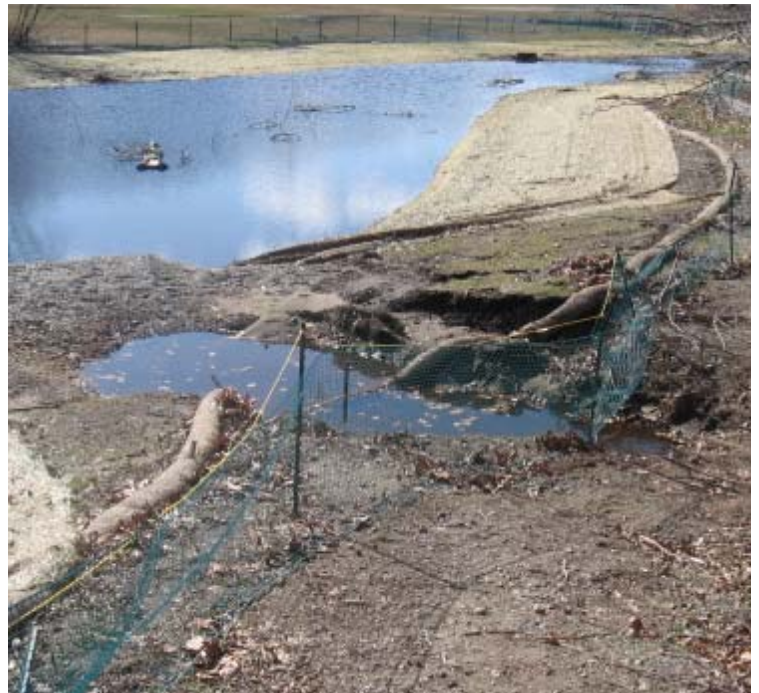
Eisenhower Park: This gully is located approximately 100 feet west of the access road. At this time, it does not appear that sediment has migrated from the mitigation site to the Wepawaug River.
