Docket No. 272 – Development and Management Plan Inspection

East Devon Substation Inspection

Date: March 26, 2008

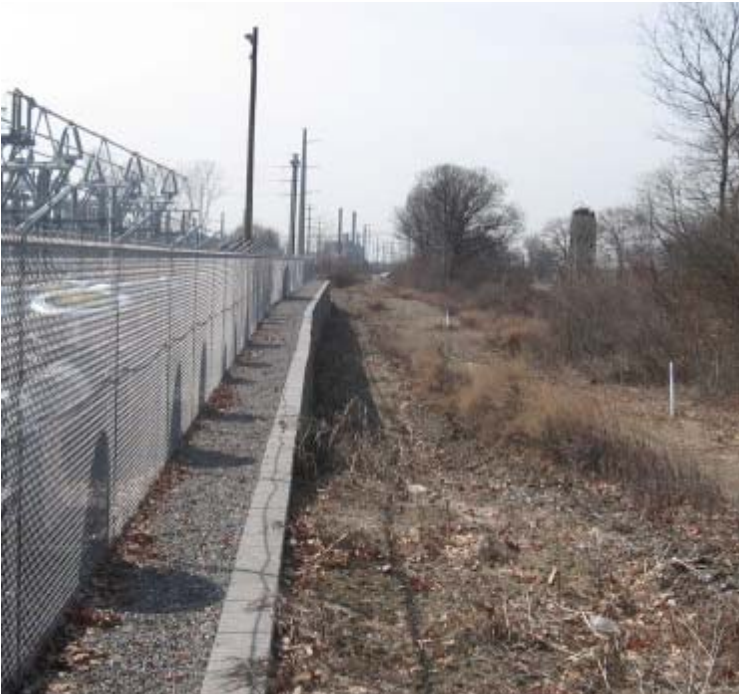
Erosion and Sediment Controls	The retaining wall continues to contain soils and prevent off site sedimentation. 3/26/08	Continue to monitor and improve controls as necessary. 3/26/08	NA at this time
	“Silt saks” remain intact within the catch basins	Continue to monitor and add controls as necessary.	NA

East Devon Substation (Milford): A view of the retaining wall located along the western boundary of the substation.

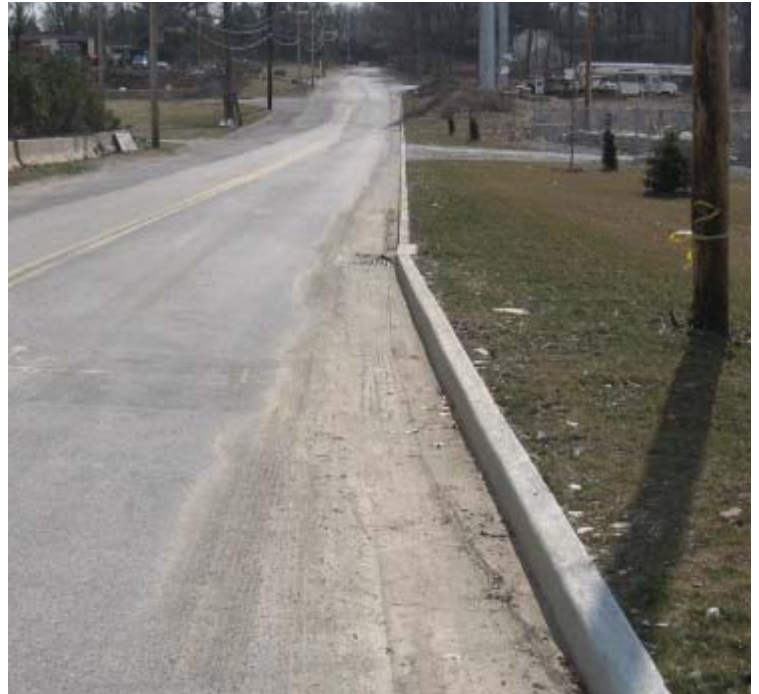
East Devon Substation (Plains Rd): Sediment from the substation is accumulating in the roadway and around the catch basins.

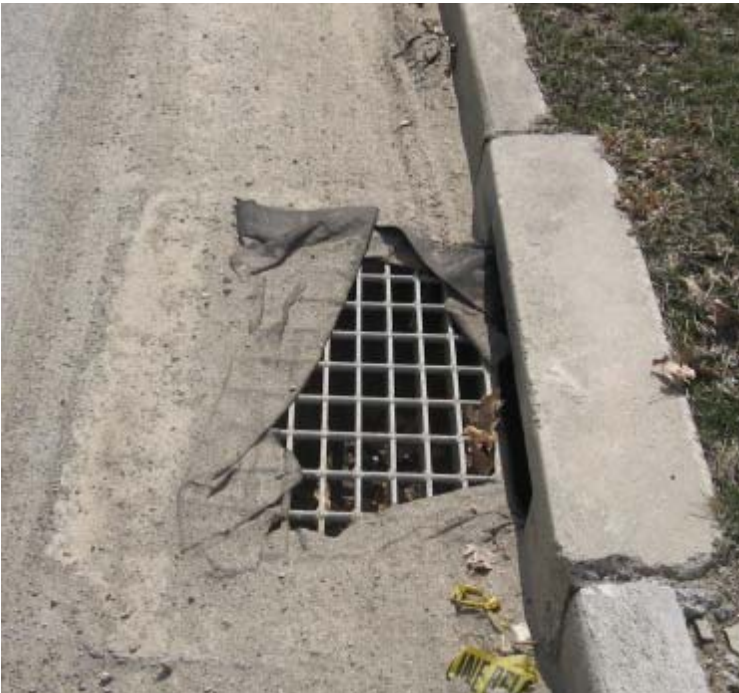
East Devon Substation (Plains Rd): “Silt saks” remain installed within the catch basins located in this area. Inlet protection is not provided on Plains Rd.

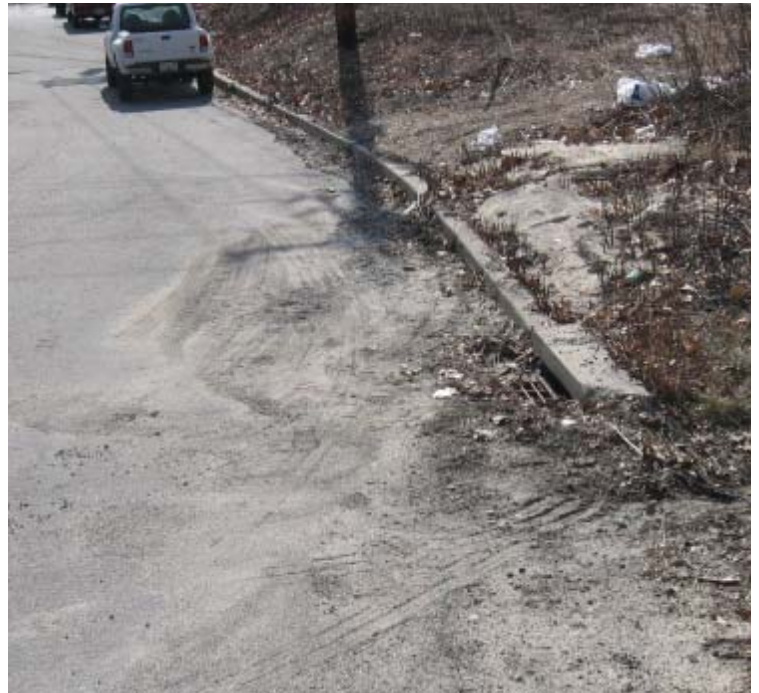
East Devon Substation (Plains Rd): Sediment is accumulating near the catch basin located at the end of Plains Rd.
