**Docket No. 272 – Development and Management Plan Inspection**

**East Devon Substation Inspection**

**Date:** April 18, 2008

**Location:** East Devon Substation

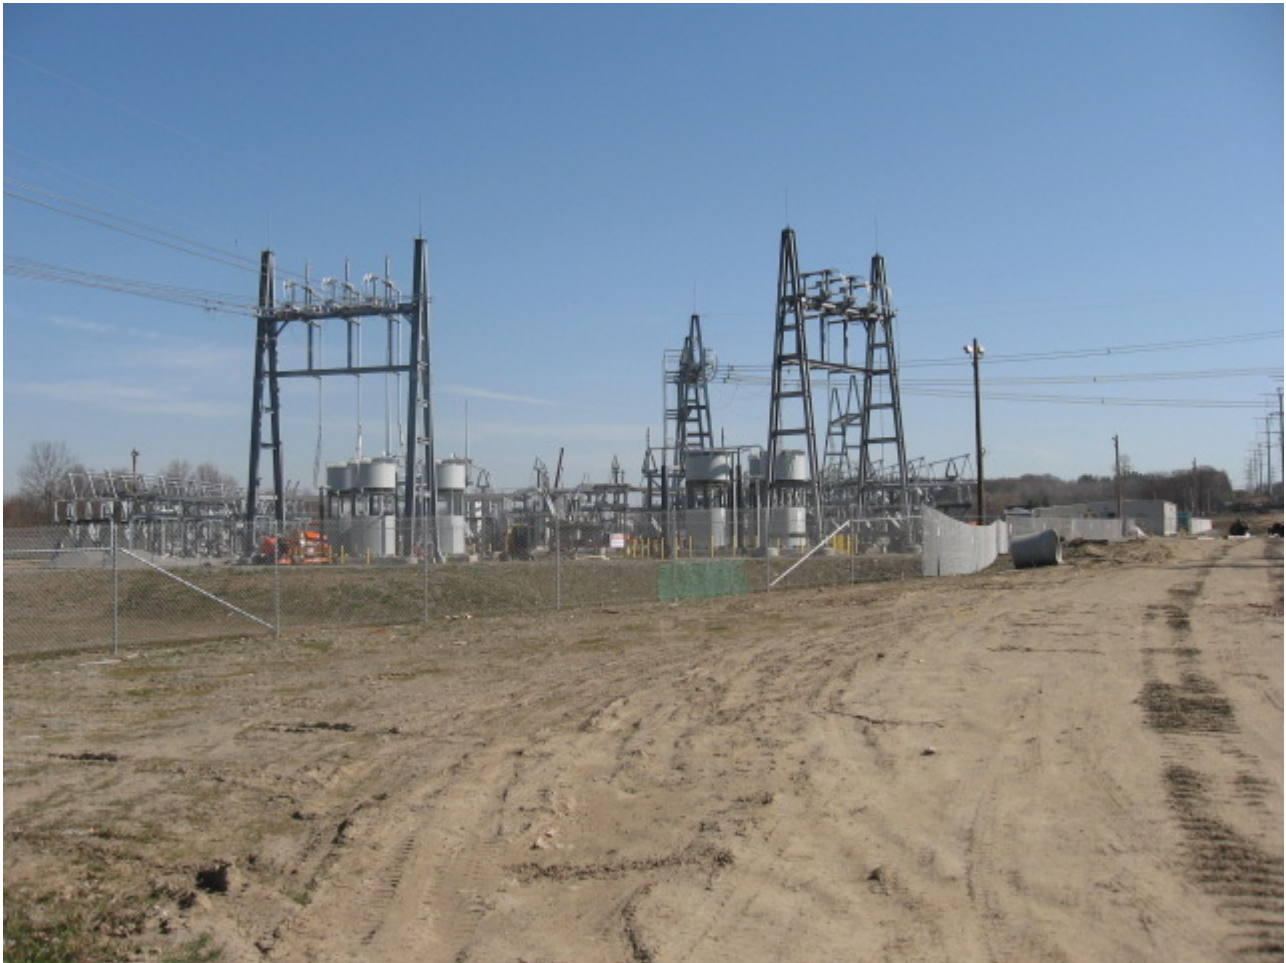
East Devon Substation (Milford): A general view of substation construction.
