**Docket No. 272 – Development and Management Plan Inspection**

**East Devon Substation Inspection**

**Date:** May 2, 2008

**Location:** East Devon Substation

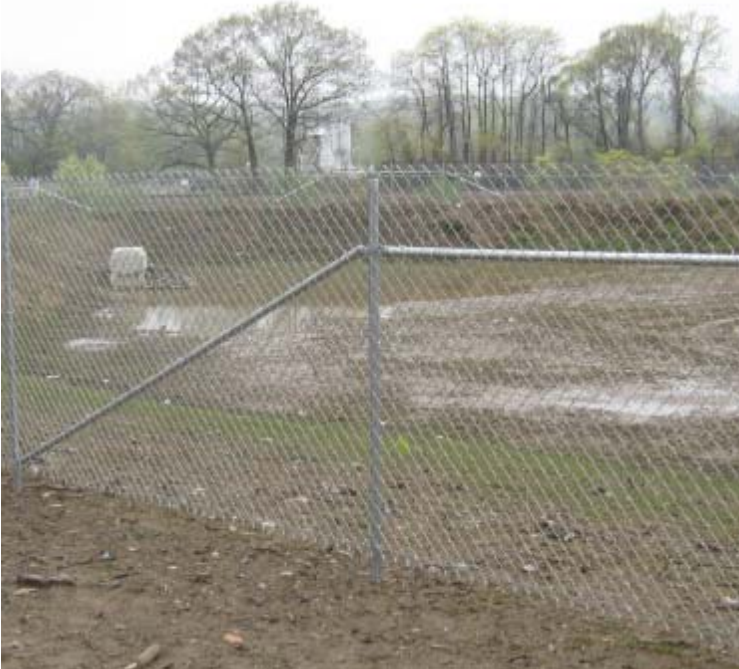
East Devon Substation (Milford): A view of the detention basin located along the southern boundary of the substation.

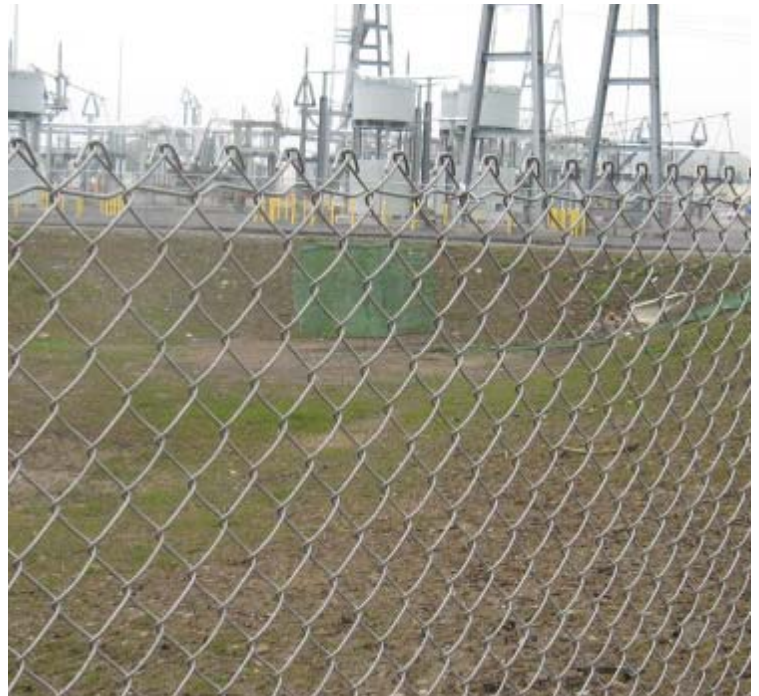
East Devon Substation: Some vegetative growth has been noted within the basin.

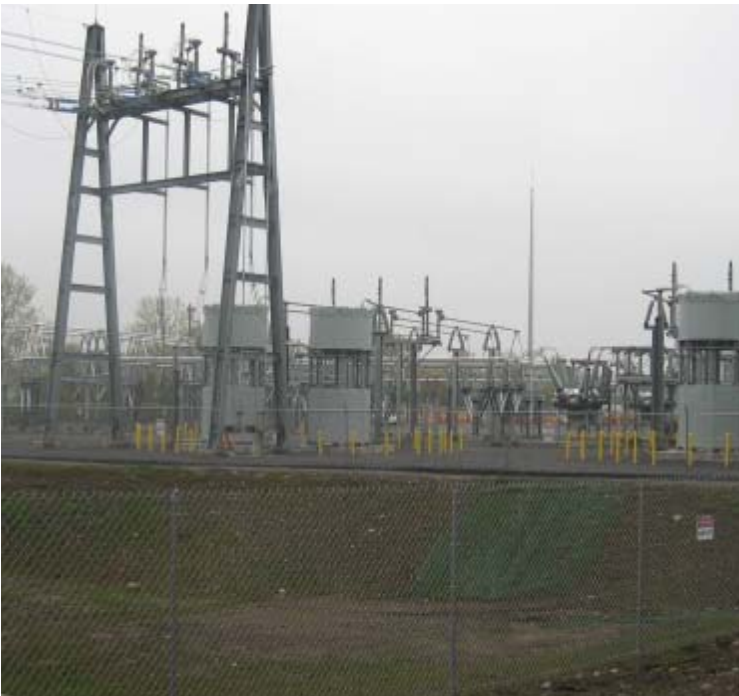
East Devon Substation: A general view of construction at the substation site.

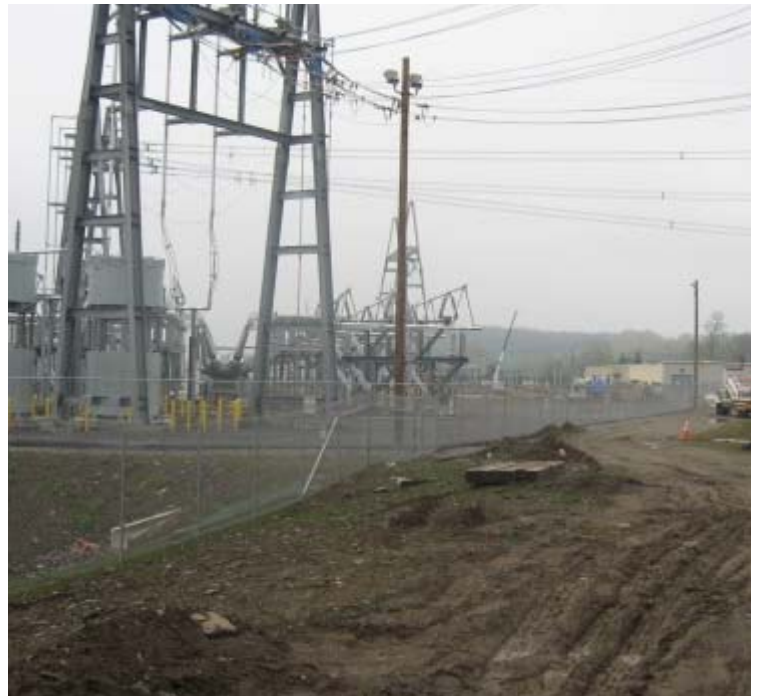
East Devon Substation: An additional view of construction at the substation.

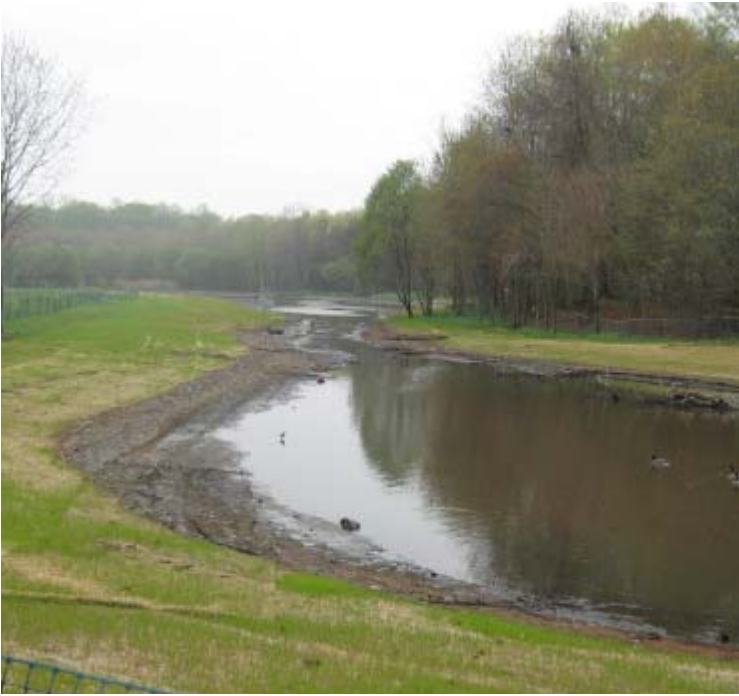
Eisenhower Park (Milford): A view of the wetland mitigation area. Grass growth continues and soils appear to be stabilized at this time.

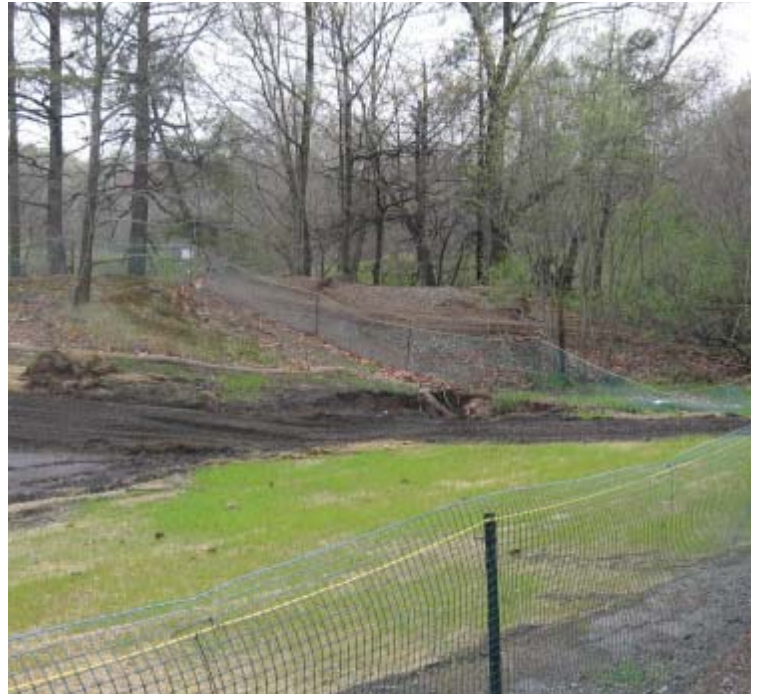
Eisenhower Park: Construction of outflow structures from the mitigation site to the Wepawaug River was active this week.
