**Docket No. 272 – Development and Management Plan Inspection**

**East Devon Substation Inspection**

**Date:** May 22, 2008

**Location:** East Devon Substation

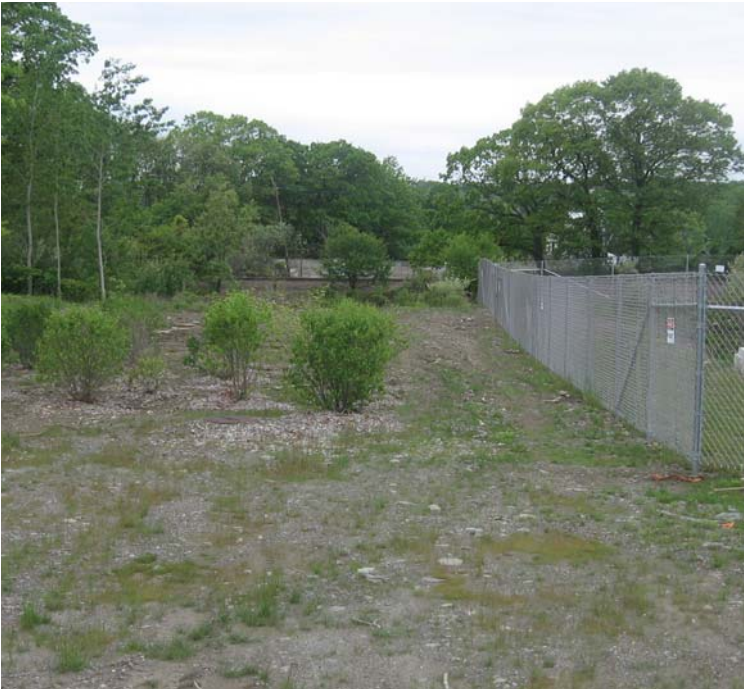
East Devon Substation (Milford): A view of the shrub plantings south of the detention basin at the substation.

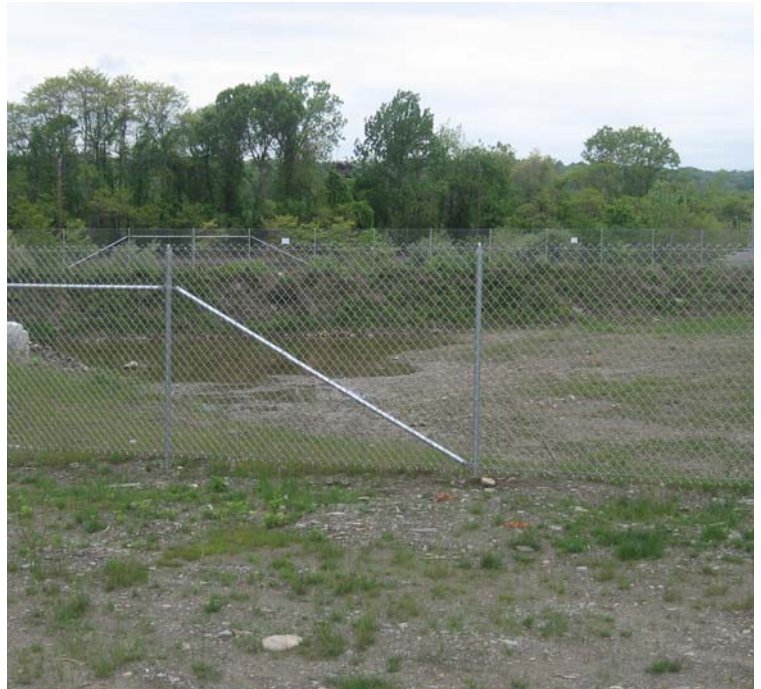
East Devon Substation: A view of the detention basin. Some grass growth has been observed.

Areas of Inspection	Observation	Recommended Action	Corrected Action
<b>Eisenhower Park Mitigation Area</b>	stabilization. 5/22/08		
	Grass growth continues within the detention basin. 5/22/08	Continue to monitor grass growth until final stabilization is achieved. 5/22/08	Grass growth noted
	Exposed soils have been re-graded in the central and southern portions of the vegetated swale and hay bale check dams remain at culvert inlets/outlets. Grass growth continues. 5/22/08	Continue to monitor and adjust existing controls until final stabilization is achieved. Evaluate additional stabilization options (e.g. EC mats, hay mulch, etc.) for the exposed portions of the swale. 5/22/08	Exposed soils have been re-graded in a portion of the vegetated swale and hay bale check dams remain at culvert inlets/outlets. Grass growth continues
	The bank of the mitigation area has been graded and stabilized with stone. 5/22/08.	Continue to monitor mitigation areas until final stabilization is achieved. 5/22/08	The bank of the mitigation area has been graded and stabilized with stone

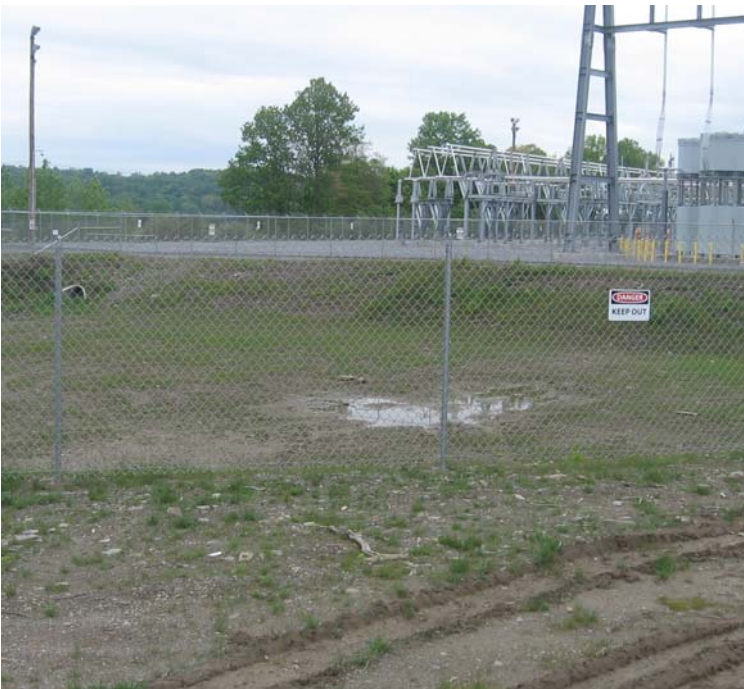
East Devon Substation: A general view of the detention basin and construction at the substation.

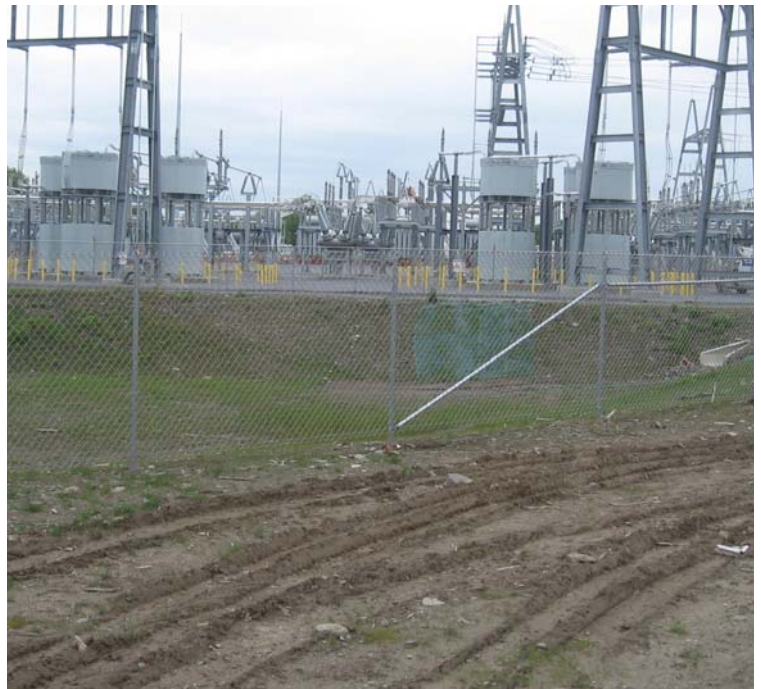
East Devon Substation: An additional view of the detention basin and construction at the substation.

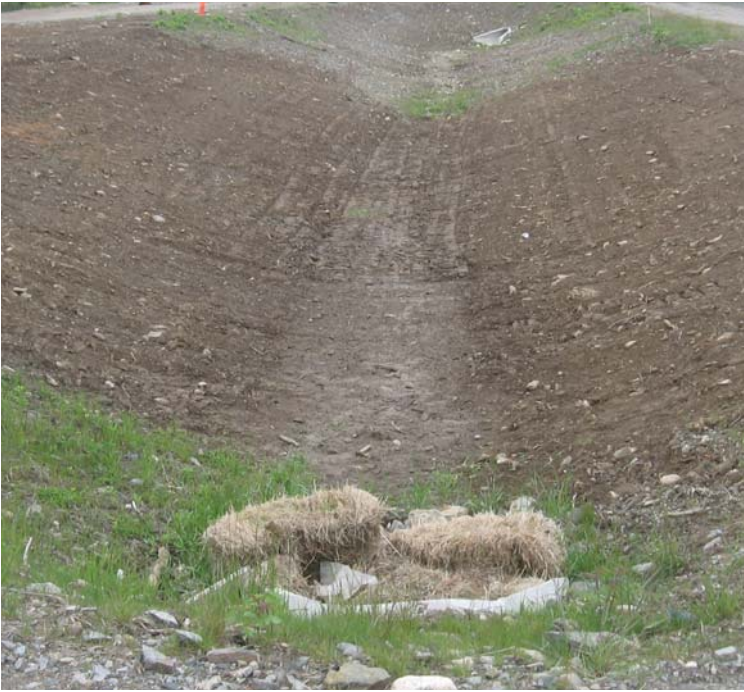
East Devon Substation: A view of the southern portion of the vegetated swale. Exposed soils remain from construction.

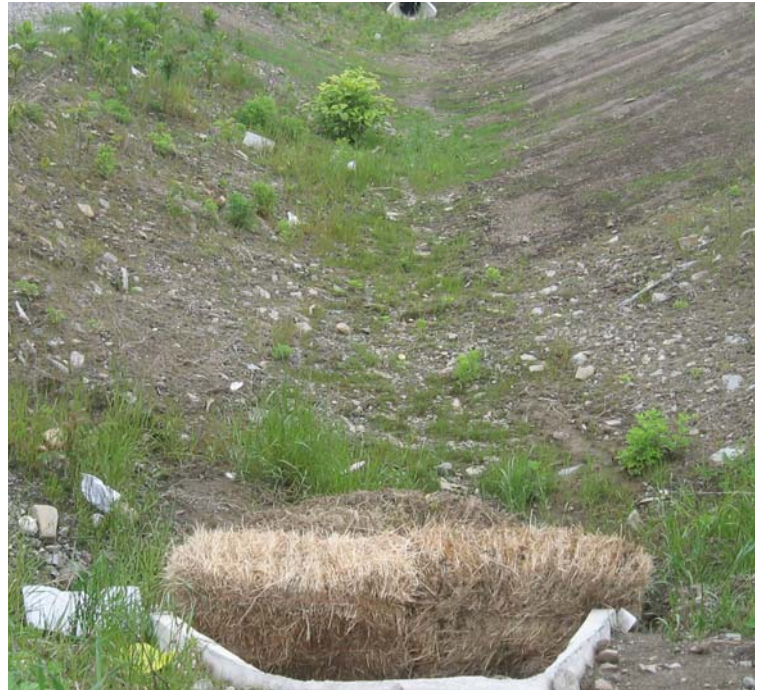
East Devon Substation: A view of the central portion of the vegetated swale. Soils appear stable and vegetation growth has been noted.

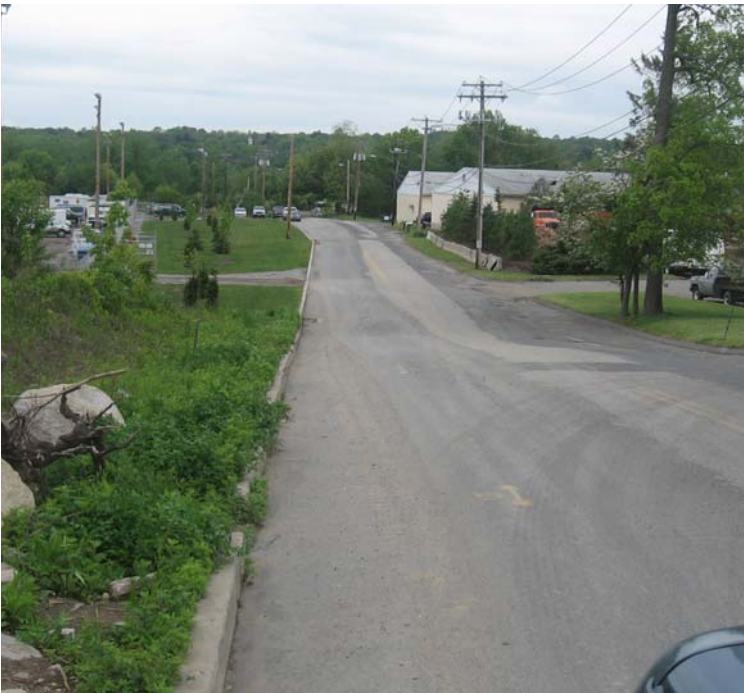
East Devon Substation: A view of Plains Rd. No tracking from the site was observed this week.

Areas of Inspection	Observation	Recommended Action	Corrected Action
Access Roads and Adjacent Roadways	No sediment tracking was noted on Plains Rd this week. 5/22/08	Continue to monitor for sediment tracking, sweep roadways as necessary, and maintain stone access pads at the entrances to reduce tracking. 5/22/08	Not Applicable (NA)
	“Silt Saks” remain intact within the Plains Rd catch basins, but sediment accumulation was noted this week. Curb inlet protection has not been provided in this area. 5/22/08	Continue to monitor for sediment tracking and clean/replace “Silt saks” when necessary. Provide curb inlet protection and continue to sweep the roadway regularly. See EC Section. 5/22/08	NA
	“Silt saks” remain intact within the Shelland Street catch basins. 5/22/08	Continue to monitor. 5/22/08	NA
Foundation and site construction	Foundation work appears to be complete, but construction continues on site. 5/22/08	None at this time. 5/22/08	NA

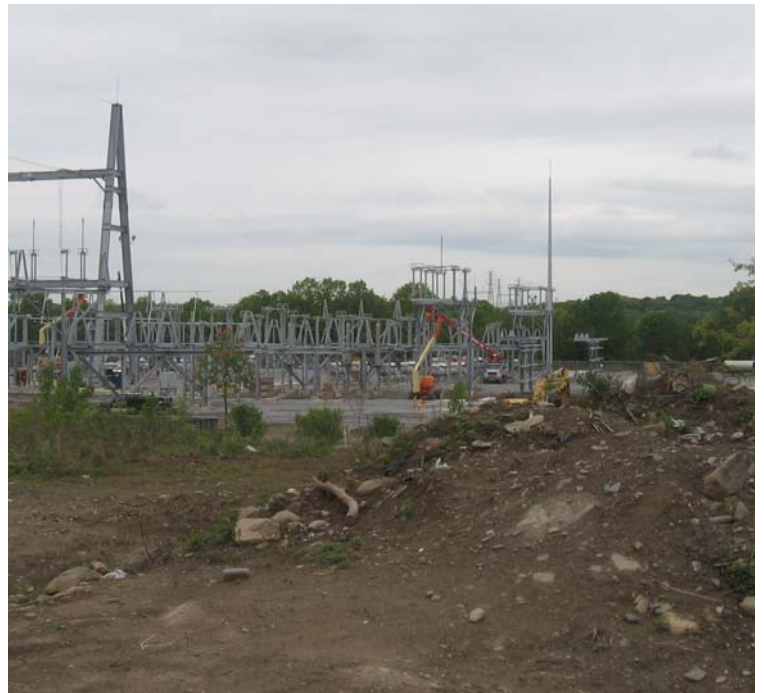
East Devon Substation: A view of construction at the substation from Plains Rd.
