Docket No. 272 – Development and Management Plan Inspection

East Devon Substation Inspection

Date: June 26, 2008

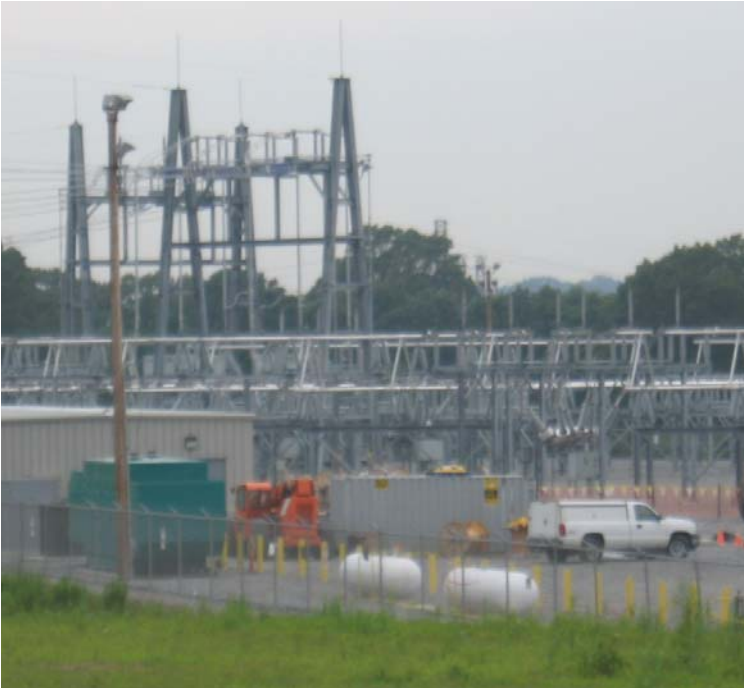
East Devon Substation (Milford): A general view of construction at the substation site.

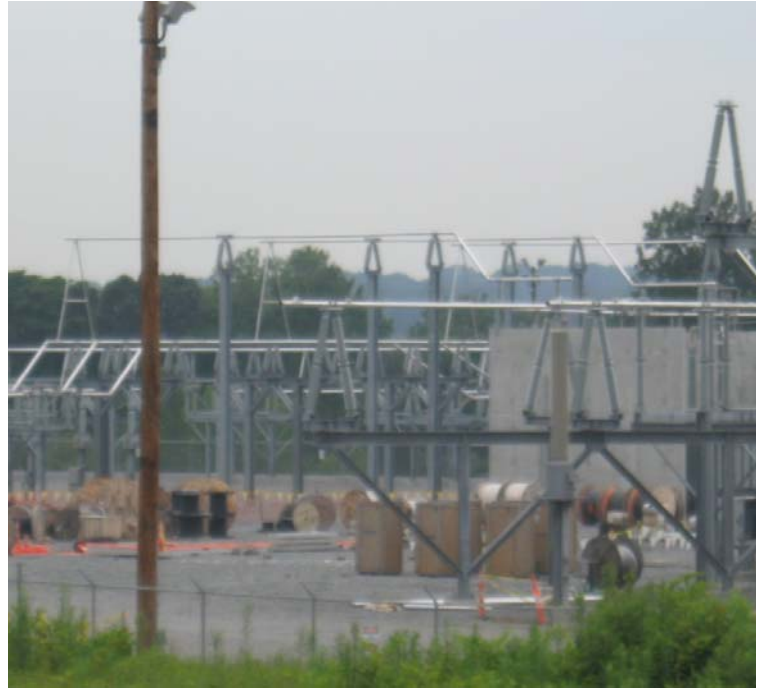
East Devon Substation: An additional view of construction at the substation site.

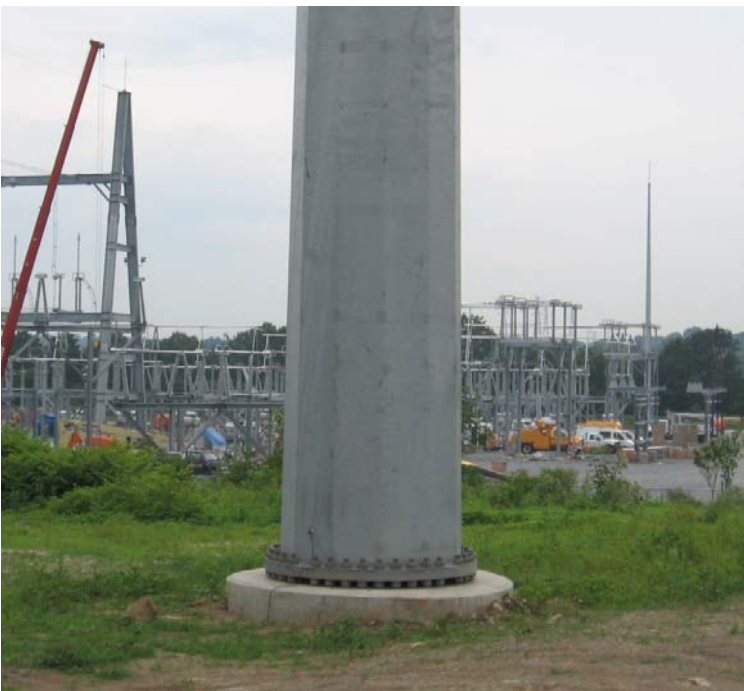
East Devon Substation: A view of the substation looking south from Plains Road.

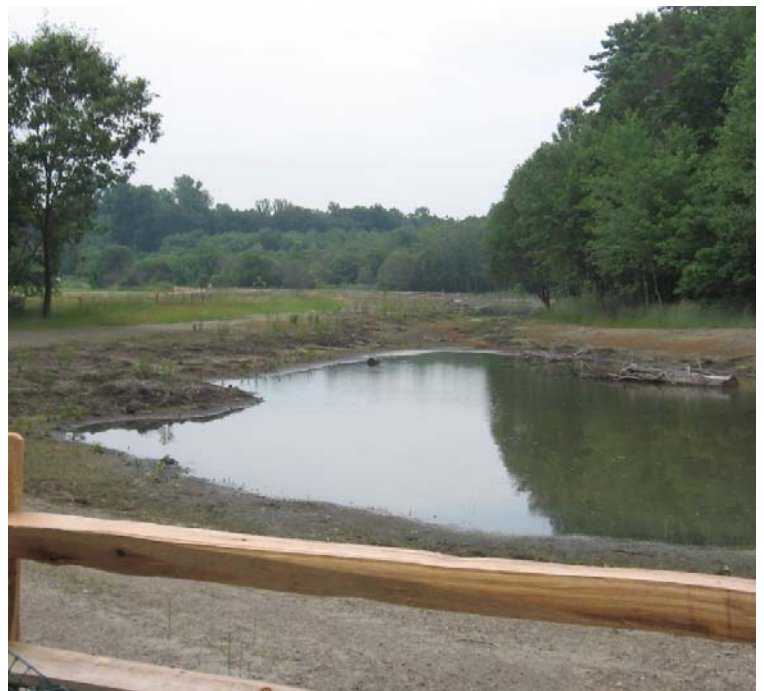
Wetland Mitigation Area (Eisenhower Park): A view of a portion of the mitigation area. Exposed soils remain stable, and the plantings appear to be doing well at this time.

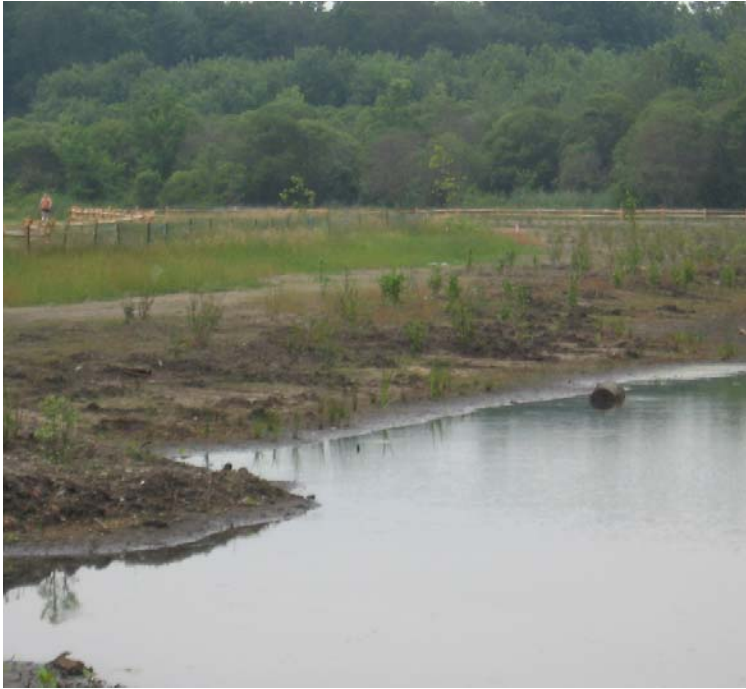
Wetland Mitigation Area: A view of the southern portion of the the area.

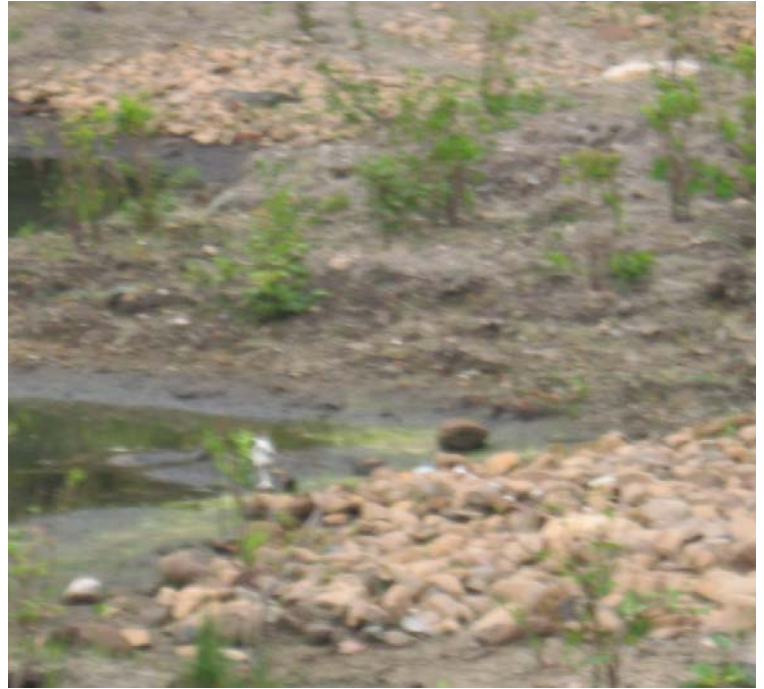
Wetland Mitigation Area: Additional view of the southern portion of mitigation area. The plantings appear to be doing well.

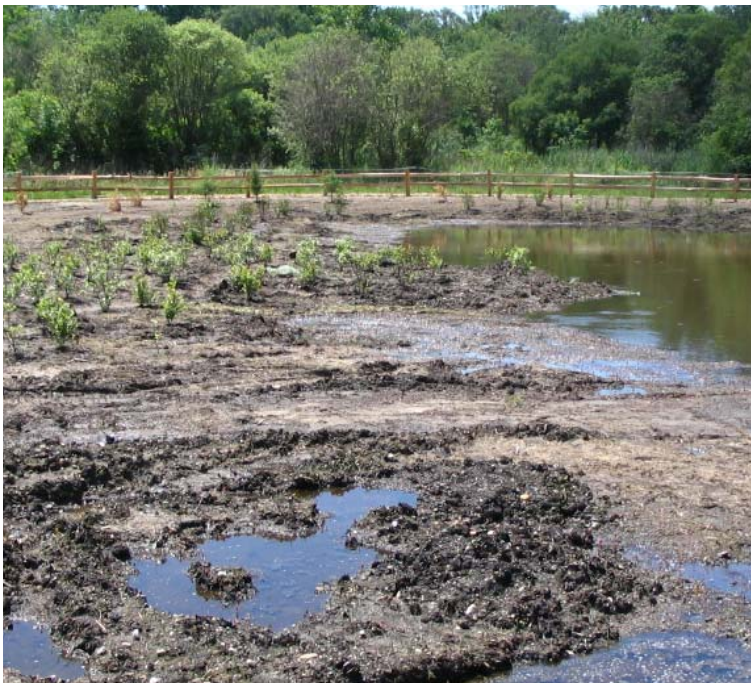
Wetland Mitigation Area: A view of the plantings located at the southern end of the mitigation area.

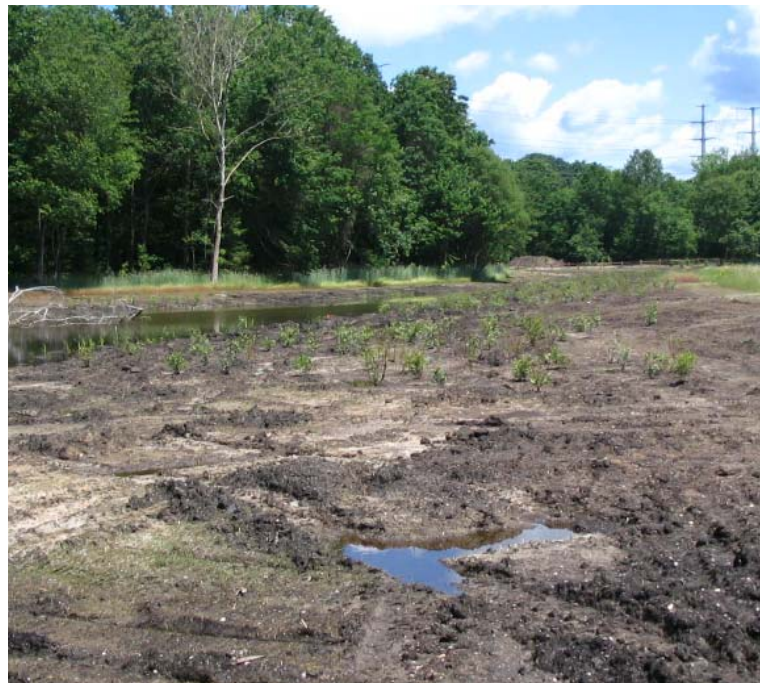
Wetland Mitigation Area: A view of the eastern side of the mitigation area. Plantings appear to be doing well at this time
