Docket No. 272 - Development and Management Plan Inspection

East Devon Substation Inspection

Date: July 1, 2008

Location: East Devon Substation

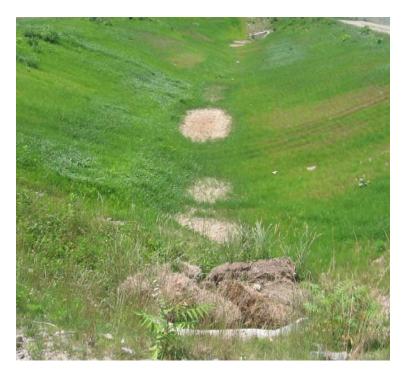
East Devon Substation (Milford): A view of the southern section of the vegetated swale.

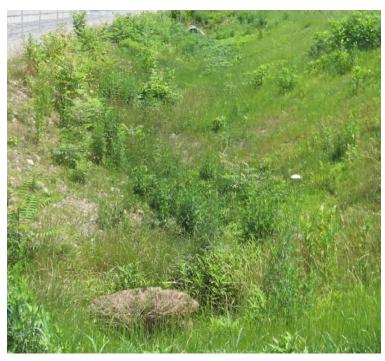
East Devon Substation: Aview of the middle section of the vegetated swale.

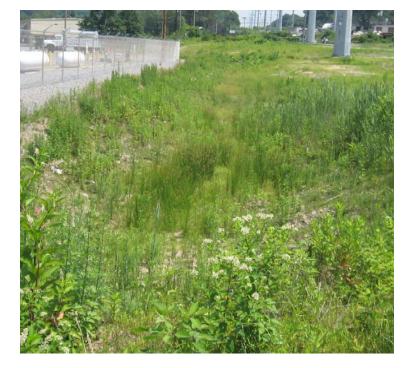
East Devon Substation: A view of the northern section of the vegetated swale.

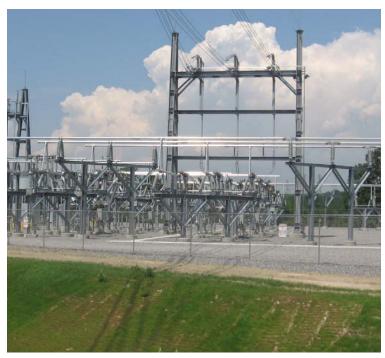
East Devon Substation: A view of the southern portion of the substation site.

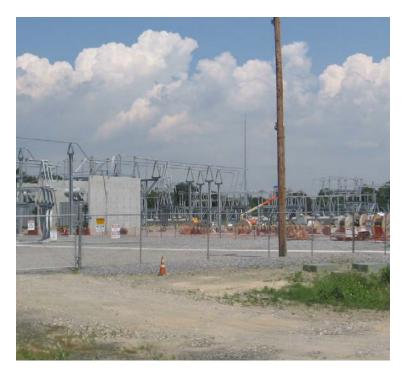
East Devon Substation: A view of the northern portion of the substation site.

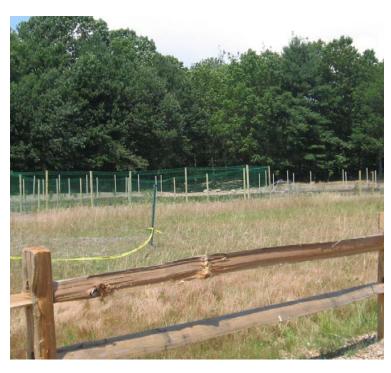
Wetland Mitigation Area (Eisenhower Park): Deer fencing is being installed around the plantings.

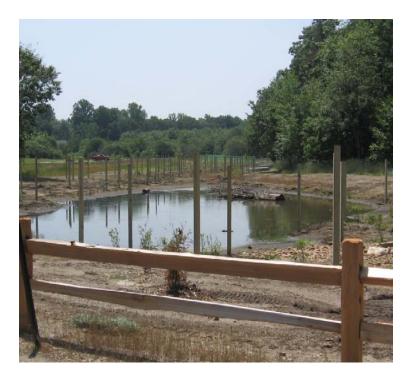
Wetland Mitigation Area: A view of the plantings and deer fencing installation.

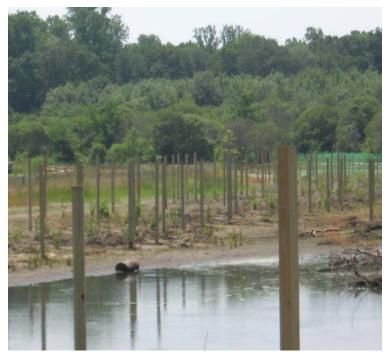
Wetland Mitigation Area: An additional view of the plantings and deer fence installation.
