Docket No. 272 – Development and Management Plan Inspection

East Devon Substation Inspection

Date: July 18, 2008

Location: East Devon Substation

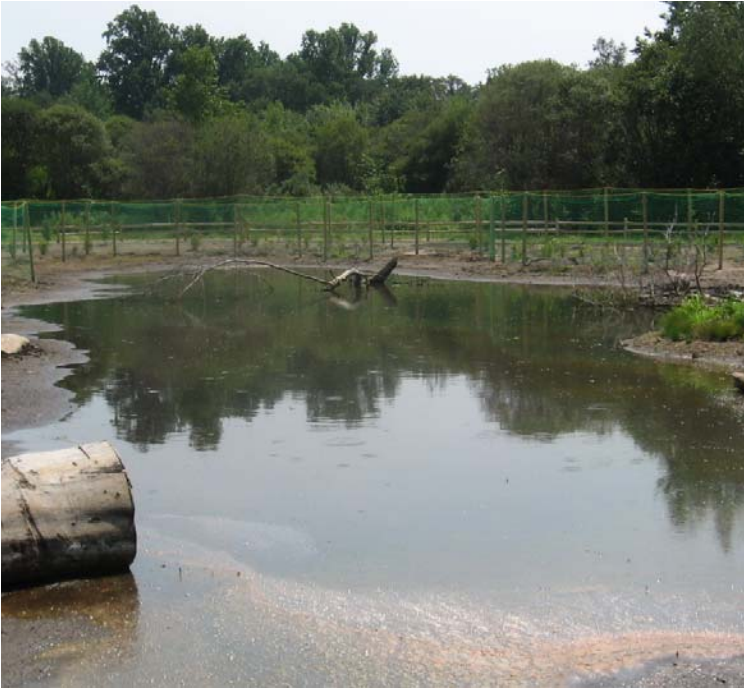
Wetland Mitigation Area (Eisenhower Park): A view of the southern portion of the mitigation area.

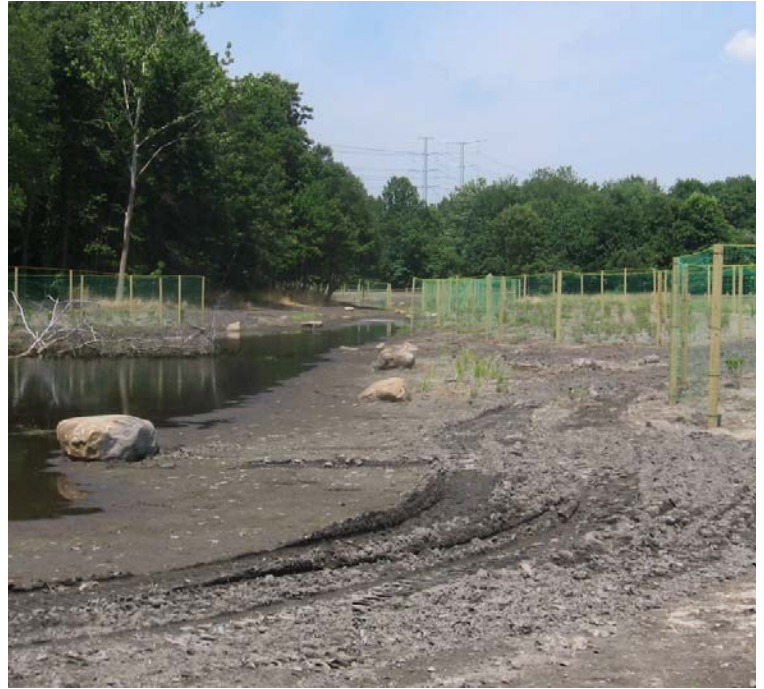
Wetland Mitigation Area: A general view of the eastern side of the mitigation area. Deer fence installation is complete.

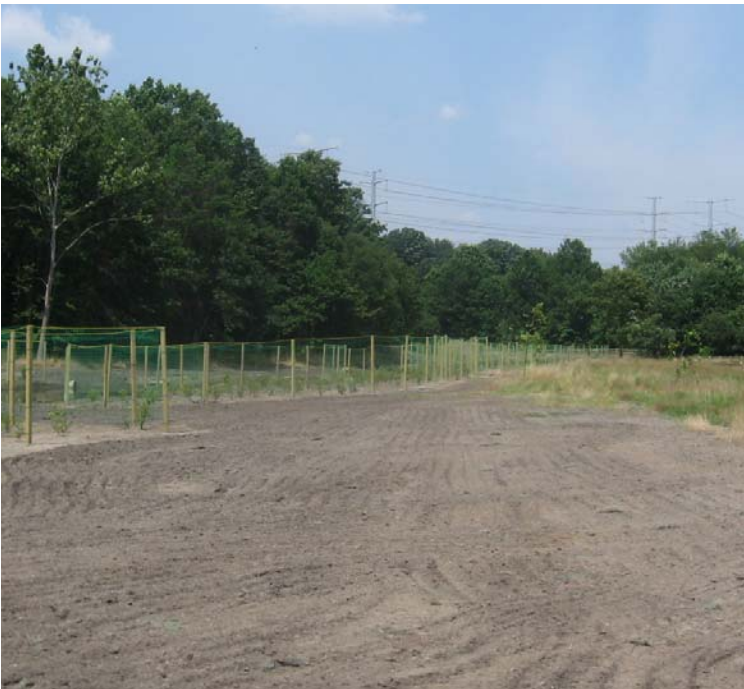
Wetland Mitigation Area: A view of the plantings/deer fencing along the eastern side of the mitigation area.

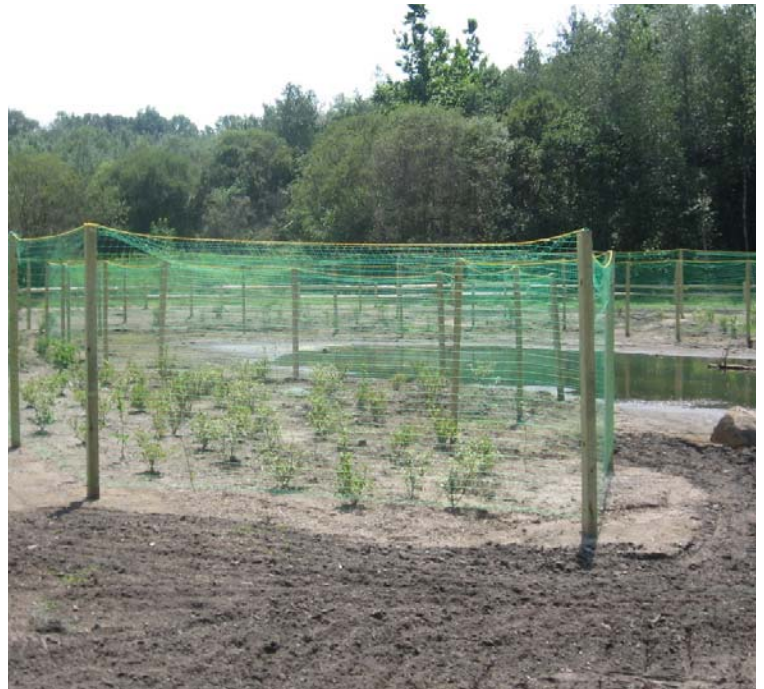
Wetland Mitigation Area: An additional view of plantings and deer fencing.
