Docket No. 272 – Development and Management Plan Inspection

East Devon Substation Inspection

Date: Augustus 1, 2008

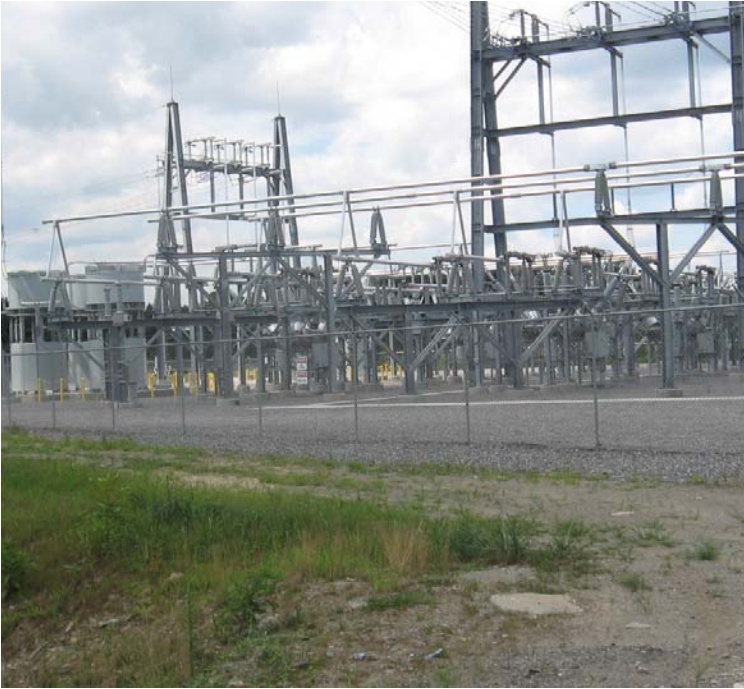
East Devon Substation (Milford): A view of the southern portion of the substation. Construction is complete in this section.

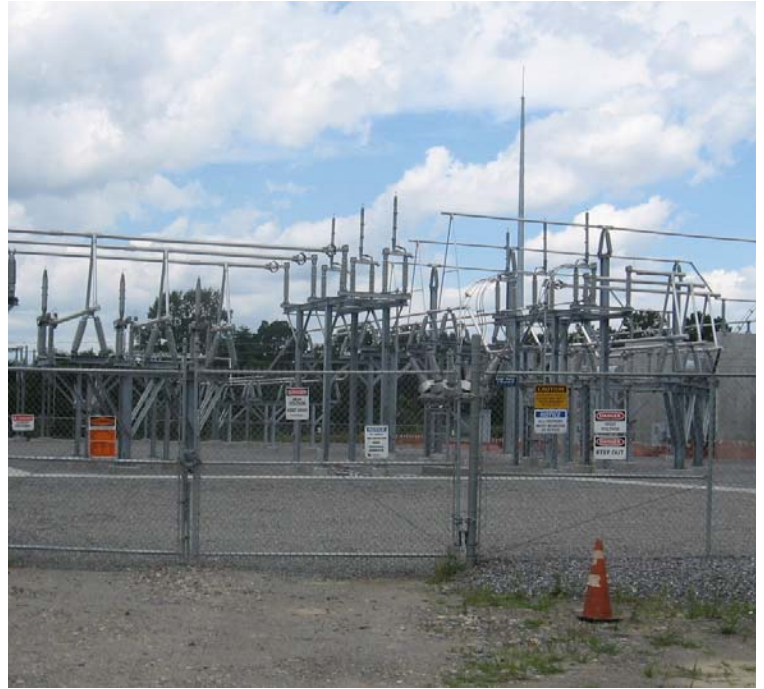
East Devon Substation: An additional view of the southern portion of the substation.

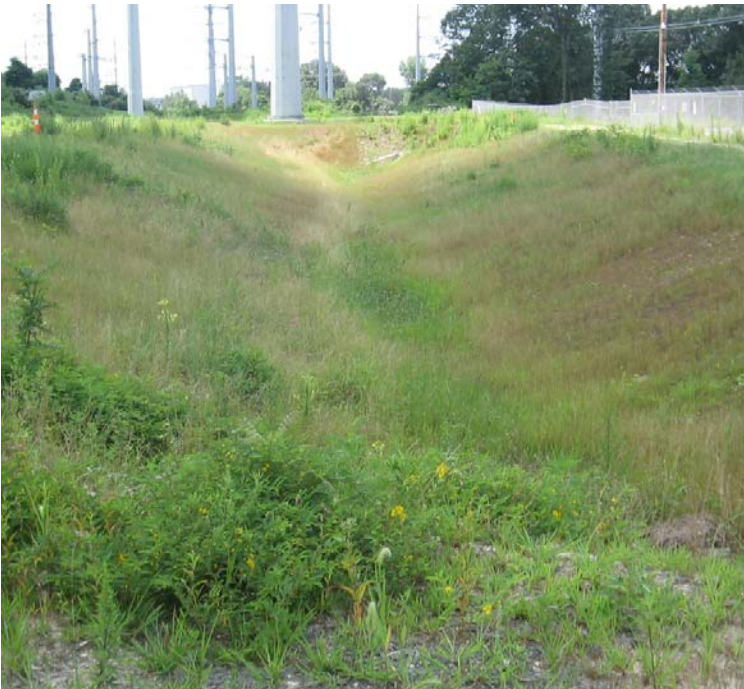
East Devon Substation: The southern section of the vegetated swale is stabilized with 90% vegetative cover.

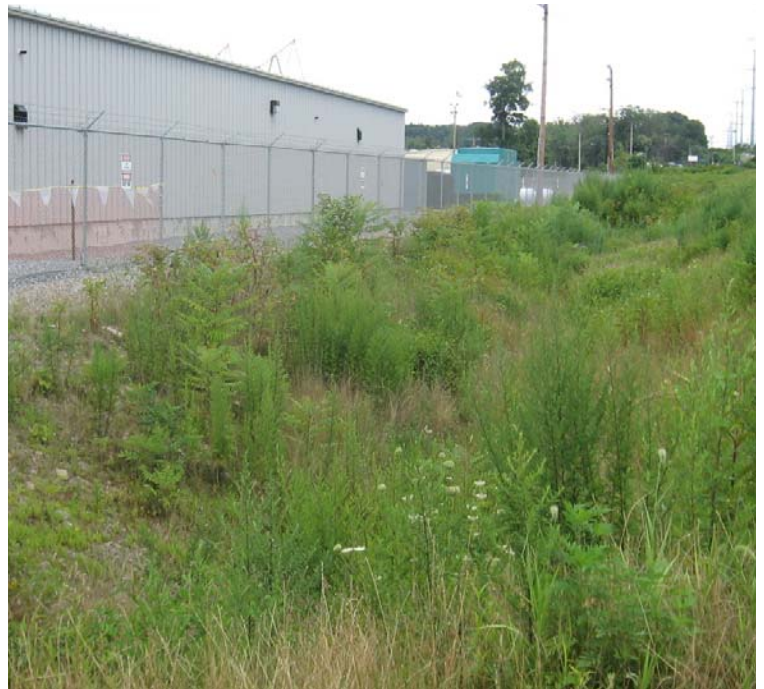
East Devon Substation: The central portion of the vegetated swale is stabilized with approximately 90% vegetative cover.
