Docket No. 272 – Development and Management Plan Inspection

East Devon Substation Inspection

Date: August 14, 2008

Location: East Devon Substation

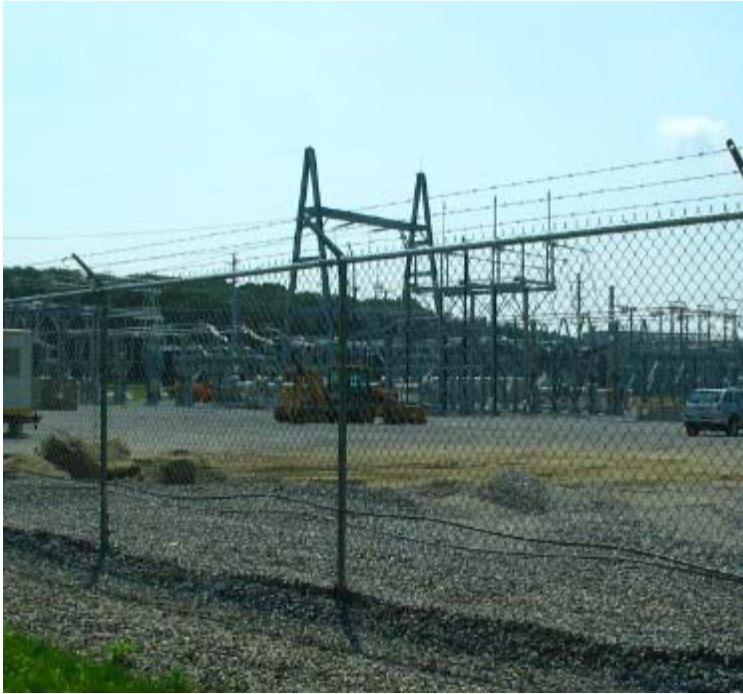
East Devon Substation (Milford): A view of the northern portion of the substation. Construction continues here.

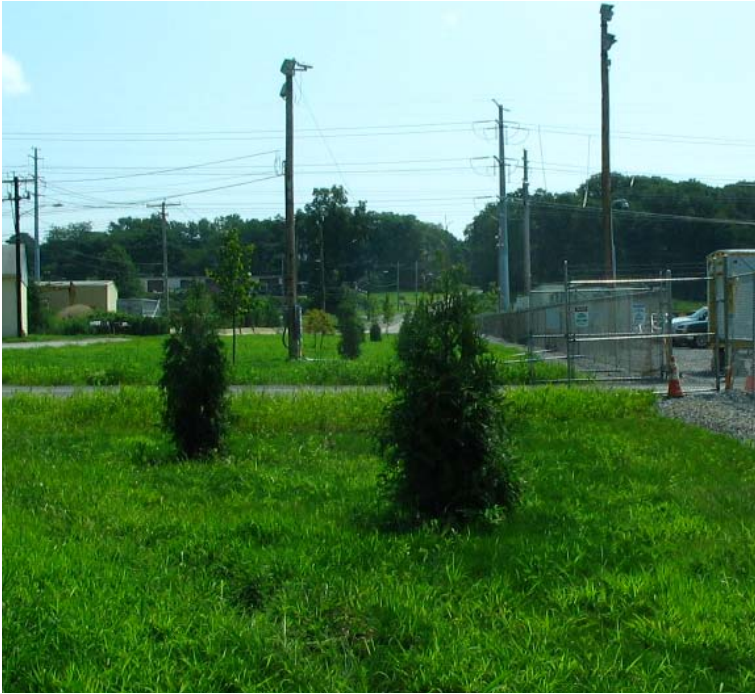
East Devon Substation: A view of vegetation growth along Plains Rd.

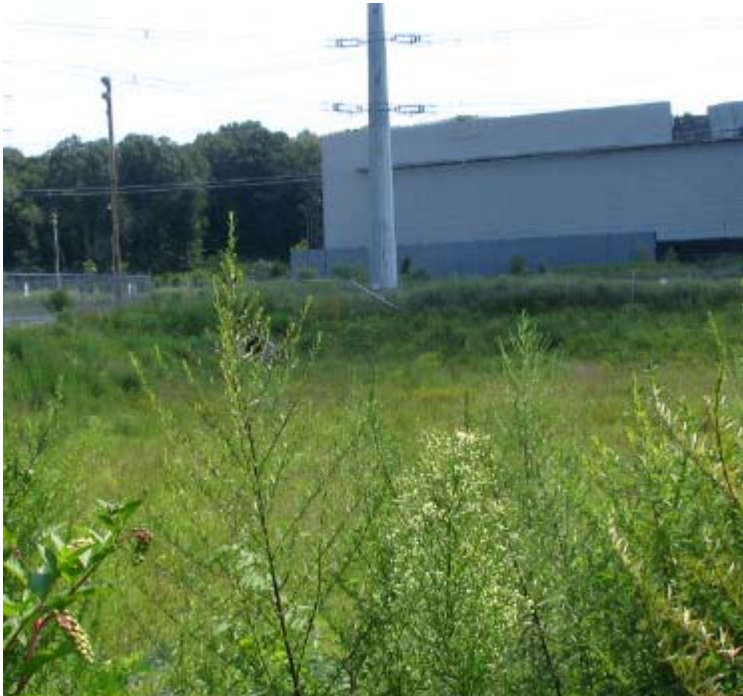
East Devon Substation: The retention basin is approximately 70-80% vegetated.

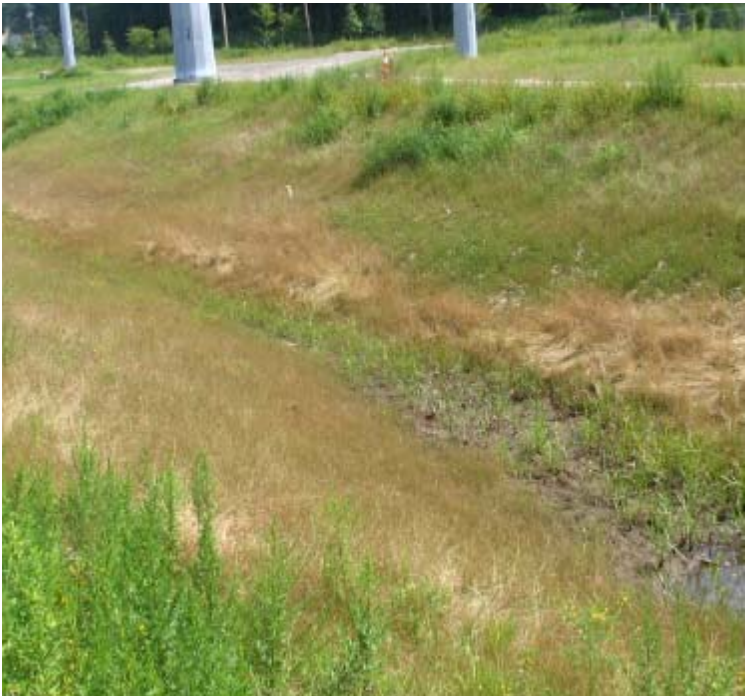
East Devon Substation: The vegetated swale remains stable.
