**Docket No. 272 – Development and Management Plan Inspection**

**East Devon Substation Inspection**

**Date:** August 29, 2008

**Location:** East Devon Substation

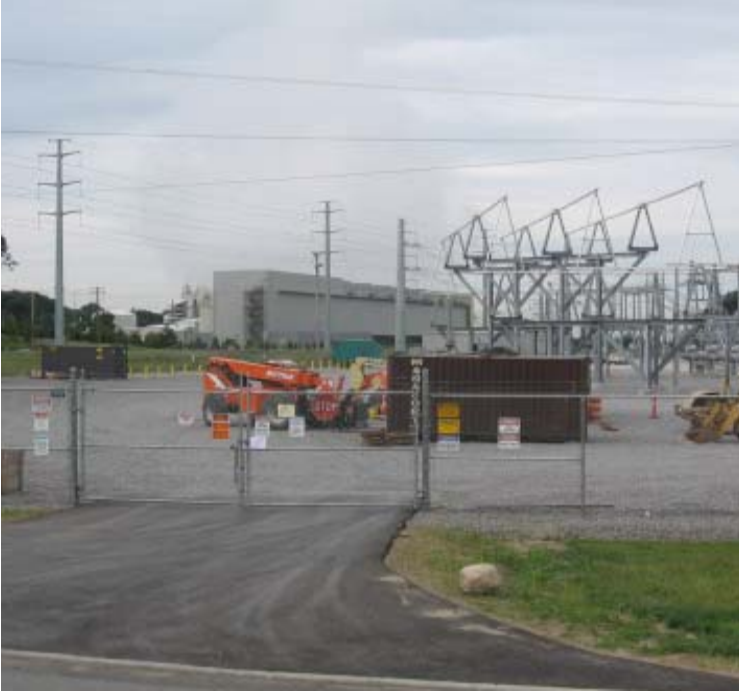
East Devon Substation (Milford): A view of the northern portion of the substation. Both northern access points have been paved with asphalt.

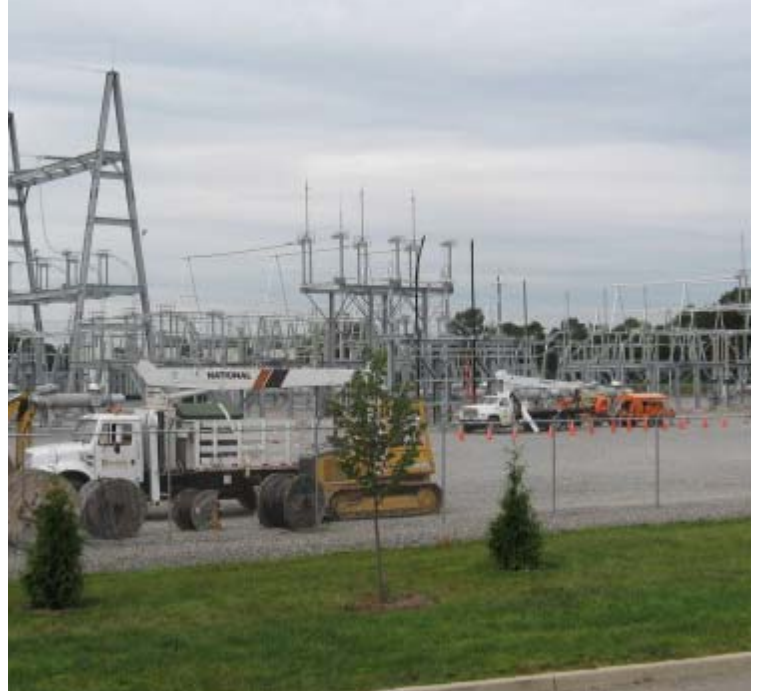
East Devon Substation: A view of the vegetative growth along Plains Rd and a general view of construction at the substation.

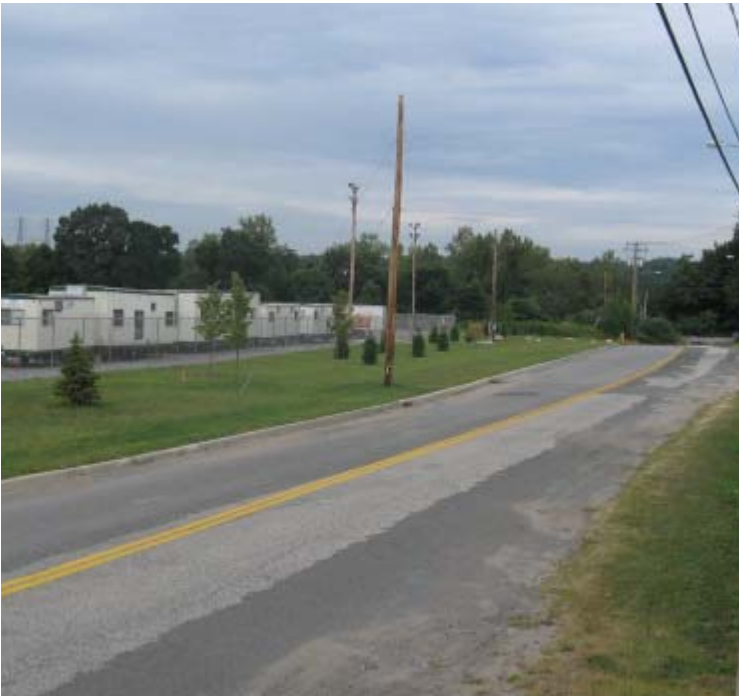
East Devon Substation: A view of Plains Rd. No sediment tracking was observed.

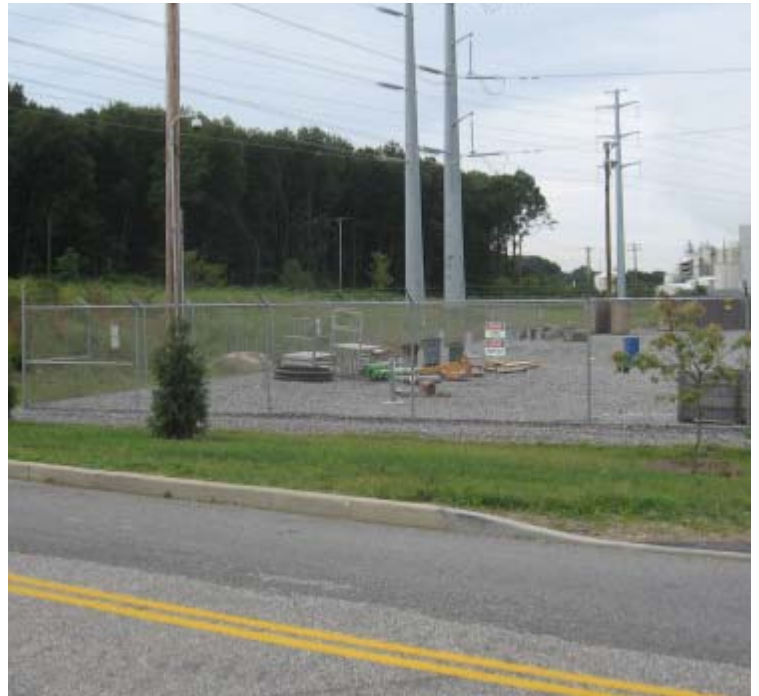
East Devon Substation: A general view of the NE corner of the substation and ROW.
