**Docket No. 272 – Development and Management Plan Inspection**

**Norwalk Substation**

**Date:** May 1, 2008

**Location:** Norwalk Substation - 50 New Canaan Avenue, Norwalk, CT

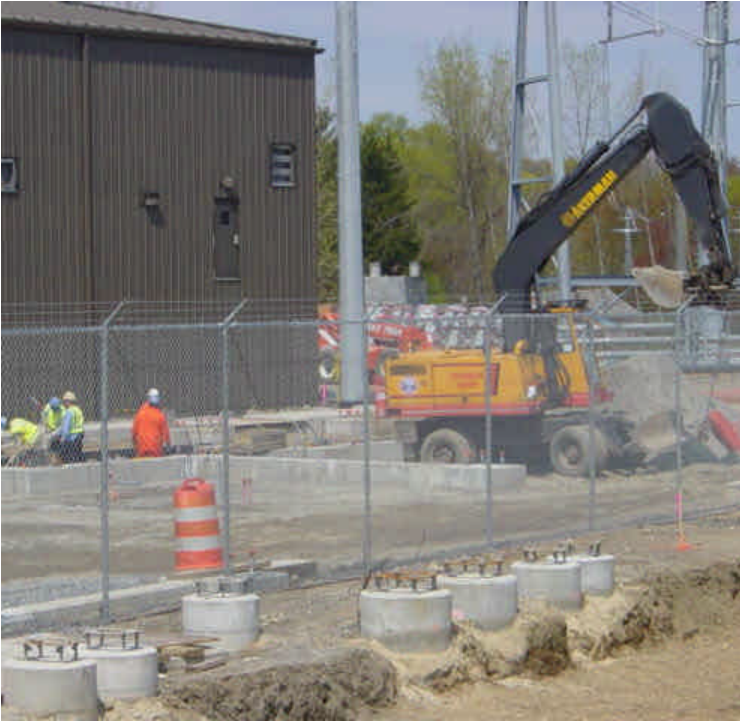
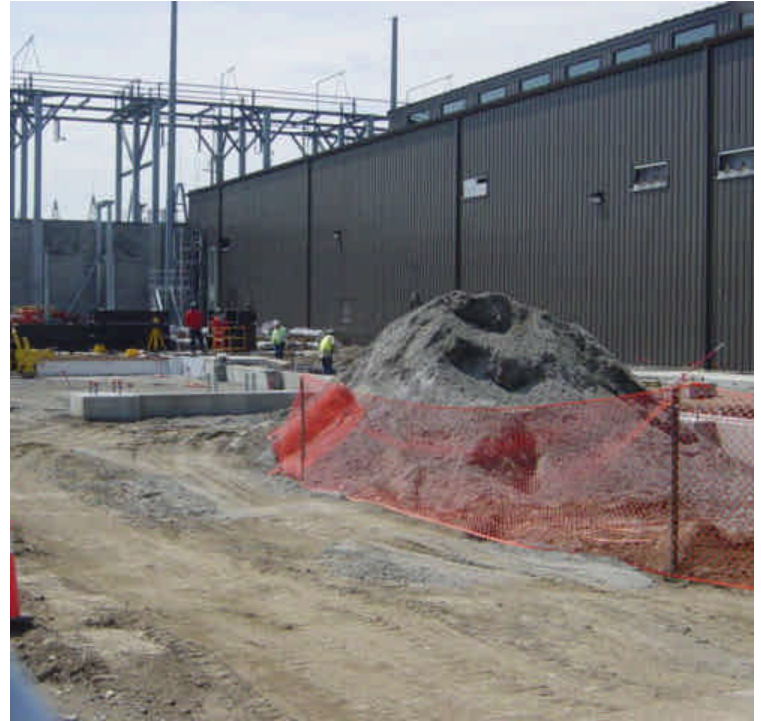
**Trenching and earthwork continue within the Norwalk substation to accommodate the new 345-kV equipment. Foundations have already been installed. The photo on the right shows a soil stockpile that was observed without adequate containment. However, the pile appeared to be actively used.**

<b>Areas of Inspection</b>	<b>Observation</b>	<b>Recommended Action</b>	<b>Corrected Action</b>
<b>or danger trees noted) or stabilization</b>	<b>and there is no vegetation within said limits. Some clearing of landscaped materials was required for Seg 4C tie-in work. 5/1/08</b>	<b>information. 5/1/08</b>	
<b>Dewatering</b>	<b>Dewatering was not observed at the time of the inspection. 5/1/08</b>	<b>Continue to properly contain/ filter discharge water when dewatering is required. 5/1/08</b>	<b>NA</b>
<b>Spills and Material Storage</b>	<b>Materials and equipment appear to be appropriately stored. 5/1/08</b>  <b>A stockpile of material was observed without appropriate containment, but the material was actively being used and was within the yard of the substation. 5/1/08</b>	<b>In general, provide regular equipment checks and repair any drips or leaks as soon as they are observed. 5/1/08</b>  <b>Provide adequate containment around temporary soil stockpiles. 5/1/08</b>	<b>NA</b>  <b>NA at this time.</b>

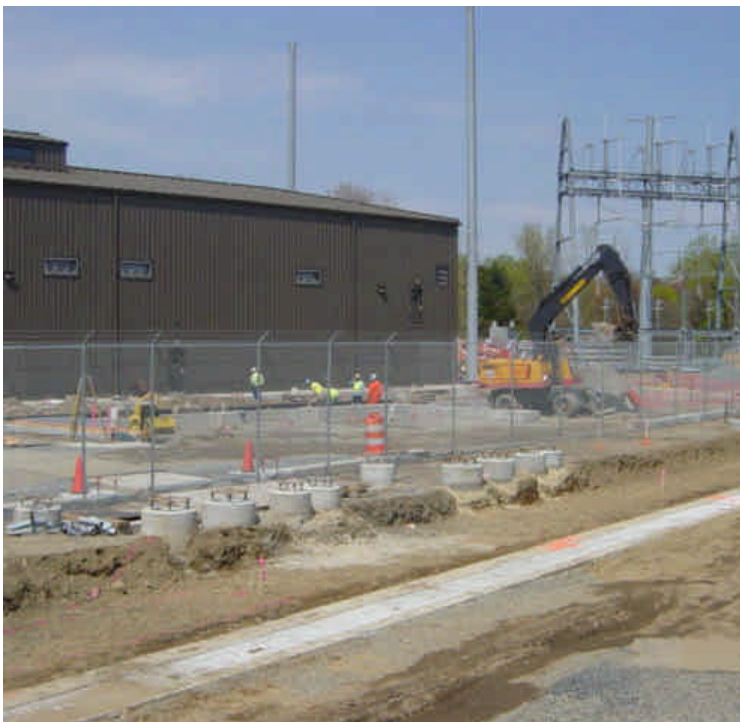
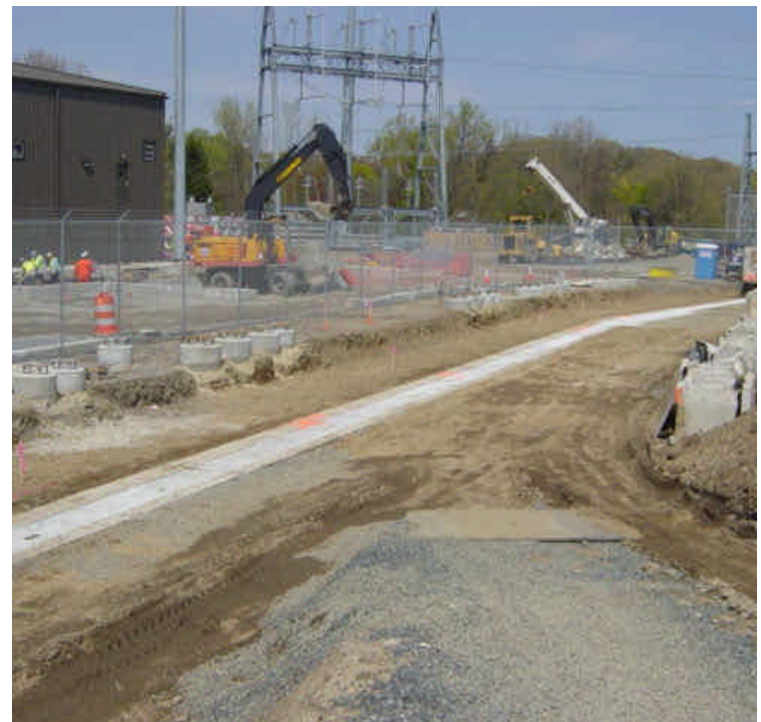
**Foundations have been installed to accommodate the new 345-kV equipment within Norwalk substation. The chain link perimeter fence has been relocated to accommodate this work. The modular concrete retaining wall has been temporarily removed to accommodate trenching and tie-in activities.**
