Docket No. 272 – Development and Management Plan Inspection

Norwalk Substation

Date: May 15, 2008

Location: Norwalk Substation - 50 New Canaan Avenue, Norwalk, CT

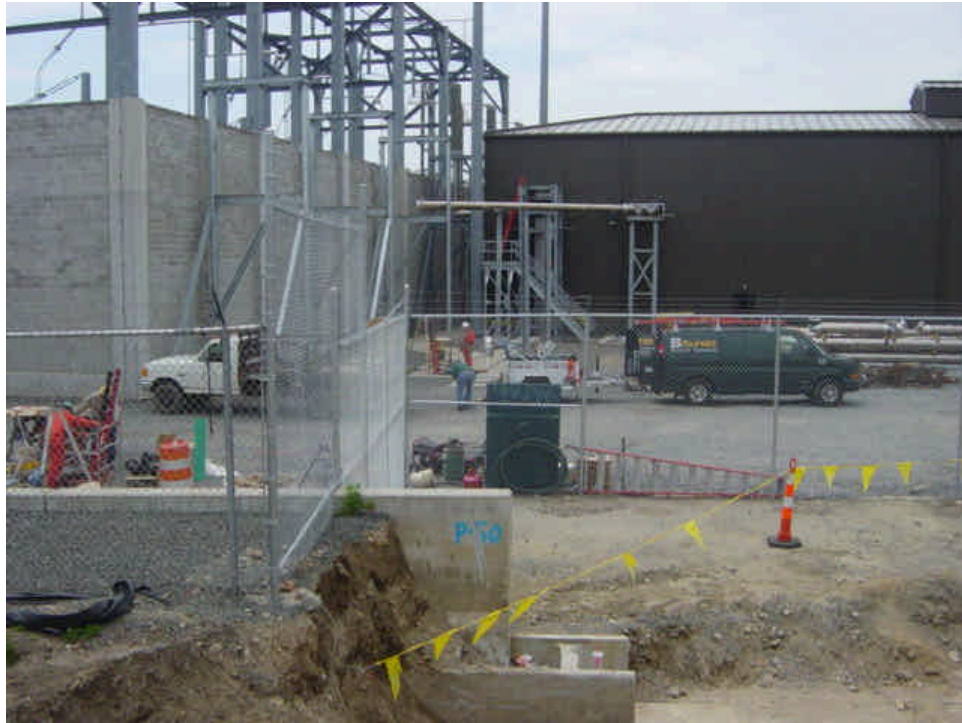
| Areas of Inspection | Observation | Recommended Action | Corrected Action |
|---|---|--|--|
| Active Construction | Electrical contractor was on site and appeared to be proofing conduit and/or pulling wires. The concrete slab has been poured. No other work was ongoing at the time of the inspection. 5/15/08 | None. 5/15/08 | Not Applicable (NA) |

Electrical contractors were on site proofing lines and pulling cables.

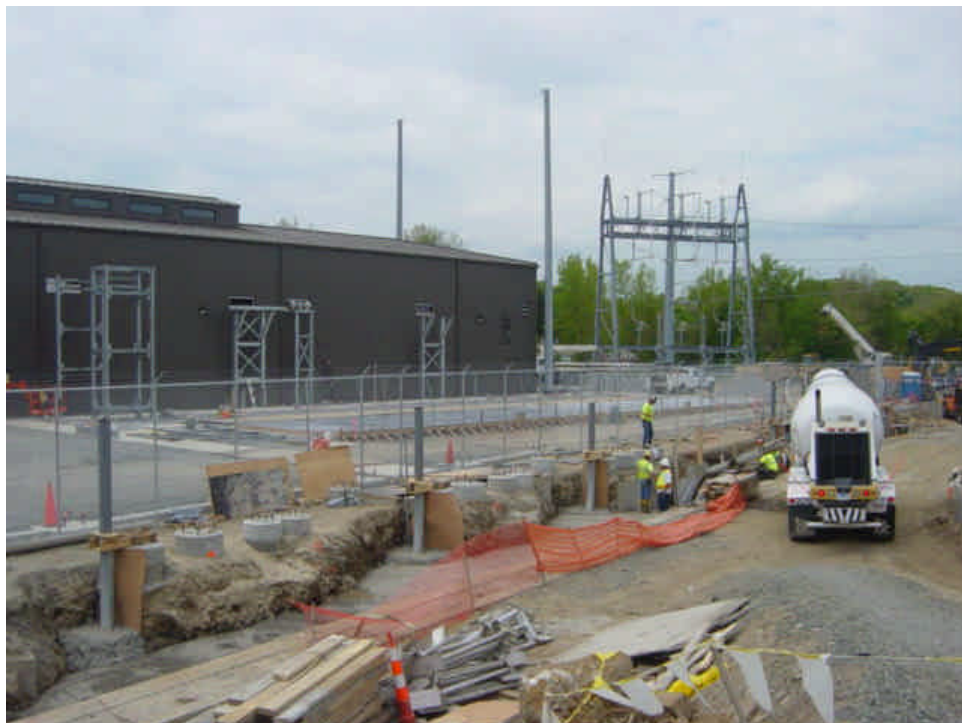
The concrete slab that was being formed during last week's inspection has been poured.
