Docket No. 272 – Development and Management Plan Inspection

Norwalk Substation

Date: May 22, 2008

Location: Norwalk Substation - 50 New Canaan Avenue, Norwalk, CT

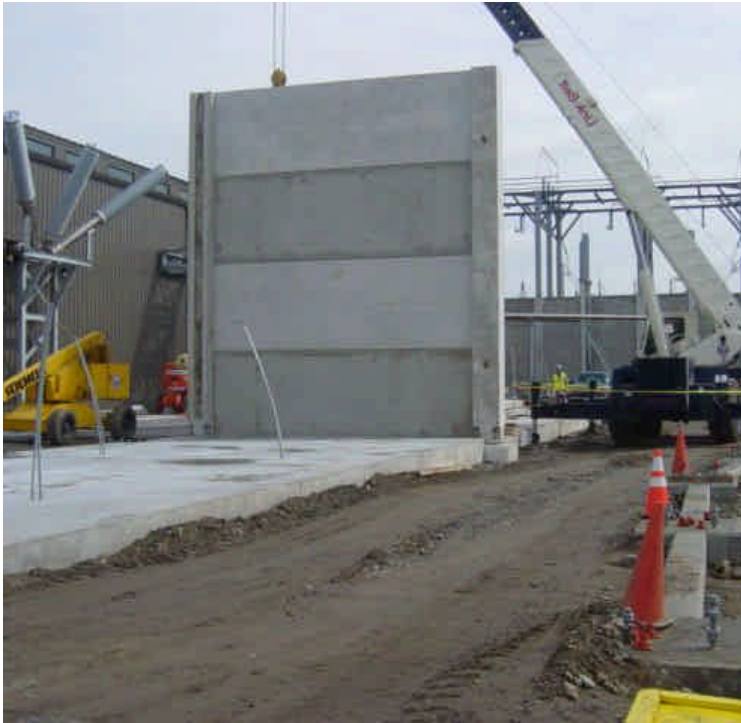
| Areas of Inspection | Observation | Recommended Action | Corrected Action |
|---|---|--|--|
| Active Construction | Crews were setting pre-cast concrete wall segments on the previously placed foundation slab. A steel structure was also being installed at the time of the inspection. 5/22/08 | None. 5/22/08 | Not Applicable (NA) |

Crews were setting pre-cast concrete wall segments on the previously placed foundation slab.

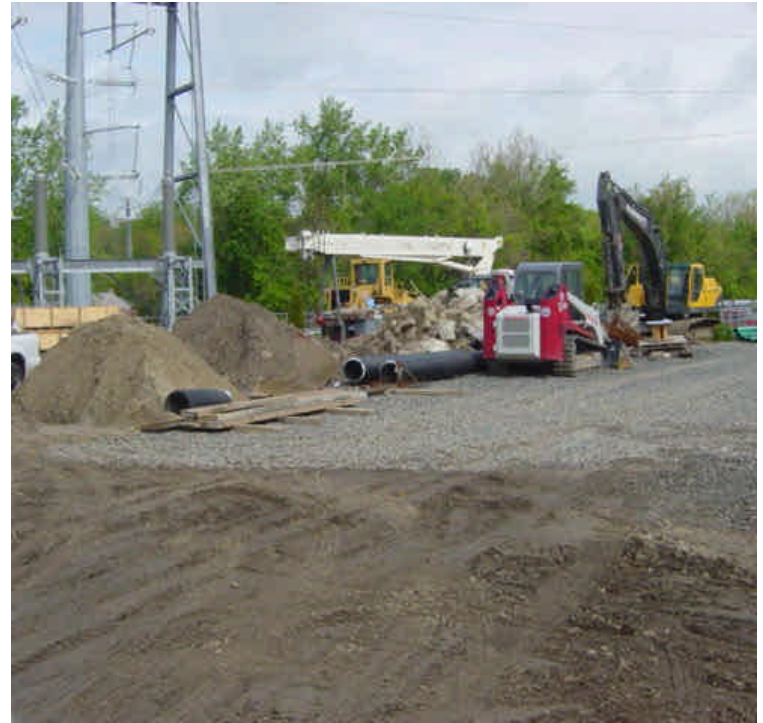
| Areas of Inspection | Observation | Recommended Action | Corrected Action |
|---|--|---|--|
| Spills and Material Storage | <p>Equipment appeared to be appropriately stored. 5/22/08</p> <p>Several stockpiles of material were observed without appropriate containment immediately at their base but they were located within the yard and surrounded with trap rock. 5/8-5/22/08</p> | <p>In general, provide regular equipment checks and repair any drips or leaks as soon as they are observed. 5/22/08</p> <p>Provide adequate containment around temporary material stockpiles. 5/8-5/22/08</p> | <p>NA</p> <p>Needs evaluation.</p> |

Several stockpiles of material were observed without appropriate containment immediately at their base, but they do remain contained to the yard.

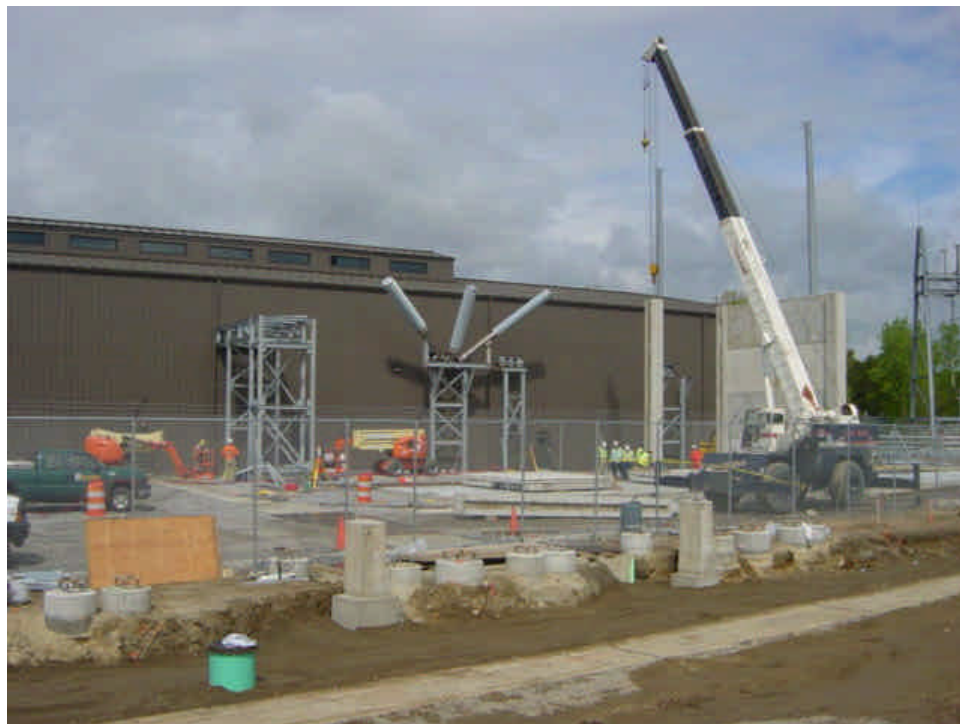
A steel structure was being installed next to the existing GIS building at the time of the inspection.
