Docket No. 272 – Development and Management Plan Inspection

Norwalk Substation

Date: June 12, 2008

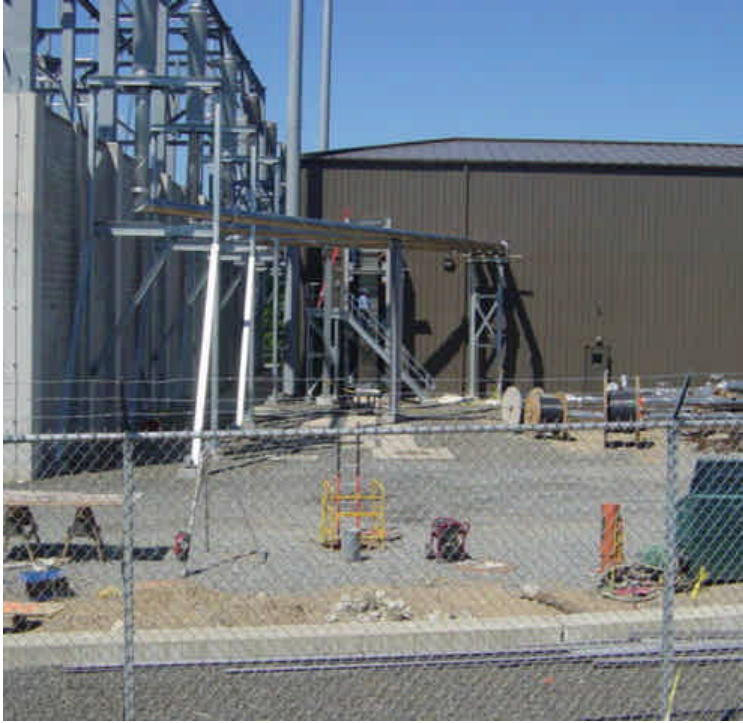
Electrical connection and tie-in work continues inside the substation. Crews were on-site preparing to pull cable.

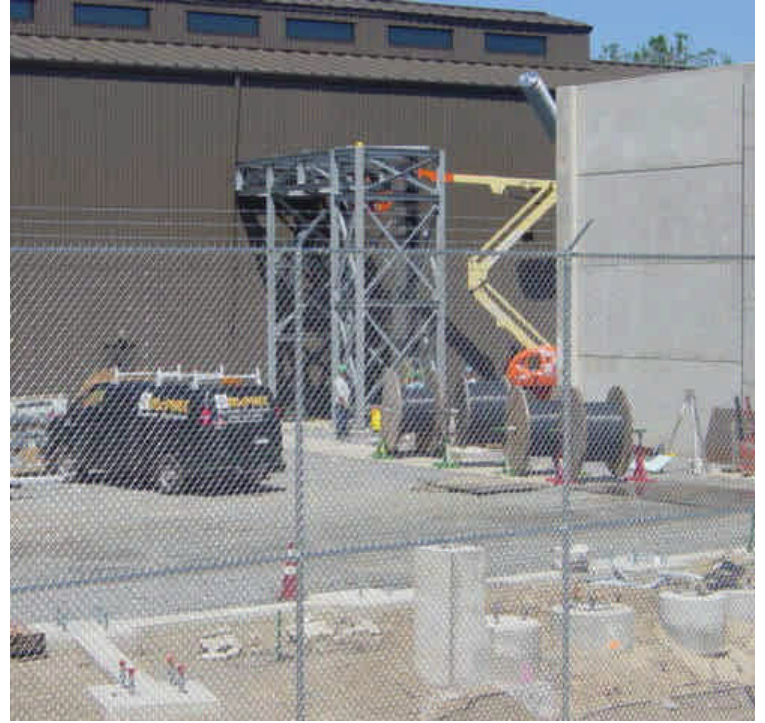
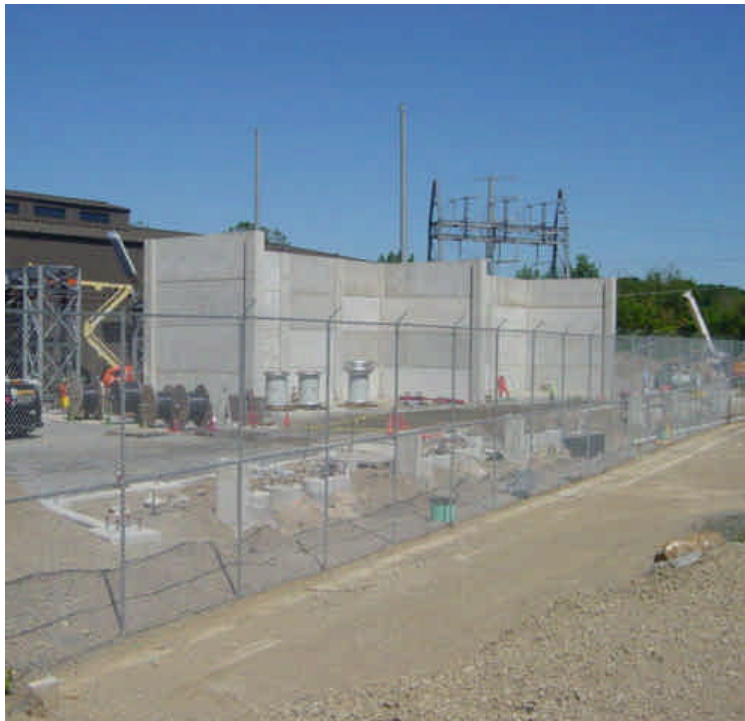
Minor excavation work was underway inside the substation.

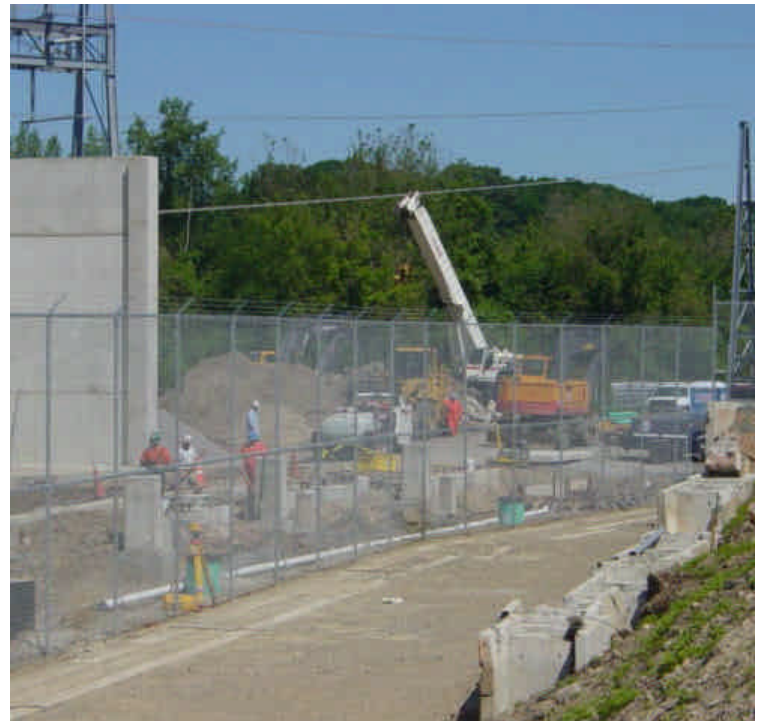
Stockpiles remain adjacent to the work area but there were no observed erosion issues. Watch any adjacent catch basins within the yard as they outlet to the river.
