Docket No. 272 – Development and Management Plan Inspection

Norwalk Substation

Date: June 20, 2008

Location: Norwalk Substation - 50 New Canaan Avenue, Norwalk, CT

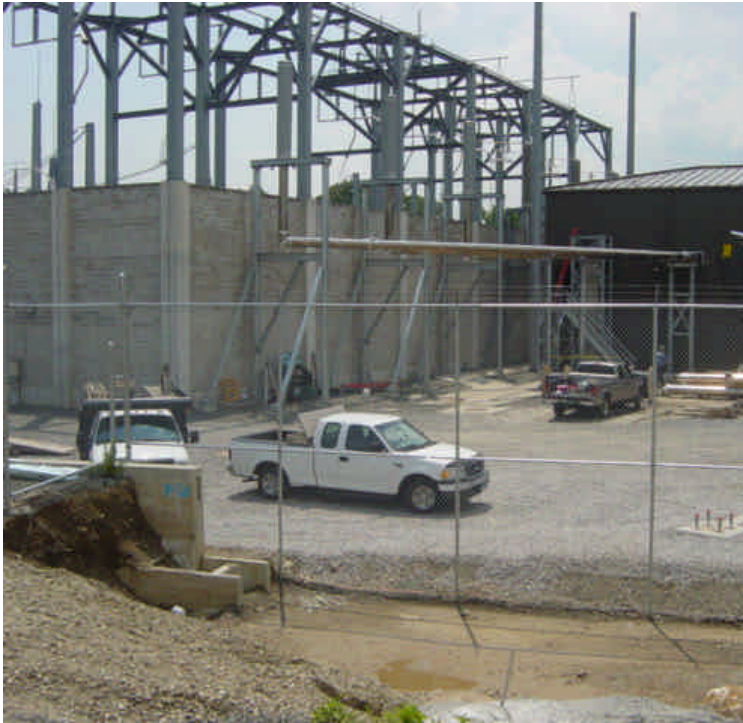
Electrical connection and tie-in work continues inside the substation.

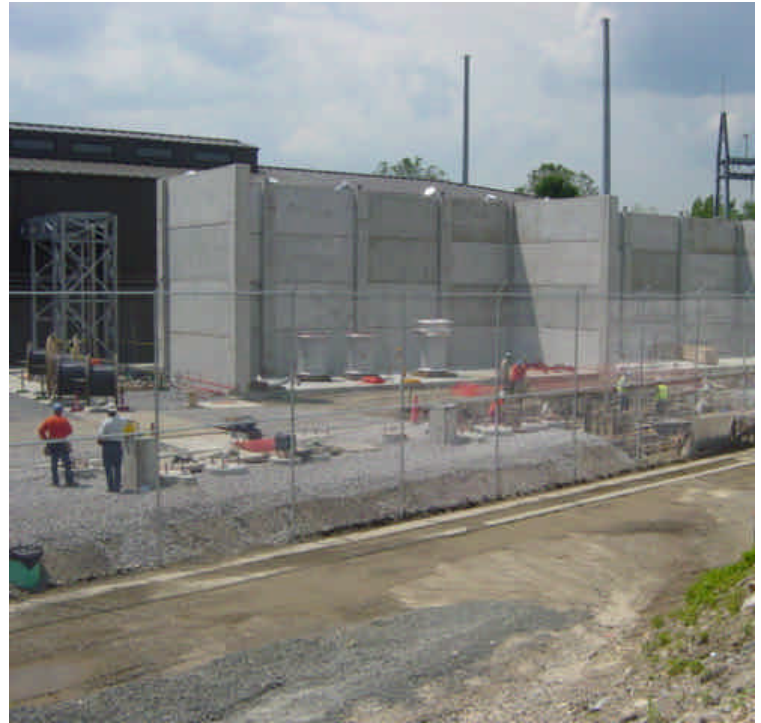
Crews were on-site preparing to pull cable and place additional equipment.

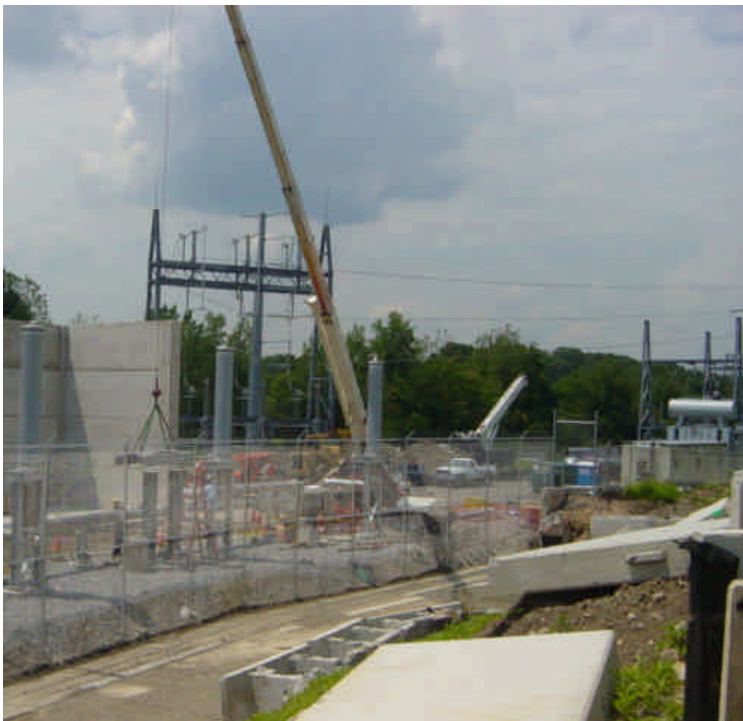
Additional electrical equipment was being placed inside the substation.

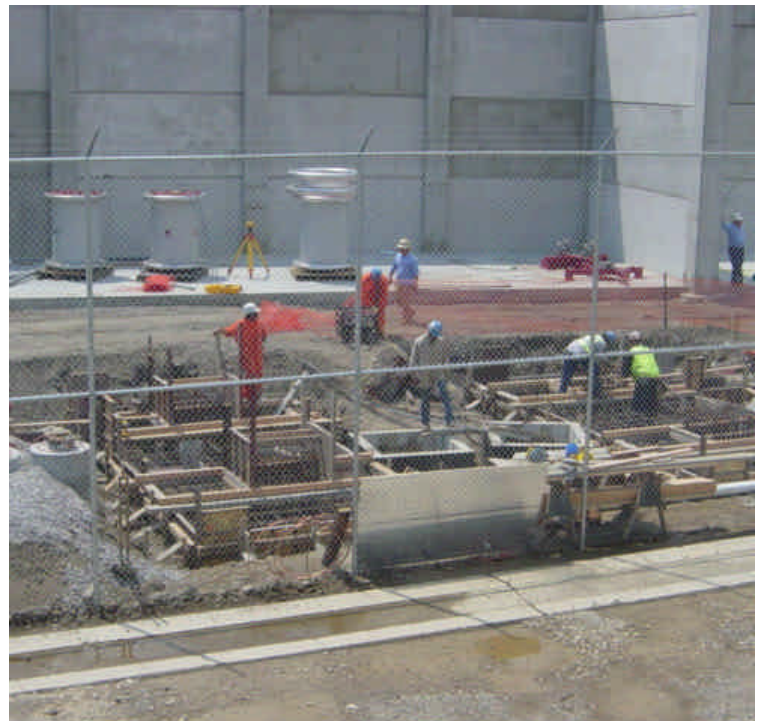
Crews were placing formwork in preparation for additional equipment foundations.
