Docket No. 272 – Development and Management Plan Inspection

Norwalk Substation

Date: June 27, 2008

Location: Norwalk Substation - 50 New Canaan Avenue, Norwalk, CT

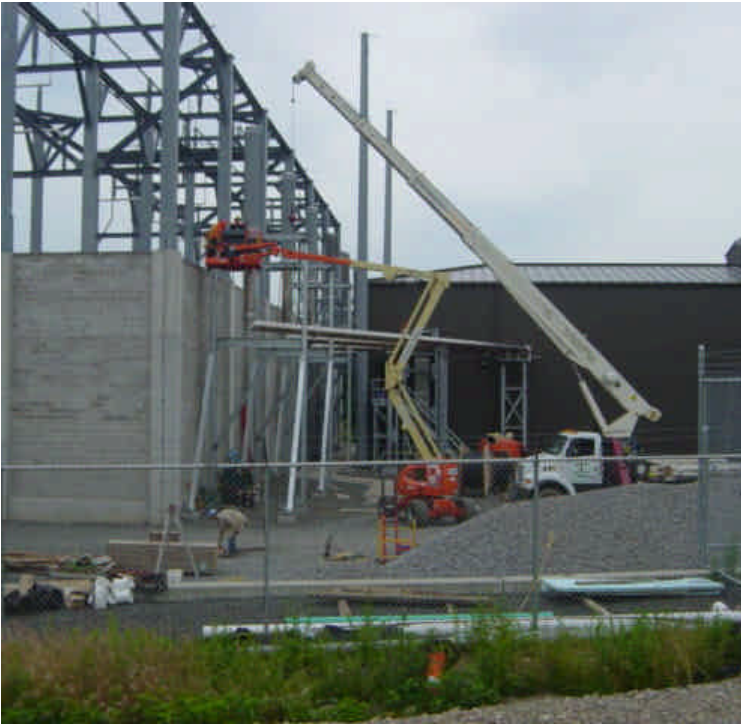
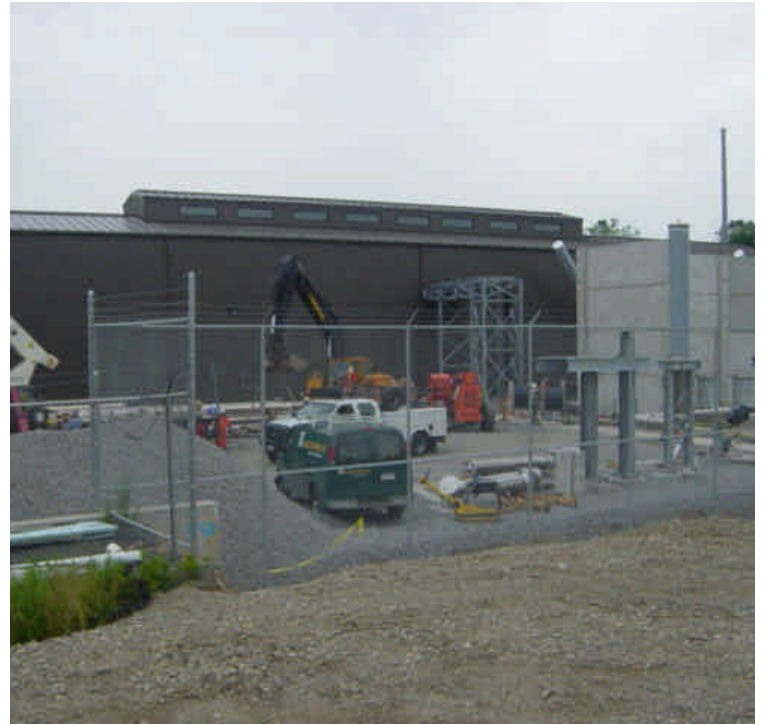
Crews were installing additional electrical equipment. A stockpile of crushed stone was also being temporarily stored near the work area.

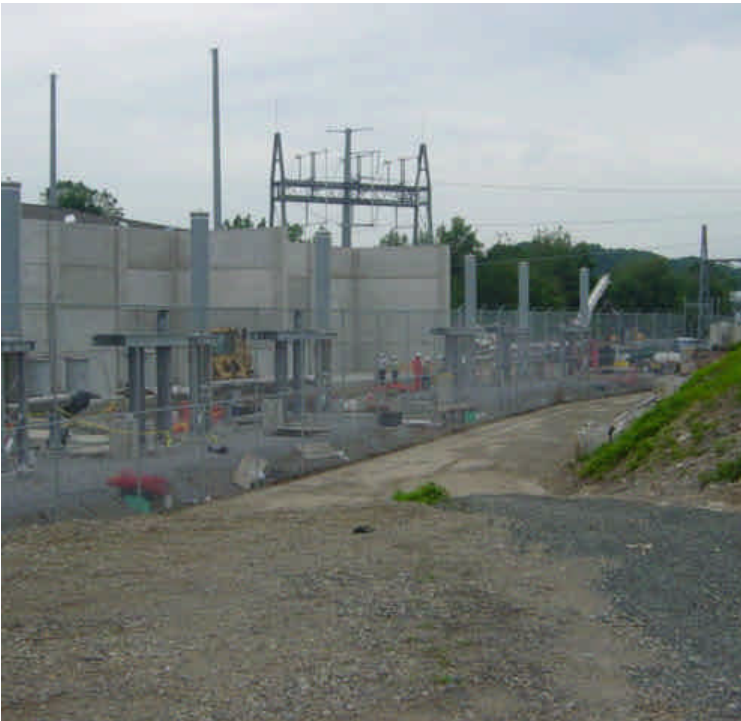
Additional concrete foundations have been placed within the substation.

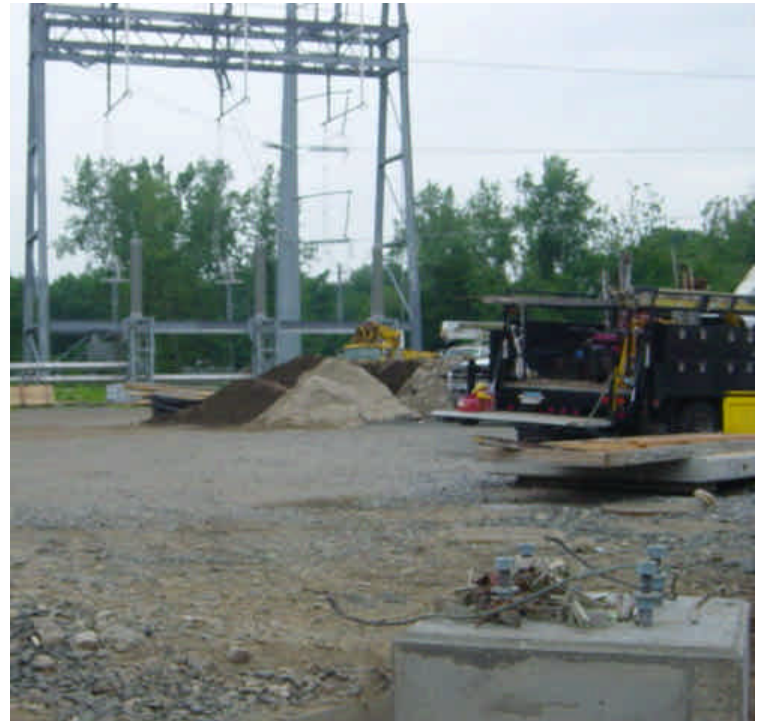
Stockpiled material was appropriately contained with silt fence.
