**Docket No. 272 – Development and Management Plan Inspection**

**Norwalk Substation**

**Date:** August 14, 2008

**Location:** Norwalk Substation - 50 New Canaan Avenue, Norwalk, CT

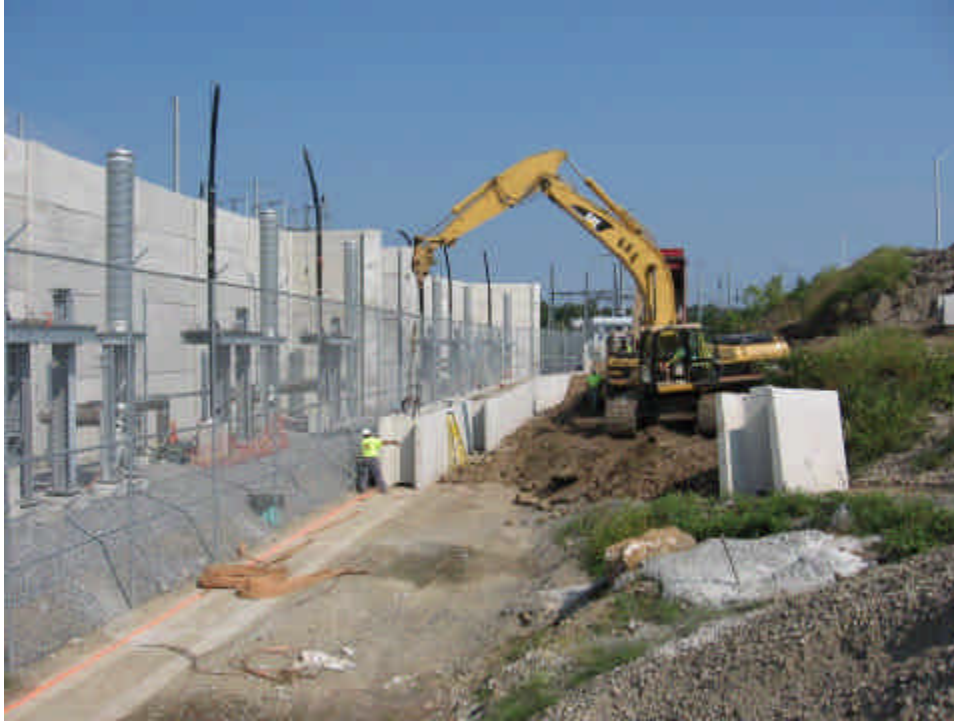
**Electrical tie-in work continues inside the substation. Pre-cast concrete retaining wall was being reset on the outside of the substation.**
