Docket No. 272 – Development and Management Plan Inspection

Norwalk Substation

Date: August 21, 2008

Location: Norwalk Substation - 50 New Canaan Avenue, Norwalk, CT

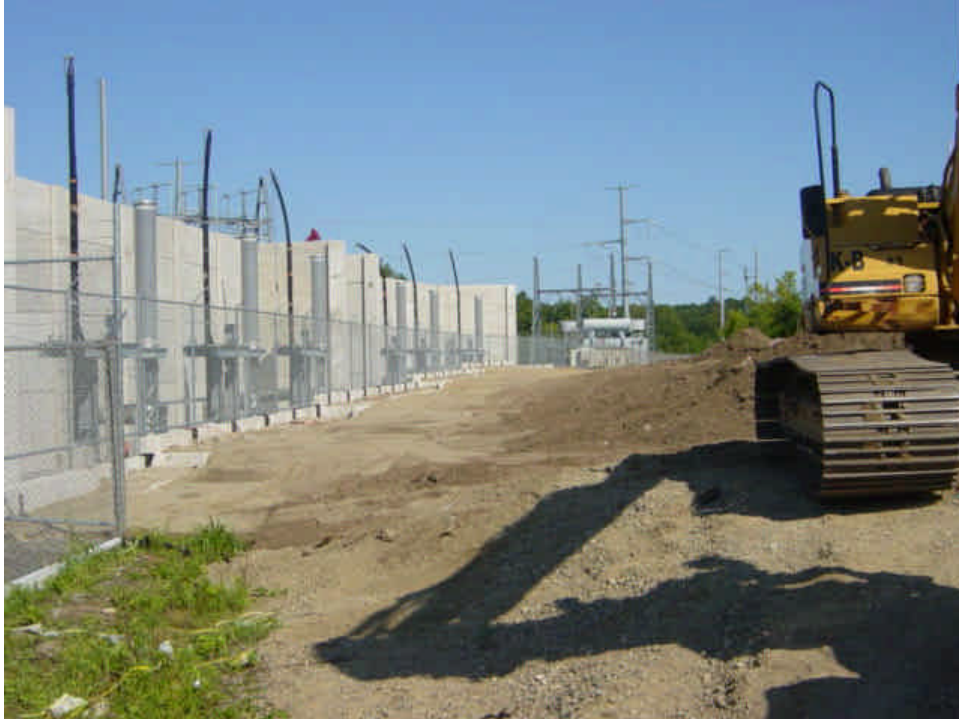
Electrical tie-in work continues inside the substation. Pre-cast concrete retaining wall has been reset along the substation perimeter.
